GROUP	MODEL
Subsequent Repair Action	2019-2020MY Optima P/HEV (JF P/HEV) w/Nu 2.0L GDI
NUMBER	DATE
PI2108Y/Z (Rev 1, 11/07/2024)	August 2023

SUBJECT: ENGINE REPLACEMENT INSTRUCTIONS FOR DTC P1326 (PI2108Y/Z)

This bulletin provides information related to the Technical Service Bulletin previously published in (PI2108) titled "Knock Sensor Detection System - ECU Logic Improvement" for certain 2019-2020MY Optima P/HEV (JF P/HEV) vehicles equipped with Nu 2.0L GDI engine, produced from July 6, 2018 through October 28, 2019. Specifically, this bulletin provides instructions on which procedures to follow if, after installation of the KSDS, any one of the subject vehicles below return to the dealer with Diagnostic Trouble Code (DTC) P1326 (Knock Signal Range/Performance).

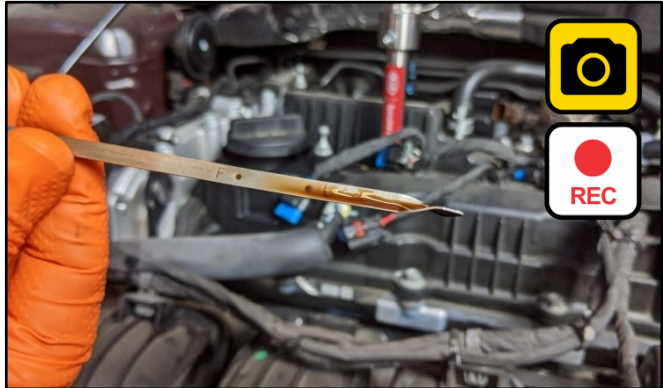
1. Start video showing vehicle and move in towards the dash VIN tag.
2. Measure and record oil dip stick level.
3. Note oil dip stick reading on the RO.
4. Take a picture of the oil reading on dipstick.

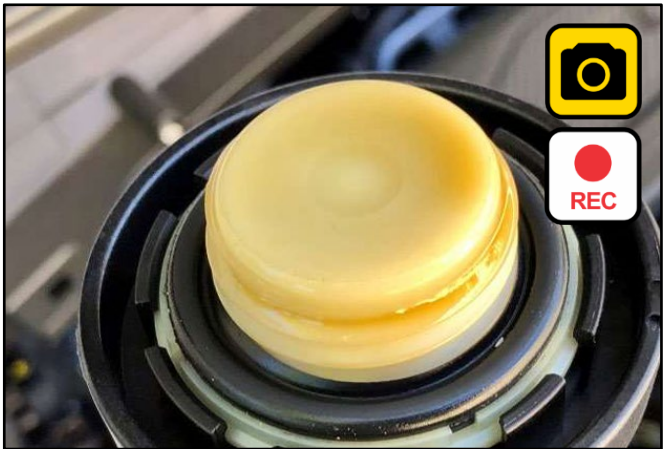
5. Inspect the inner/bottom of the oil cap and inside oil filler opening.

6. Take a picture of both, the bottom of the oil cap and oil filler opening.

Record/Note findings: No oil, oil sludge, varnish, burnt oil smell condition(s) found.

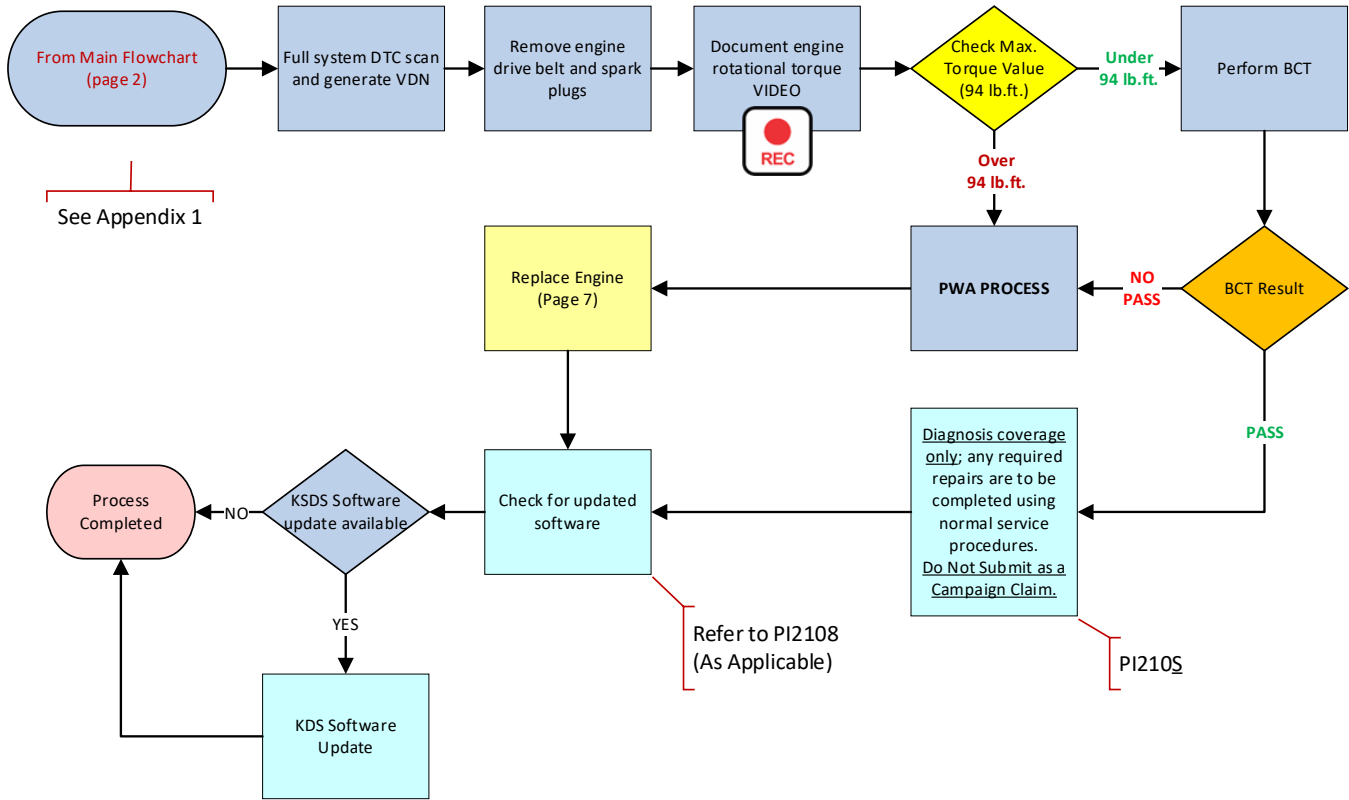
C. Engine No Crank

Techline PWA Required; Diagnosis Only Campaign Possible

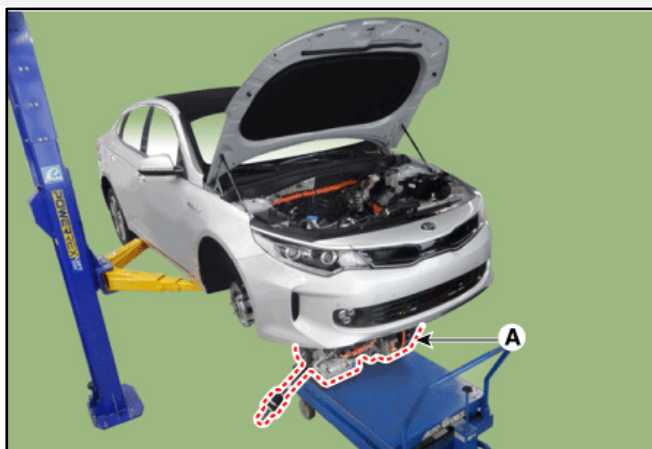
**Engine Replacement Procedure:**

1. Replace the engine assembly by referring to the "Engine Mechanical System → Engine And Transaxle Assembly → Engine And Transaxle Assembly → Repair Procedures" chapter in the applicable Shop Manual on KGIS.

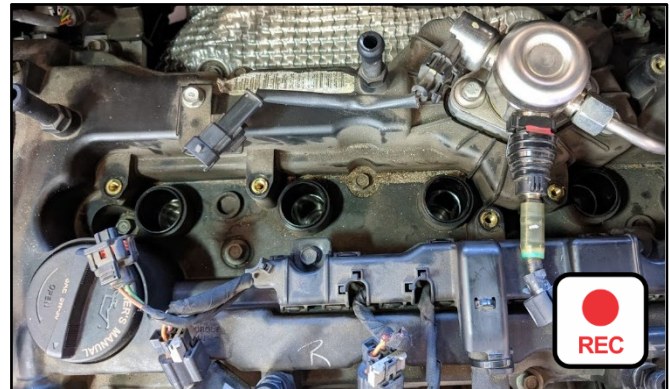
3. Show the empty spark plug holes from the engine.

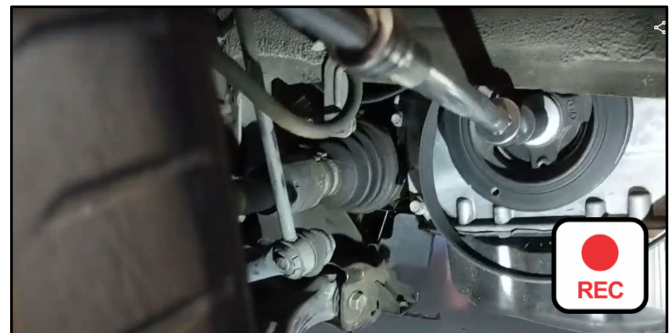
5. Show the removed drive belt and attached torque wrench to crank bolt.

Prepare the vehicle prior to the video by removing the spark plugs and drive belt as well as setting the torque wrench to 94 lb.ft.

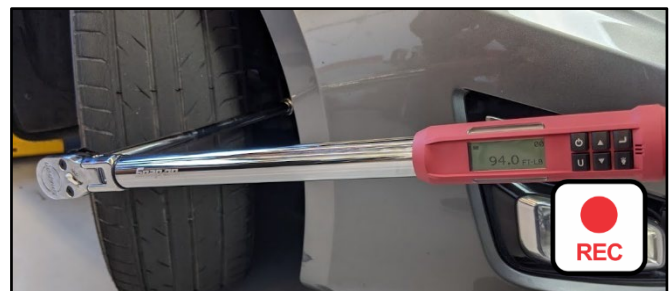
6. Show the engine being cranked and torque specification exceeding 94 lb.ft. torque.
