GROUP	MODEL
Voluntary Emissions Service Campaign	2024MY Sorento (MQ4a) w/ 2.5L T-GDI Theta III
NUMBER	DATE
SC318	November 2024

### ECM LOGIC UPDATE (SC318)

This bulletin provides the procedure to update the software logic of the Engine Control Module (ECM) system on certain 2024MY Sorento (MQ4a) vehicles equipped with 2.5L T-GDI Theta III engines produced from December 7, 2023 through February 26, 2024. The subject vehicles may have engine calibrations that were not optimized for emissions standards under certain specific conditions, which may cause the vehicle to release air pollution which exceed Federal and California standards. As a result, the subject vehicles may exhibit an illumination of the Malfunction Indicator Lamp (MIL) with DTC P060547. Follow the procedure outlined in this publication to apply the improved logic to the 'Engine' system using the KDS ECU Upgrade function as described in this bulletin. For more information that the latest reflash has been applied to a vehicle you are working on, verify the ROM ID using the table on page 3 of this bulletin. Before conducting the procedure, verify that the vehicle is included in the list of affected VINs.

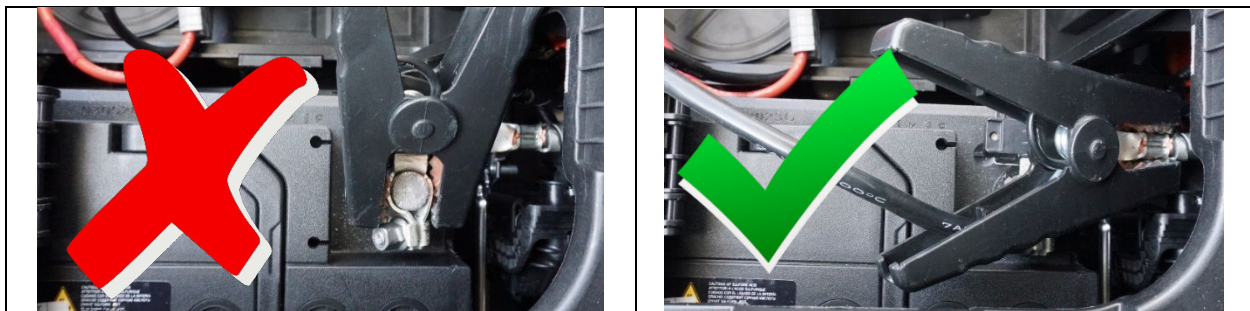
**Note:** When connecting the external battery pack, in-vehicle operation built-in CAM might be issued by impossible charging amount sensing of the battery sensor.

[Connect the negative \(-\) terminal to the battery as shown below.](#)

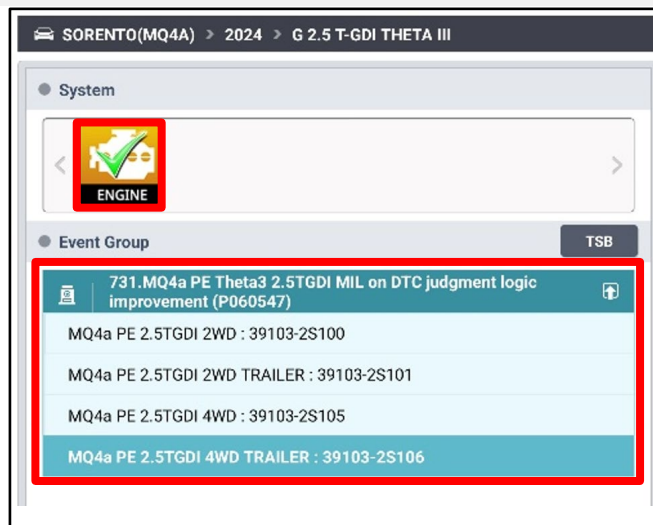
**UPGRADE EVENT:**

**731.MQ4a PE Theta3 2.5TGDI MIL ON DTC Judgment Logic Improvement (P060547)**
