# TECHNICAL SERVICE BULLETIN

| <b>SERVICE BULLETIN SUBJECT:</b> | 800 Volt Vehicle Controller Software Update |
| <b>SERVICE BULLETIN #:</b> | SB-22-85 |

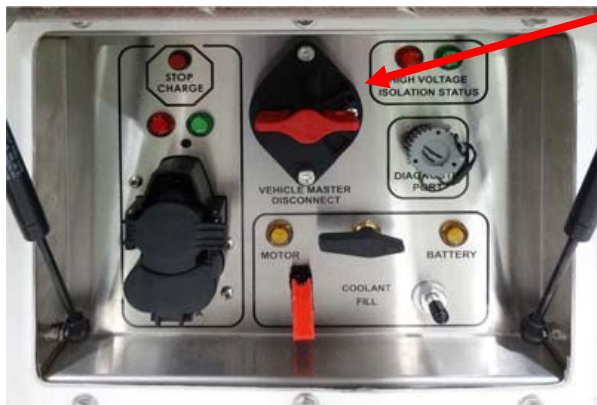
1. Power up and login to the Proterra-Supplied laptop or a comparable PC that has the Proterra Diagnostics Tool software installed with a valid license.
2. Turn ON the 12/24V rear Vehicle Master Disconnect located at the curbside rear charge port access panel.

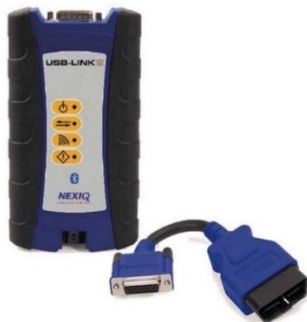
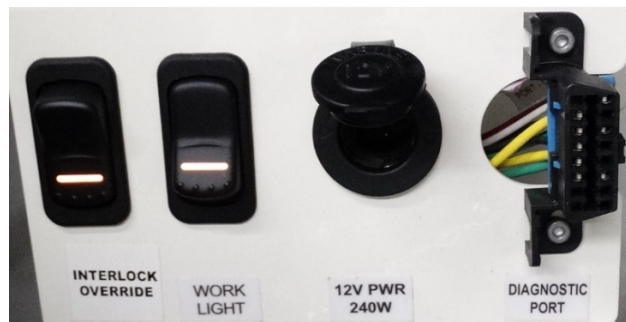
3. Connect the Nexiq USB Link2 device to the laptop and to the OBDII Diagnostic Port located in the streetside wheel well box.

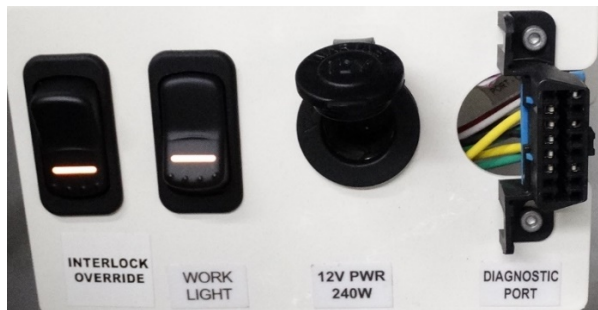
7. After completing the software update, turn OFF the Work Light switch inside the streetside wheel well box.

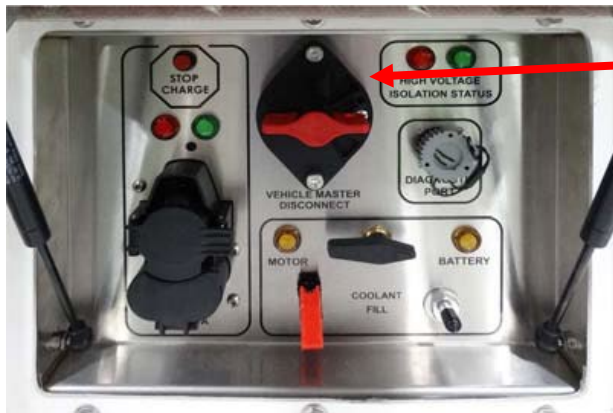
13. These parameters should all have a value of 0. If these parameters have any other value, use the Diagnostic Tool to set them to 0.
14. Scroll through the entire list of Body Parameters. No Body Parameter should have a value of 238. If any Body Parameters have a value of 238, use the Diagnostic Tool to set the value to 0.
15. Turn OFF the 12/24V rear Vehicle Master Disconnect located behind the vehicle curbside rear charge port access panel, wait ten seconds, and then turn back to ON.
