GROUP	MODEL
ELE	2020-2024MY Multiple Models w/ AVN 5.0 Wide
NUMBER	DATE
303 (Rev 3, 11/15/2024)	August 2023

TECHNICAL SERVICE BULLETIN

SUBJECT: **AVN 5.0 WIDE NON-RESPONSIVE RADIO ICON (AM, FM, SXM)**

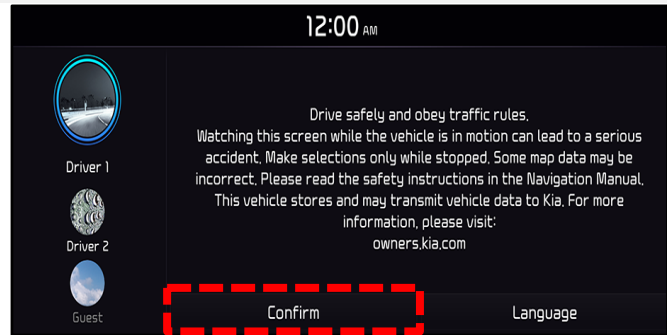
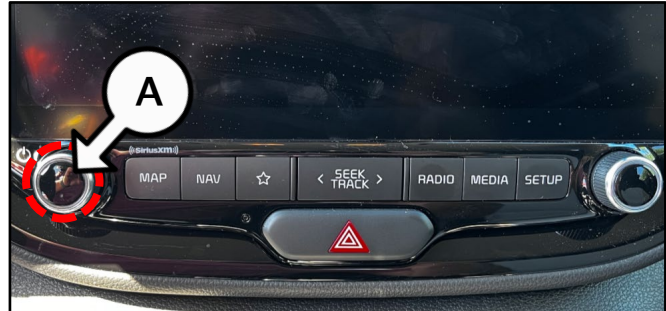
3. Press the 'Power' button (A) to turn the Radio/Media 'OFF'.

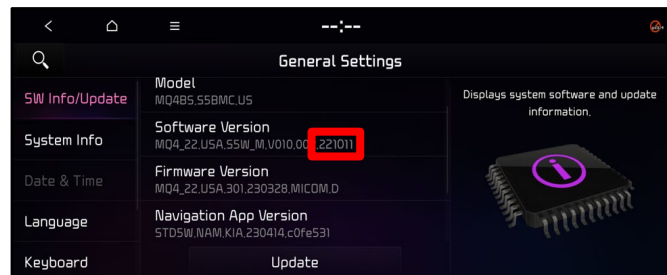
6. Inspect the last six (6) digits of the AVN Software Version displayed in 'General Settings'.

- If the current software version shown in 'General Settings' is included in the software version listed below, then proceed to step 7.
- If the current software version shown in 'General Settings' is not included in the software version listed below, **this TSB does not apply.**

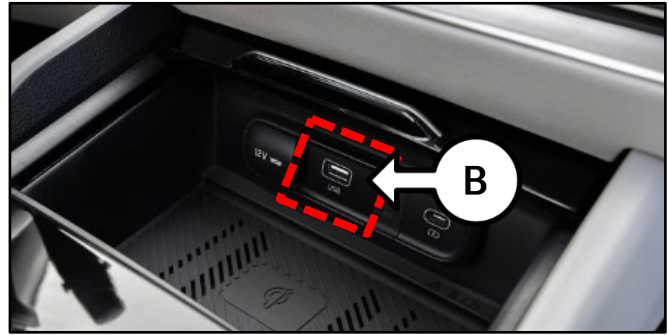
7. Insert the USB Flash Drive (refer to the table below) into the USB slot (B) located underneath the AVN unit.

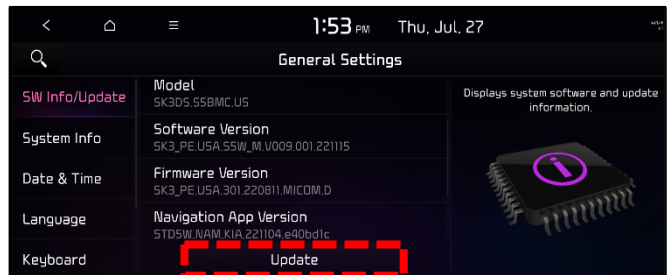
8. On the 'General Settings' screen, select 'SW Info/Update', then select 'Update'.

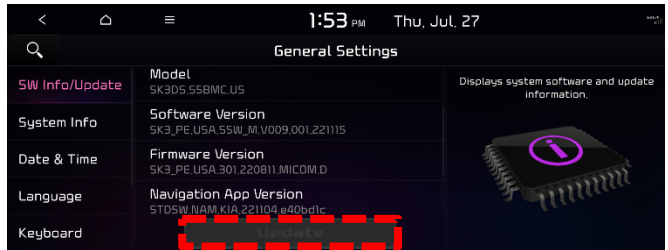
Note: If the USB Flash Drive is not recognized, the 'Update' button will not be activated, as shown. If this occurs, remove the USB Flash Drive and repeat steps 3-7.

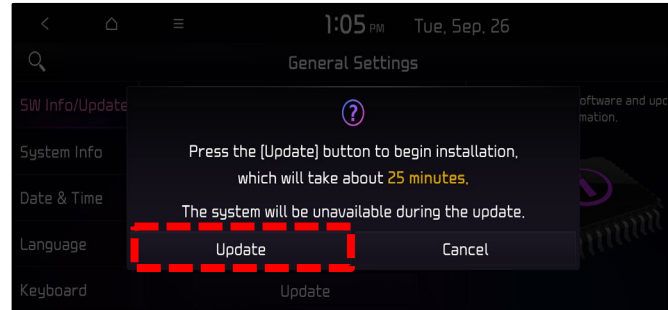
10. Select 'Update' on the pop-up screen.

Note: In some cases, the software update may take up to 2 hours and 30 minutes to complete. During this dwell time, it is acceptable to work on other vehicles.

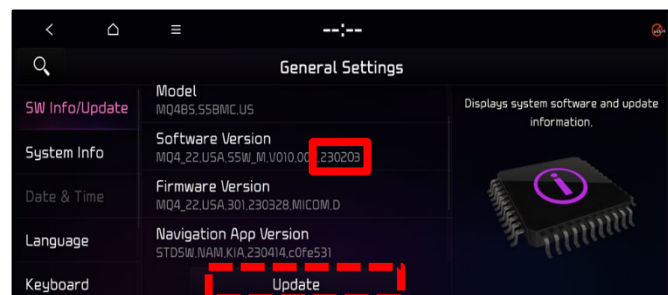
11. Once the update has completed, repeat steps 4-6 to confirm the Software Version has been correctly updated.
