GROUP	MODEL
TRA	2021-2023 MY Sorento (MQ4a) and K5 (DL3a) w/2.5L T-GDI w/DCT
NUMBER	DATE
111 (Rev 2, 11/14/2024)	July 2024

TECHNICAL SERVICE BULLETIN

8-SPEED DUAL CLUTCH TRANSMISSION EOP SENSORLESS LOGIC IMPROVEMENT

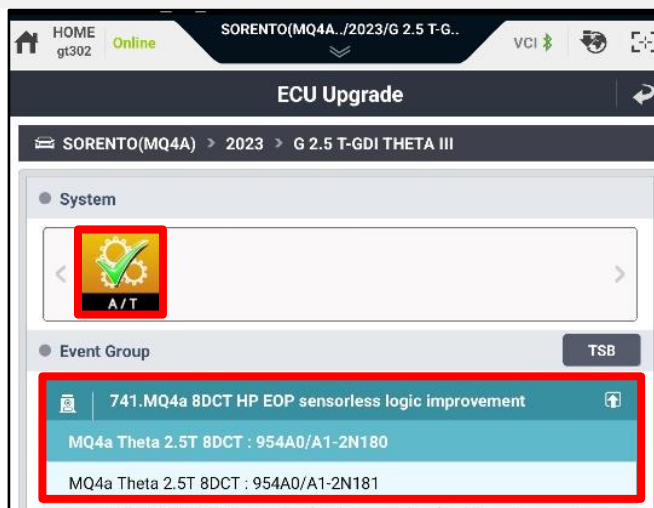
1. **UPGRADE EVENT:**

741.MQ4a 8DCT HP EOP Sensorless Logic Improvement

742.DL3a 8DCT HP EOP Sensorless Logic Improvement
