GROUP	MODEL
ELE	2025MY Carnival (KA4) and Carnival HEV (KA4 HEV)
NUMBER	DATE
360	November 2024

TECHNICAL SERVICE BULLETIN

SUBJECT: **SERVICE ACTION: CCU LOGIC IMPROVEMENT (SA593)**

This bulletin provides the procedure to update the software logic of the Central Communication Unit (CCU) system on certain 2025MY Carnival (KA4) vehicles produced from April 15, 2024 through August 26, 2024 and Carnival HEV (KA4 HEV) vehicles produced from July 8, 2024 to September 23, 2024. The affected vehicles may experience a 'dark current' draw from the 12V battery while the vehicle is parked, potentially resulting in low battery voltage and no-start condition. Follow the procedure outlined in this publication to apply the improved logic to the 'CCU' system using the KDS ECU Upgrade function as described in this bulletin. Before conducting the procedure, verify that the vehicle is included in the list of affected VINs. For confirmation that the latest reflash has been applied to a vehicle you are working on, verify the ROM ID using the table on page 3 of this bulletin.

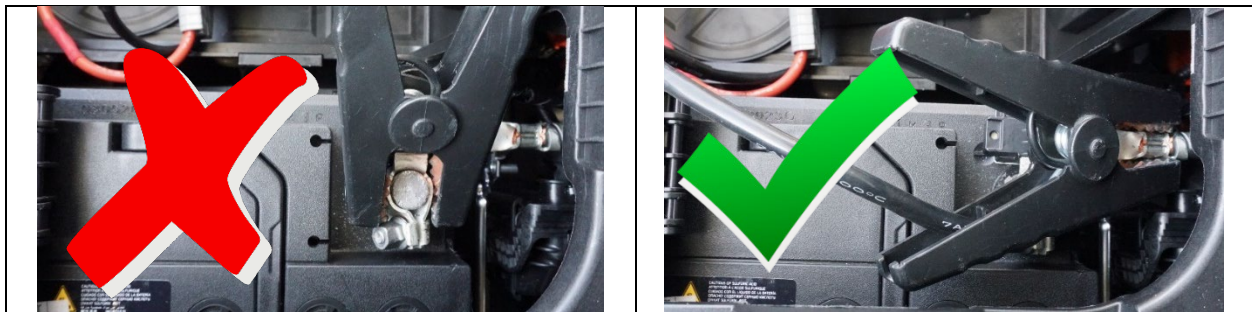
[Connect the negative \(-\) terminal to the battery as shown below.](#)

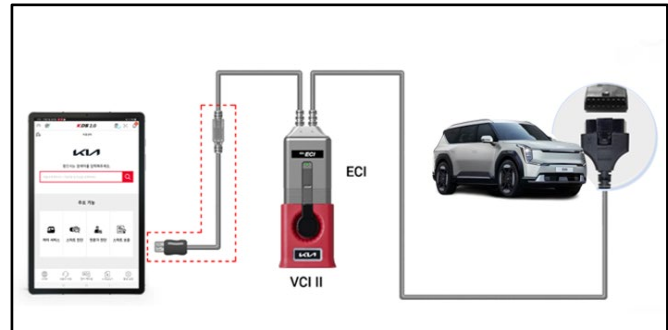
- 1a. Connect the ECI DLC connector to the OBD-II connector, located under the driver's side of the instrument panel.
- 1b. Connect the ECI USB -C connector to the KDS tablet.
- 1c. Connect the VCI II to the ECI OBD-II connector.

Ensure the ECI cable is configured by referring to the ['KDS Configuration for ECI Cable Usage'](#).

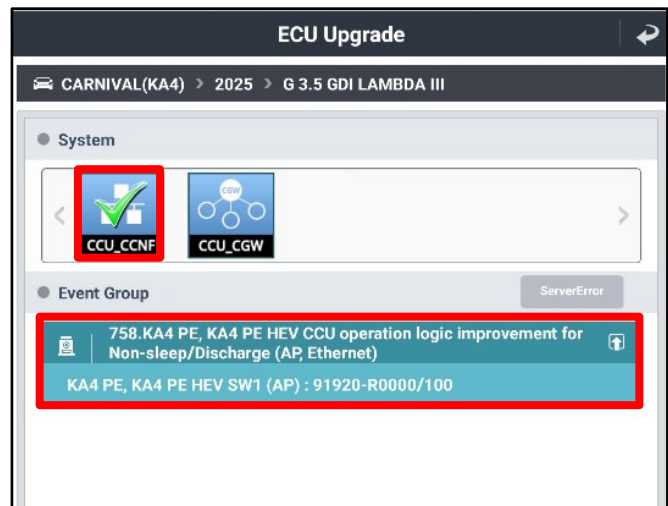
2. **UPGRADE BOTH EVENTS:**

- 758.KA4 PE, KA4 PE HEV CCU Operation Logic Improvement for Non-Sleep/Discharge (AP, Ethernet)
- 759.KA4 PE, KA4 PE HEV CCU Operation Logic Improvement for Non-Sleep/Discharge (MCU, Ethernet)

If the automatic upgrade fails, error code '9000-37-7F22' may appear on the screen during the first manual upgrade attempt. However, in most cases, attempting the manual upgrade a second time is typically successful.
