# TECHNICAL SERVICE BULLETIN

| <b>SERVICE BULLETIN SUBJECT:</b> | 800 Volt Vehicle Controller Software Update |
| <b>SERVICE BULLETIN #:</b> | SB-22-79 |

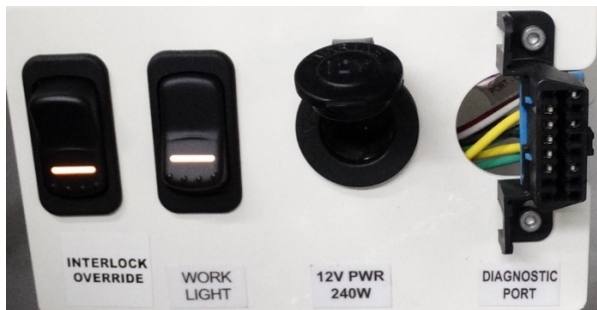
7. After completing the software update, turn OFF the Work Light switch inside the streetside wheel well box.

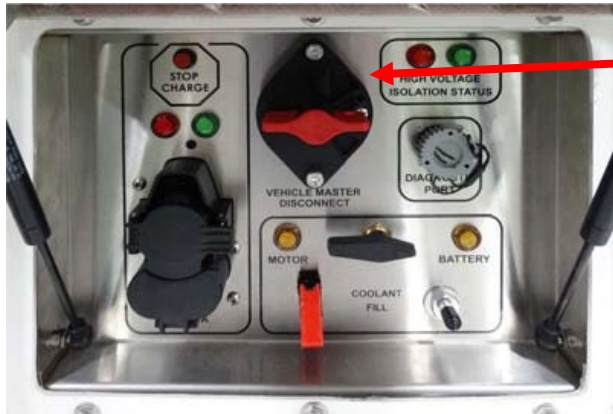
13. These parameters should all have a value of 0. If these parameters have any other value, use the Diagnostic Tool to set them to 0.
14. Scroll through the entire list of Body Parameters. No Body Parameter should have a value of 238. If any Body Parameters have a value of 238, use the Diagnostic Tool to set the value to 0.
15. Turn OFF the 12/24V rear Vehicle Master Disconnect located behind the vehicle curbside rear charge port access panel, wait ten seconds, and then turn back to ON.
