TECHNICAL SERVICE BULLETIN

ISSUE DATE:	6-27-2022
SERVICE BULLETIN SUBJECT:	Prodrive Powertrain Software Update
VINs or MODELS AFFECTED:	Service Specified Buses
COMPLETE BY:	Next Service Opportunity
SERVICE BULLETIN #:	SC-22-78
LABOR OPERATION CODE:	PD45Z

PRODRIVE POWERTRAIN SOFTWARE UPDATE

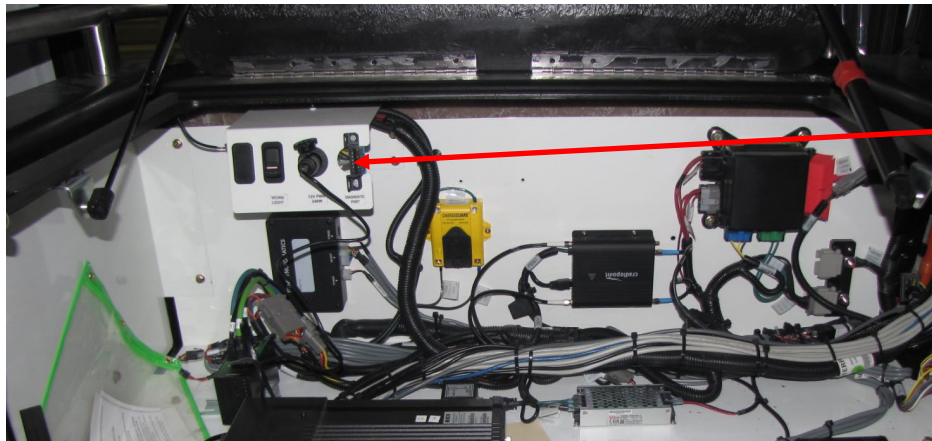
OBDII Port

3. Open the Streetside wheel well box to access to the OBDII Port.

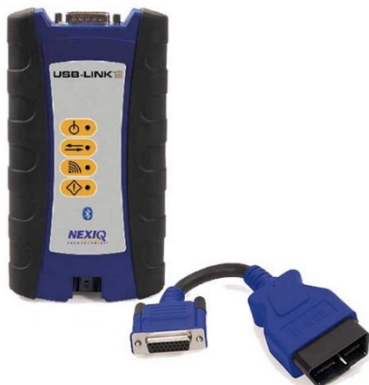
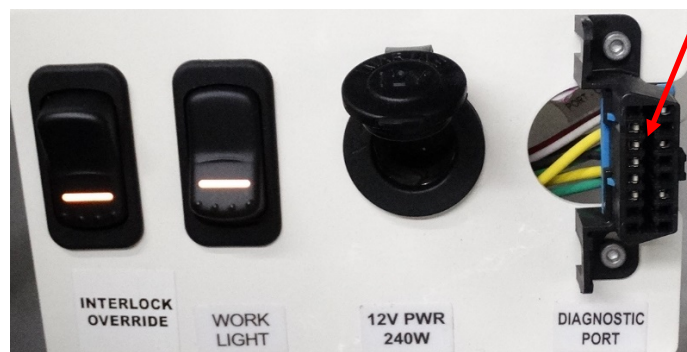
4. Power up (boot) the Proterra-supplied laptop containing the Proterra Diagnostic Tool.
5. Connect the Nexiq USB Link2 device to the laptop and to the appropriate OBDII Diagnostic Port.

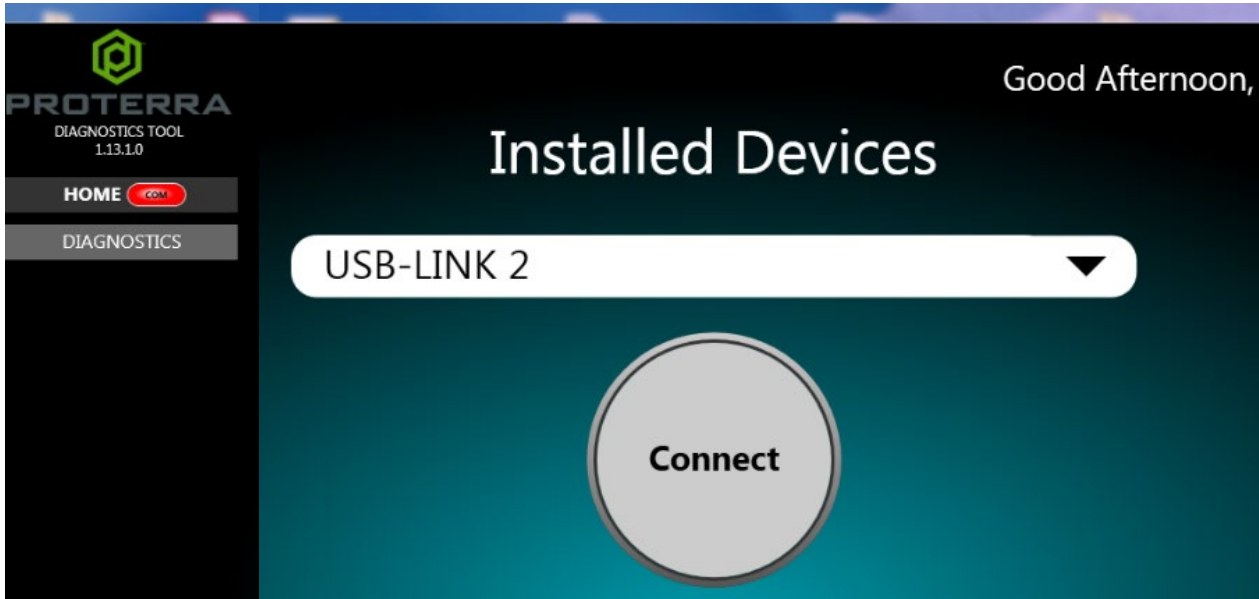
8. On the Home tab, select the appropriate device from the drop down, then click “Connect”.

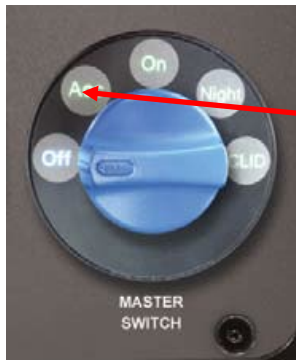
Master Switch "ACC"

1. Ensure you have the latest software file **061858.hex** in a known location on the service technician's computer (Folder or Desktop).
IMPORTANT! NEVER access the software from a remote server or from a USB memory device, ALWAYS copy the software files to your computer hard drive and access the software from this location. It is recommended that you copy the entire "service bulletin files" folder to your local machine in order to more effectively keep track of the software versions you are deploying:
<\\bus.local\files\Engineering\Service Bulletins\Service Bulletin Files for SC-22-78>
2. Turn ON the 12/24V rear Vehicle Master Disconnect located behind the vehicle curbside rear upper access panel.
3. Turn ON the bus Master Switch at the Driver's Workplace and ensure the Dash screen is **ACC**.

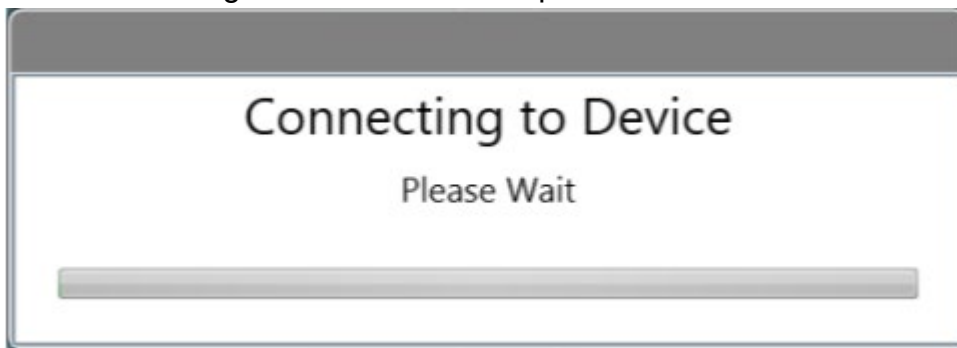
9. The Proterra Diagnostic Tool will attempt to connect to the device.

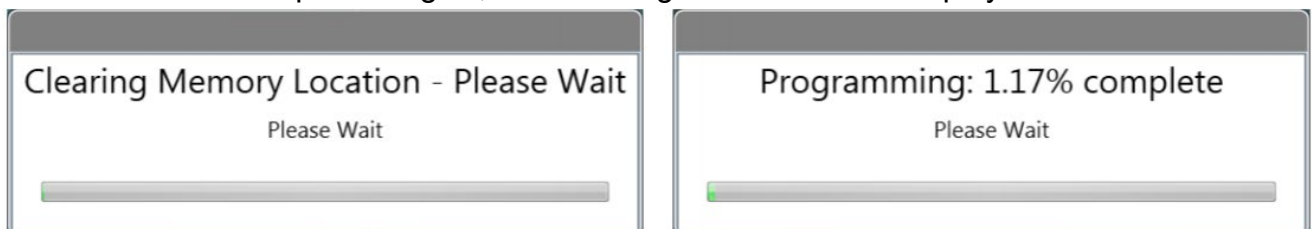
10. When the software update begins, the following screens will be displayed.

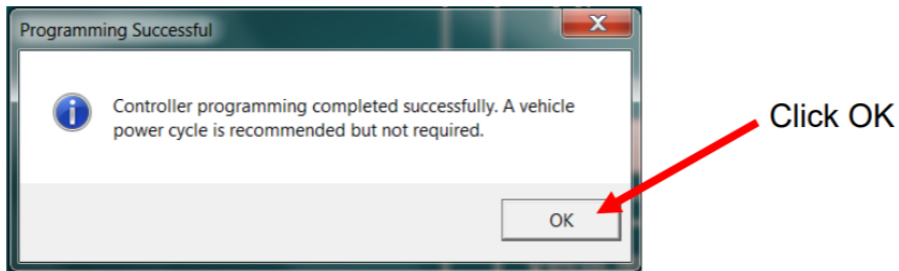
11. The software update may take several minutes to complete. When the update is complete the following will be displayed. Click the “OK” button to complete the update process.

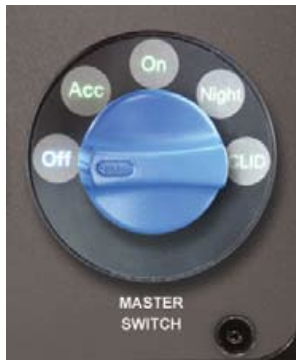
12. Power off the bus by selecting “Off” on the Master Switch.
