SIM 01 05 24

F60 PHEV HV BATTERY CELL MODULE TEMPERATURE SENSORS  
EXT LTD WTY (ELW) 10/120

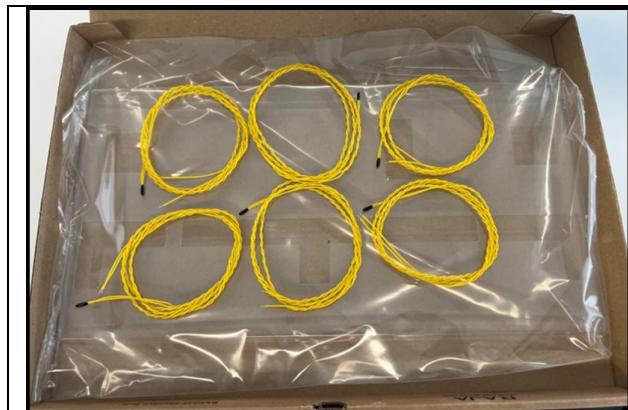
If there are failed cell module temperature sensors, the test plan will instruct you to replace the applicable HV cell module's internal temperature sensors (NTC) repair kit(s).
