GROUP	NUMBER	
CAMPAIGN	24-01-084H	
DATE	MODEL(S)	
NOVEMBER 2024	SANTA FF (MY5A)

BDC SOFTWARE UPDATE TO REVISE TPMS LOGIC

AND SMART KEY RECOGNITION (SERVICE CAMPAIGN TCJ)

**Description:** Certain Santa Fe (MX5A) vehicles' Body Domain Controller (BDC) software logic may disable the Tire Pressure Monitoring System (TPMS) system that leads to a low-voltage logic error with active DTC C112600. Follow the instructions in this bulletin to update the BDC software to correct the TPMS system and to enhance Smart Key recognition.

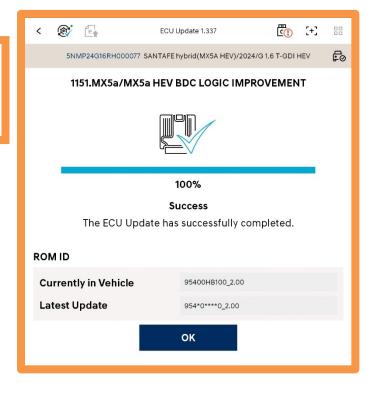
4.

Take a screenshot of the ECU update complete screen using your tablet and upload to STUI.
