Technical Service Bulletin

GROUP	NUMBER
CAMPAIGN	24-01-083G
DATE	MODEL(S)
NOVEMBER 2024	GV60 (JW1 EV)

SUBJECT: BMS UPDATE FOR CELL VOLTAGE VARIANCE AND CHARGING INTERRUPTION PREVENTION (SERVICE CAMPAIGN T62G)

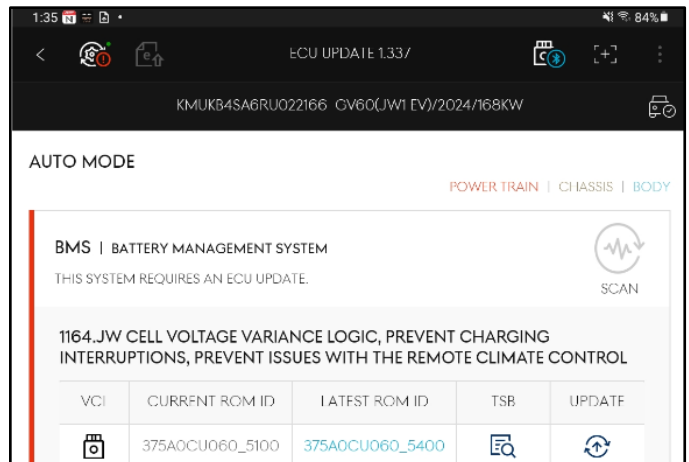
If the update fails, please remove the power connector or the battery (–) connector from the indoor fuse box for at least 5 seconds and reassemble it to retry the update.

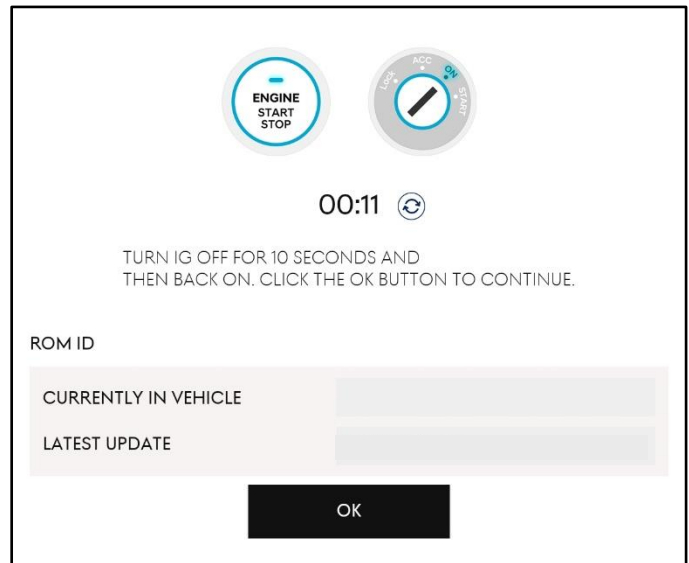
- After the ECU update process shows 100% complete, follow the prompts on the screen to cycle the ignition **OFF** for at least **10 seconds** to reset the control unit (certain models may take up to **30 seconds**).

Use the **Refresh** button to reset the timer.

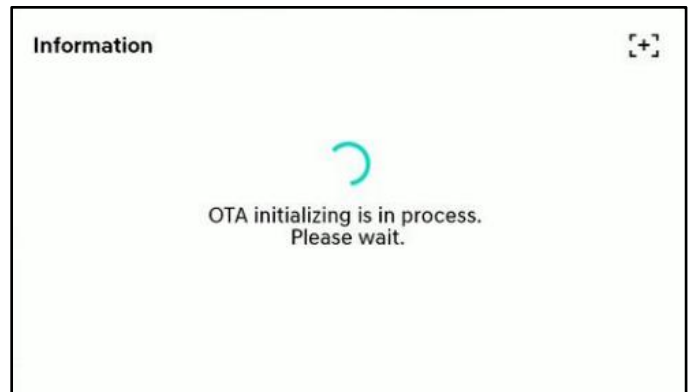
After clicking **OK**, the OTA Initialization process will begin.

- If OTA initialization performs automatically, then proceed with the service procedure.
- If the OTA initialization fails, **connect GDS-Smart > S/W Management > Central Communication Unit (CCNF) > OTA Initialization**

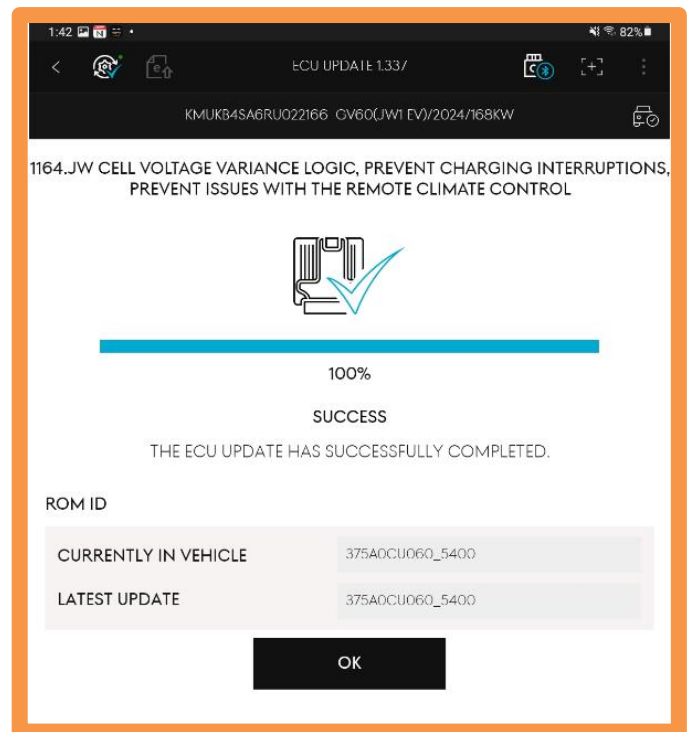
Take a screenshot of the ECU update complete screen using your tablet and upload to STUI.
