Technical Service Bulletin

GROUP CAMPAIGN	NUMBER 24-01-088H
DATE NOVEMBER 2024	MODEL(S) IONIQ 5 (NE EV) IONIQ 6 (CE EV)

SUBJECT: SOFTWARE UPDATE FOR VCU LIMP HOME ENHANCEMENT
(SERVICE CAMPAIGN TCP)

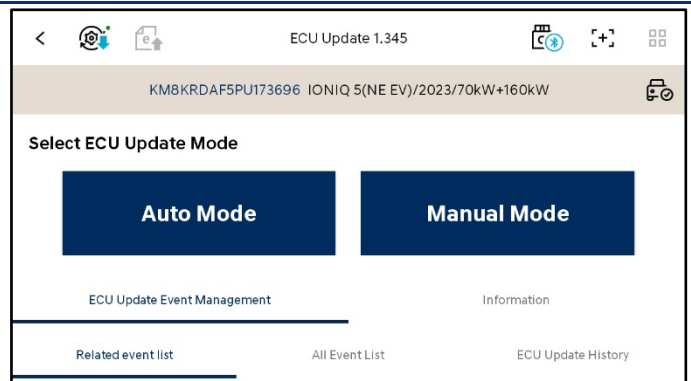
2. Select the **VCU** system to scan the vehicle's current ROM ID.

Check the current ROM ID version and compare it to the ROM ID Information table before attempting to perform the software update.

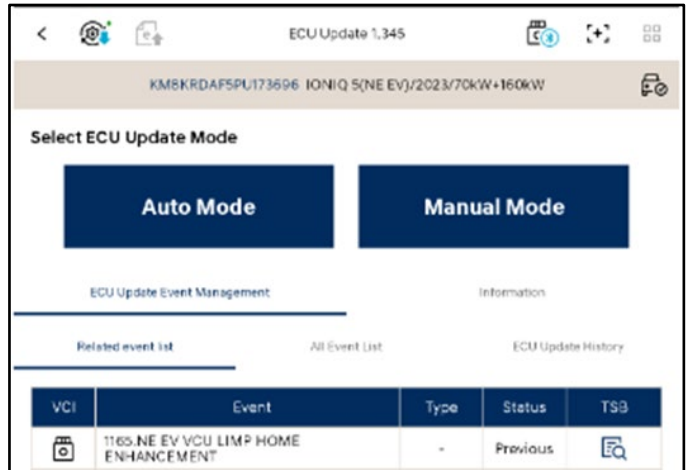
3. After the ECU update process shows 100% complete, follow the prompts on the screen to cycle the ignition **OFF** for at least **10 seconds** to reset the control unit (certain models may take up to **30 seconds**).

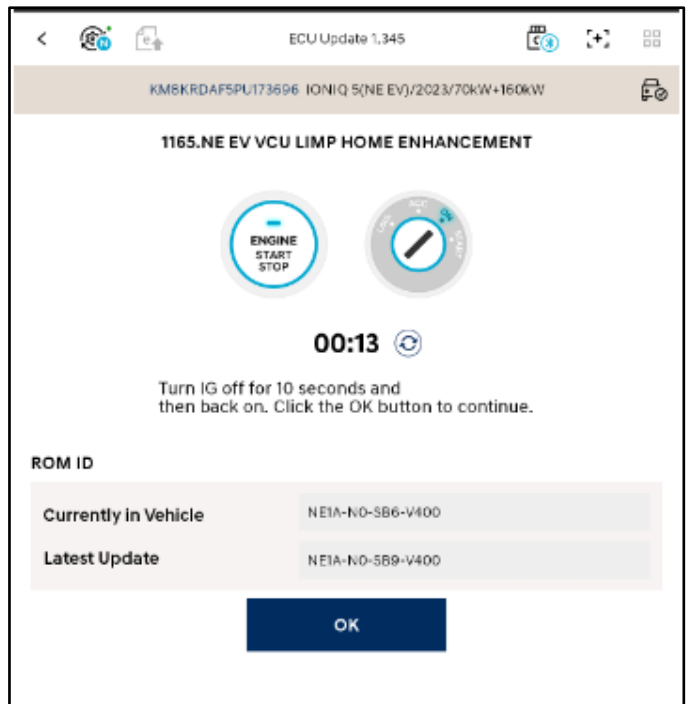
Use the **Refresh** button to reset the timer.

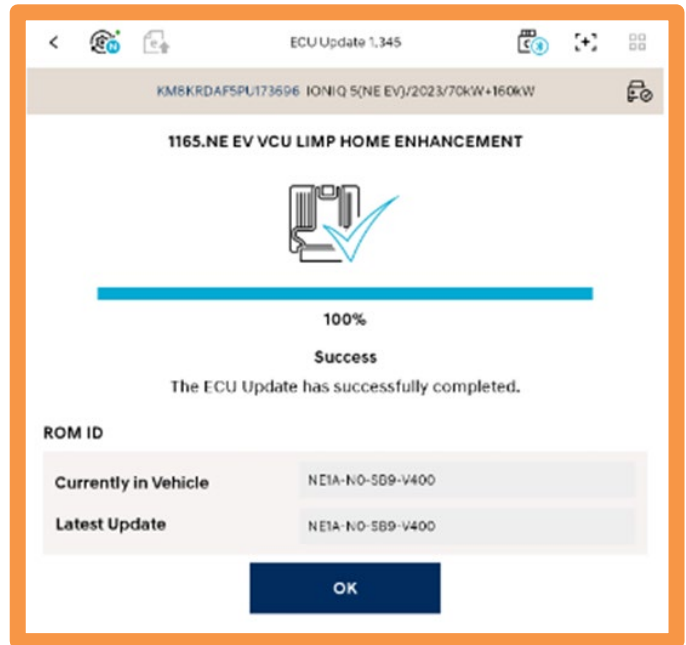
Take a screenshot of the ECU update complete screen using your tablet and upload to STUI.
