CERTAIN 2024 MODEL YEAR NAUTILUS VEHICLES — INFOTAINMENT SOFTWARE UPDATE

SUBJECT: **NEW VEHICLE RECOMMENDED DEMONSTRATION / DELIVERY HOLD**
Customer Satisfaction Program 24B54 – Supplement #1
Certain 2024 Model Year Nautilus Vehicles
Update Infotainment Software

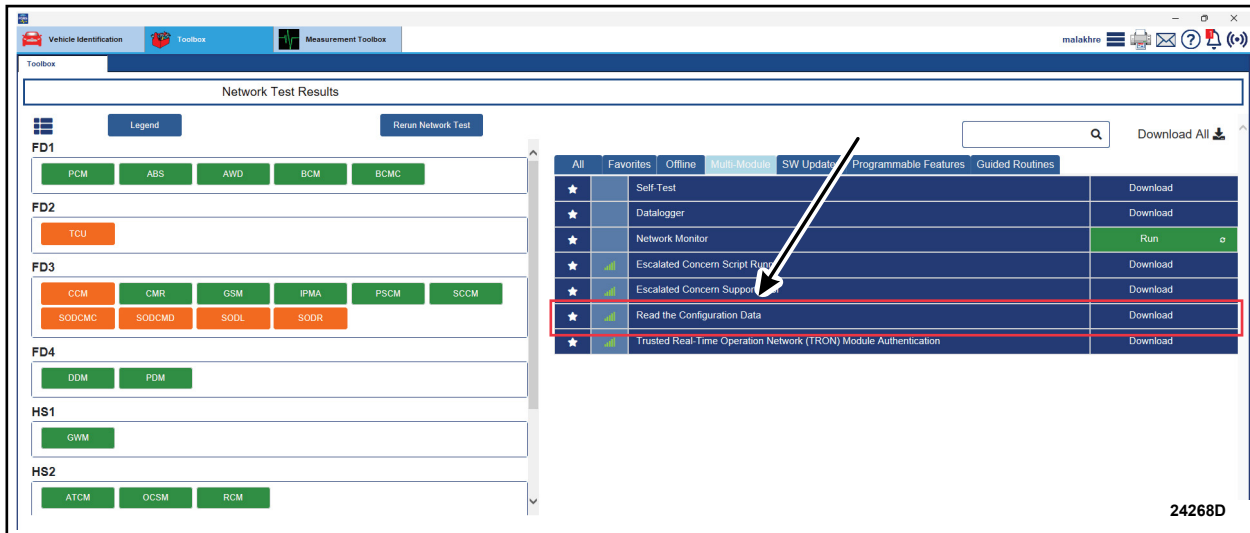
FIGURE 1

9. From the list on the RH side of the screen, select **Read the Configuration Data**. See Figure 1.

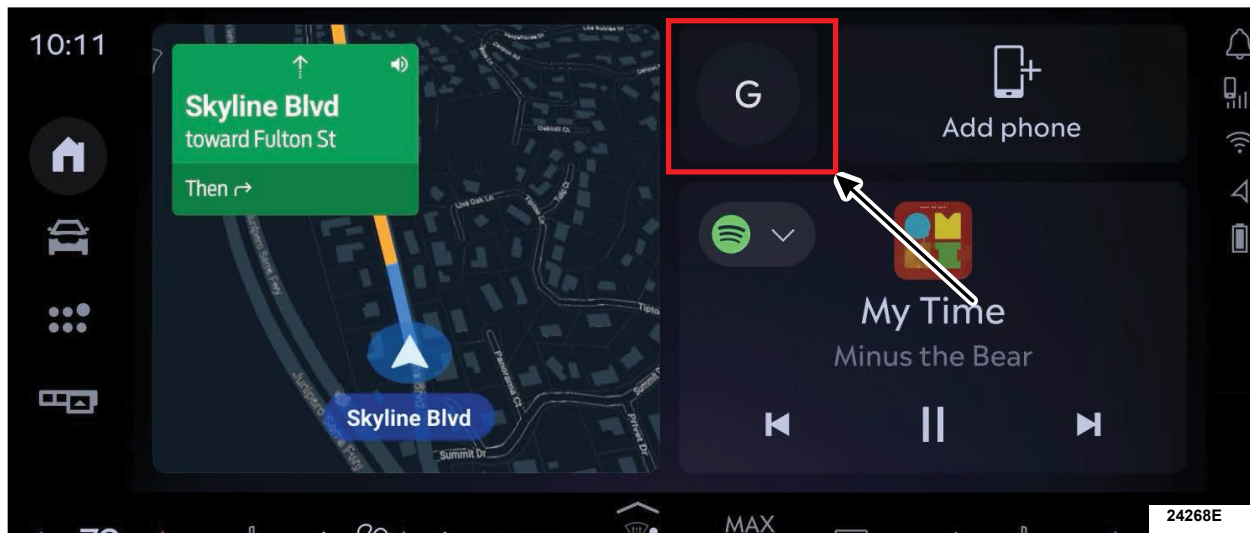
FIGURE 2

11. On the center display screen of the vehicle, make sure the system setting is **NOT** using a guest profile. Change the system profile by selecting the center upper button on the home screen. See Figure 2.

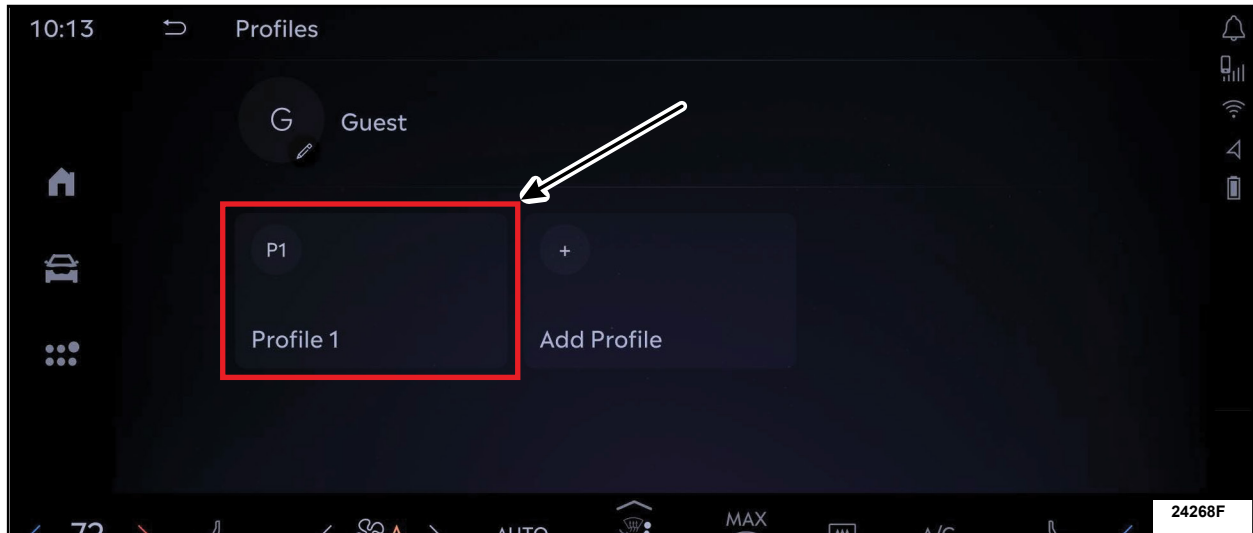
FIGURE 3

12. Select any other profile on the profile selection screen to switch out of the guest profile. See Figure 3.

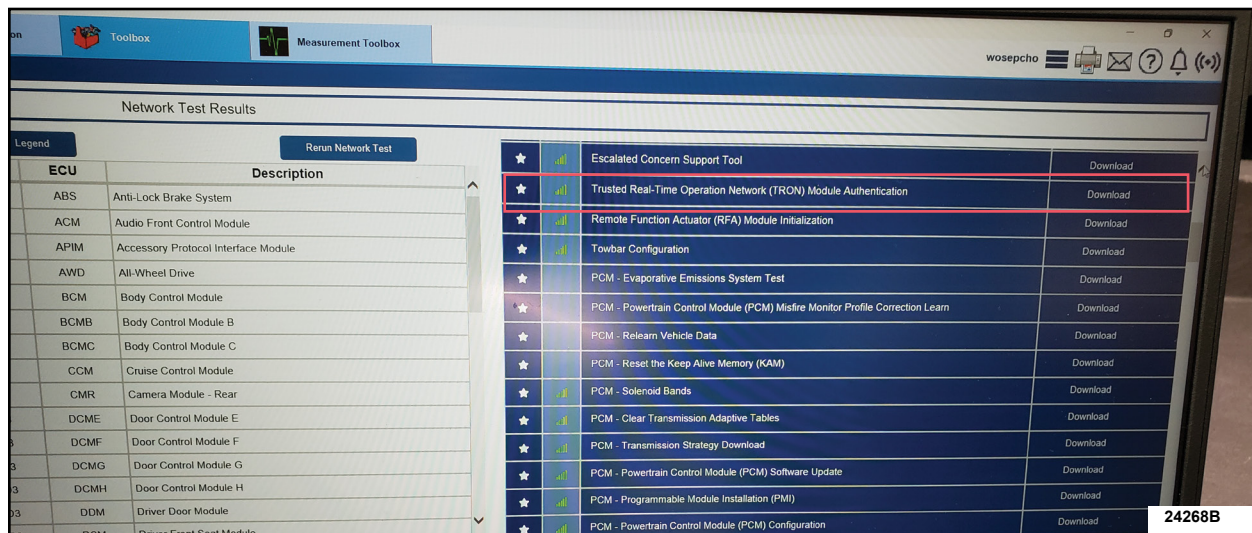
FIGURE 4

50. From the list on the RH side of the screen, download and select the Trusted Real-Time Operation Network (TRON) *module authentication*. See Figure 4.
