Technical Service Bulletin

Subject: AUDIO SOUND PAUSES AFTER I-STOP OPERATION	Bulletin No.: 09-052/24
	Last Issued : 11/21/2024

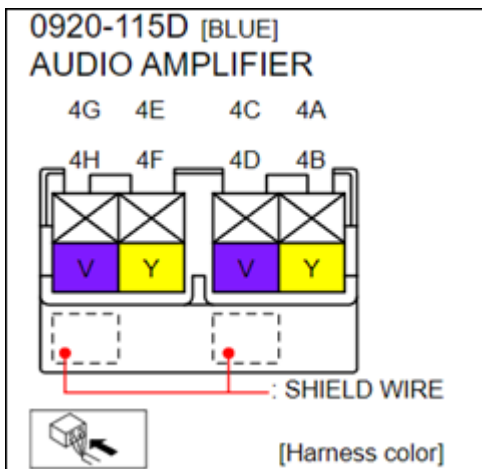
Wiring Diagram:

- CX-30: AUDIO SYSTEM (Bose® TYPE AUDIO)
- CX-50: AUDIO SYSTEM (Bose® TYPE AUDIO)
- CX-90: AUDIO SYSTEM (Bose® TYPE AUDIO)
- Mazda3: AUDIO SYSTEM (Bose® TYPE AUDIO)
