# Service Bulletin

Bulletin No.: 24-NA-248

**Subject: Blank or Black Screen, Update A22 Radio Control**

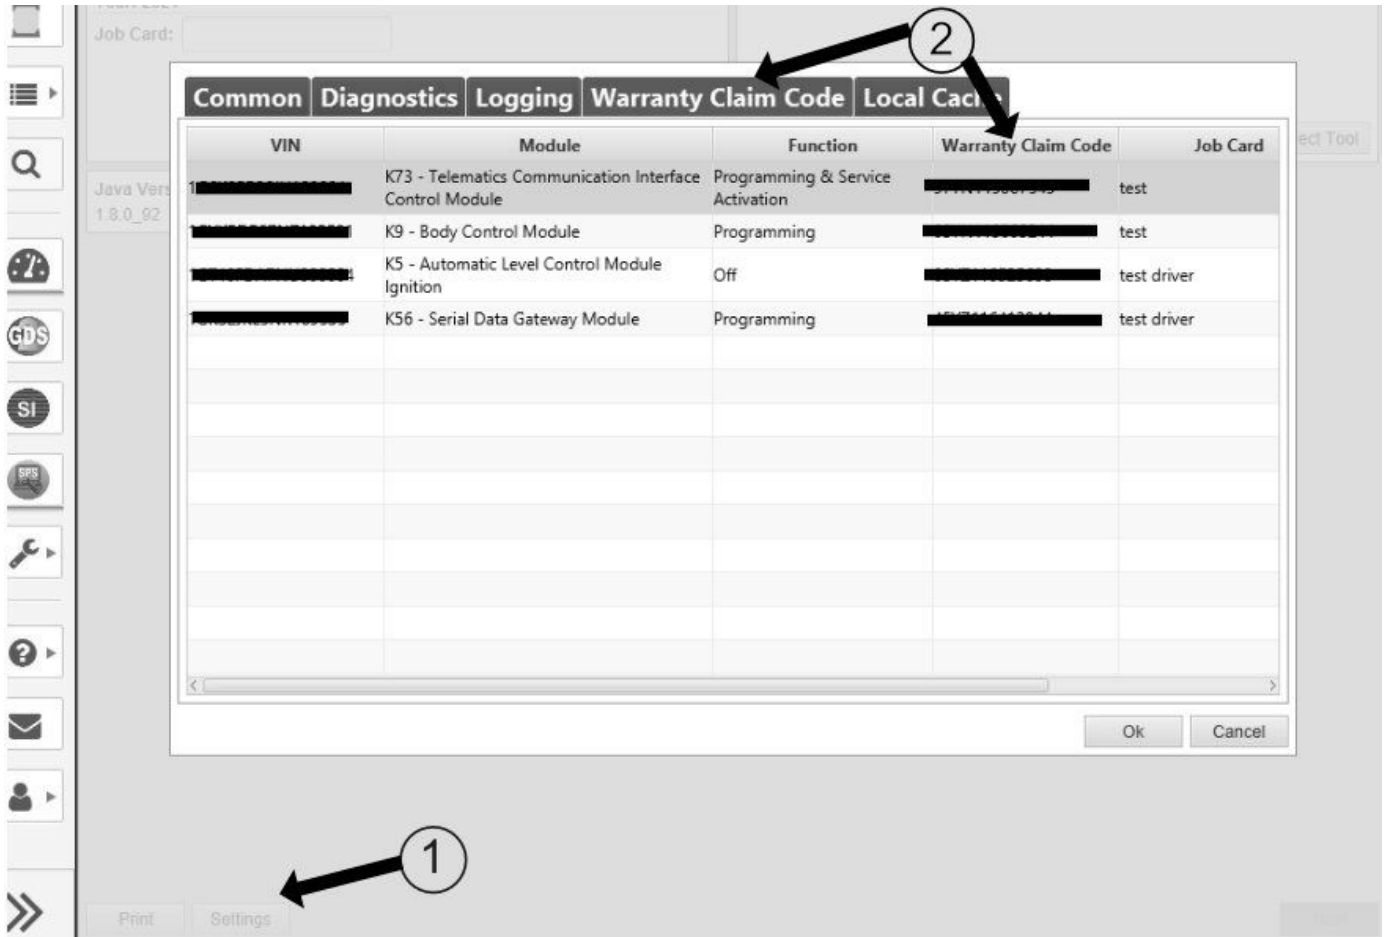
6125774

**Warranty Claim Code Information Retrieval**

If the Warranty Claim Code was not recorded on the Job Card, the code can be retrieved in the SPS2 system as follows:

The VIN, Warranty Claim Code and Date/Time will be listed on a roster of recent programming events. If the code is retrievable, dealers should resubmit the transaction making sure to include the code in the SPS Warranty Claim Code field.
