HYUNDAI Technical Service Bulletin	GROUP CAMPAIGN	NUMBER 24-01-093H
	DATE DECEMBER 2024	MODEL(S) SONATA (DN8) SONATA HYBRID (DN8 HEV)
SUBJECT: REAR CORNER RADAR TEMPERATURE CORRECTION (SERVICE CAMPAIGN TCM)

Description: Certain Sonata (DN8) and Sonata Hybrid (DN8 HEV) vehicles may exhibit DTC C2A274B due to the rear corner radar missing the outside temperature input from the ADAS sensor. Follow the procedures in this bulletin to input the external temperature from the cluster and correct the rear corner radar temperature software using GDS.

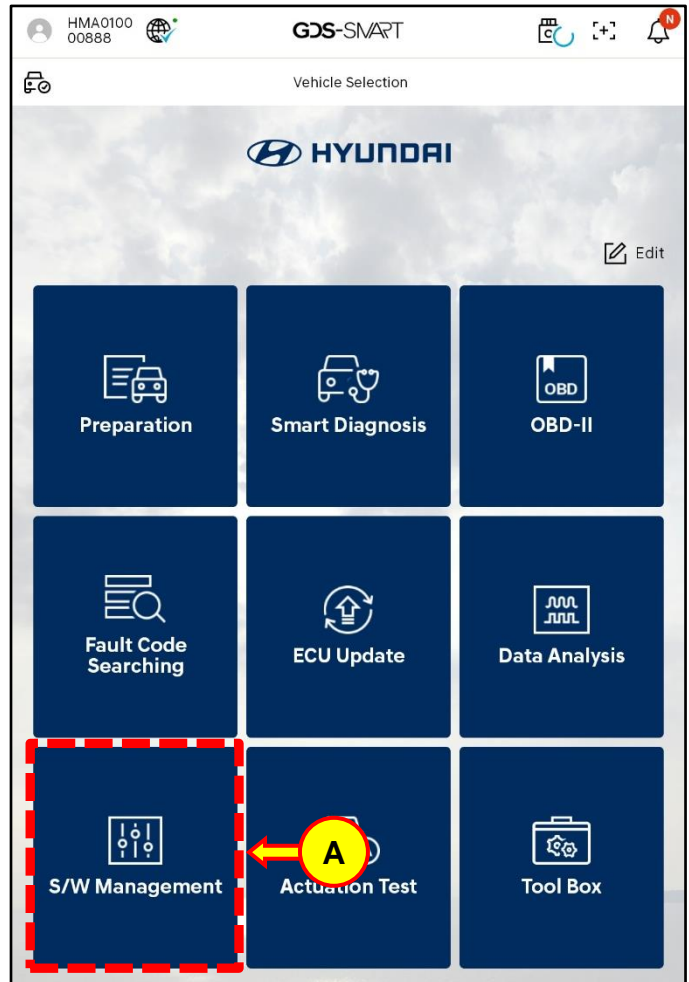
1. Connect GDS to the vehicle and select **S/W Management (A)** on the GDS-Smart home page.

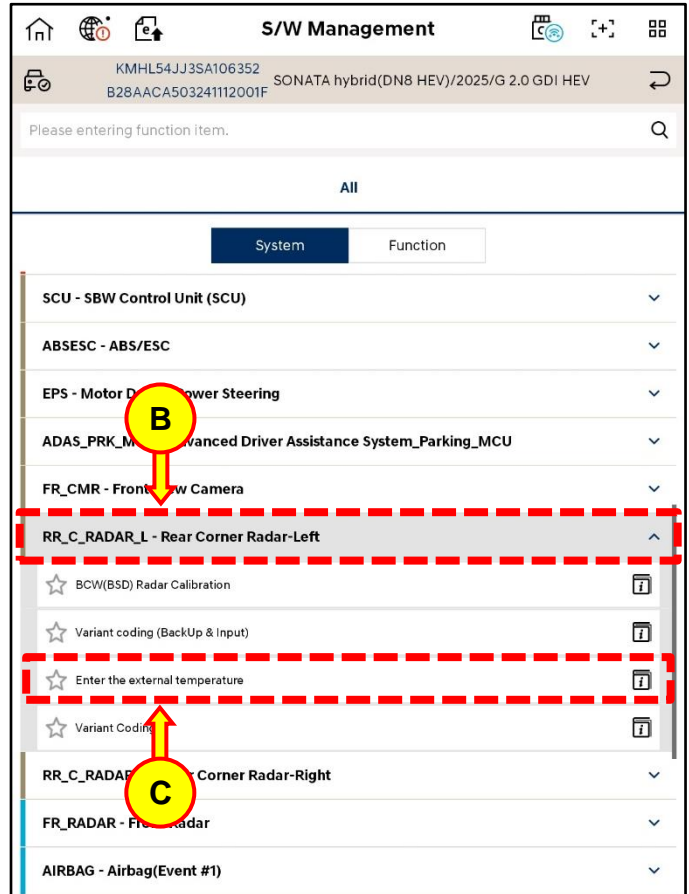
2. Select **RR_C_RADAR_L - Rear Corner Radar-Left (B)** then **Enter the external temperature (C)**.

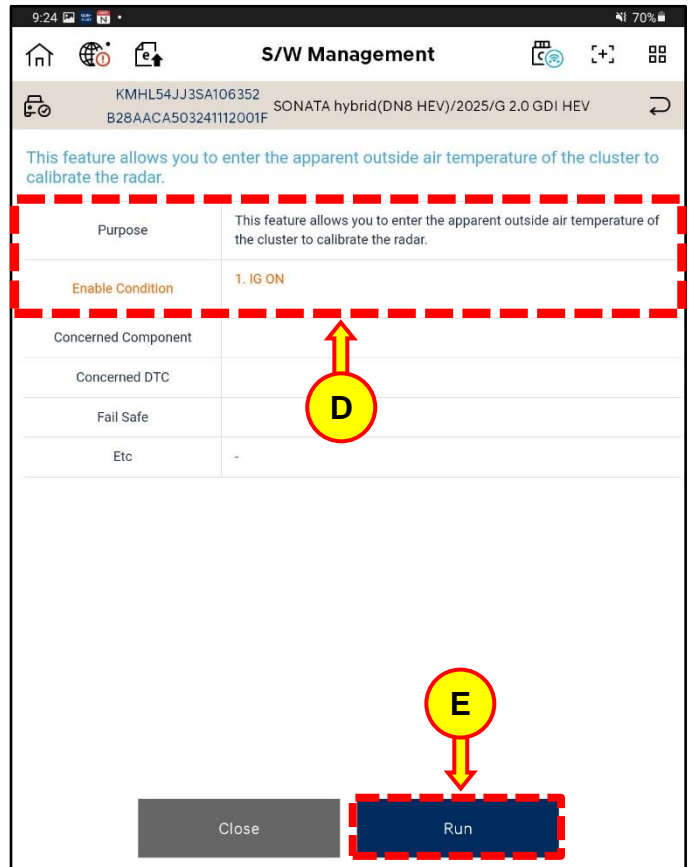
3. Turn **ON** the ignition, read the **Purpose**, verify the **Enable Condition (D)** on screen is met, and select **Run (E)**.

Repeat **steps 3 – 7** above.

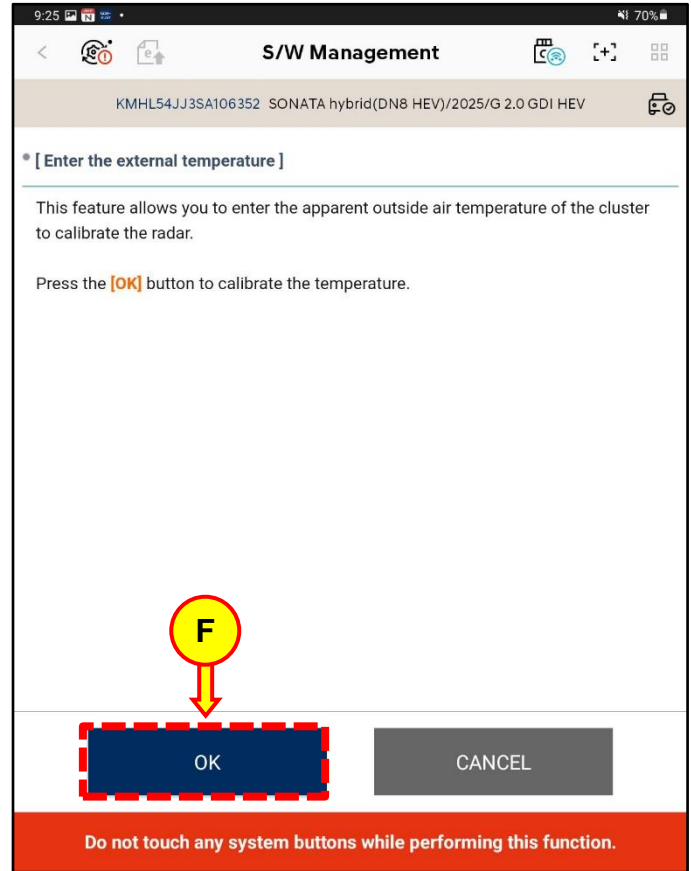
4. Read the inspection details on screen and select **OK** (F).

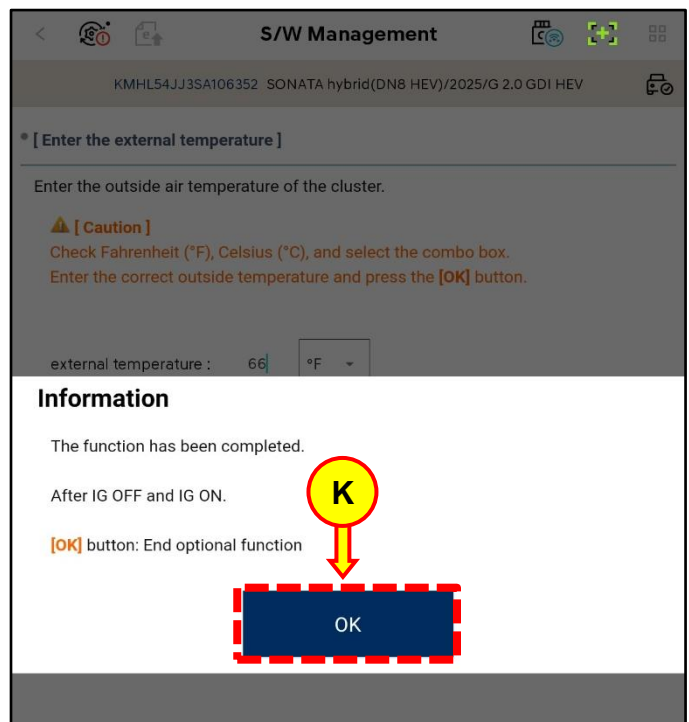
7. Cycle the ignition **OFF** and **ON** again, then select **OK** (K).

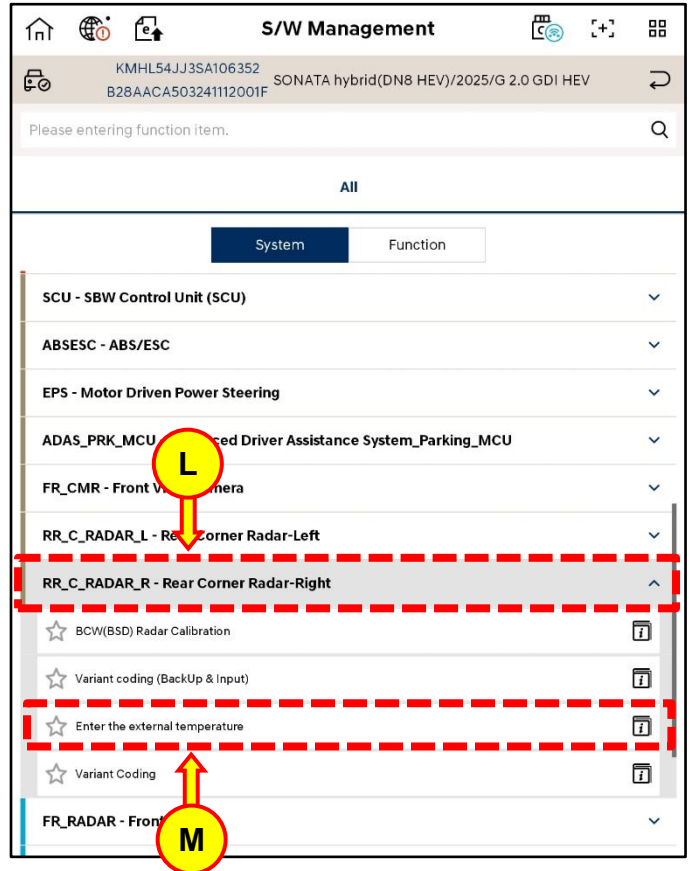
8. Return to the **S/W Management** main page.

Select **RR_C_RADAR_R - Rear Corner Radar-Right (L)** then **Enter the external temperature (M)**.

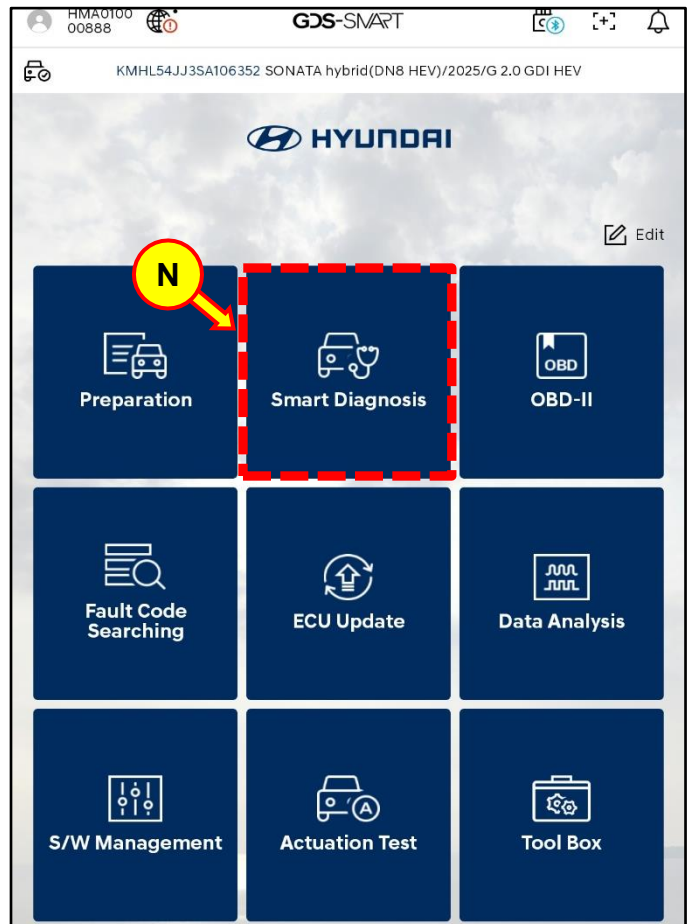
9. On the GDS-Smart home screen, select **Smart Diagnosis (N)**.

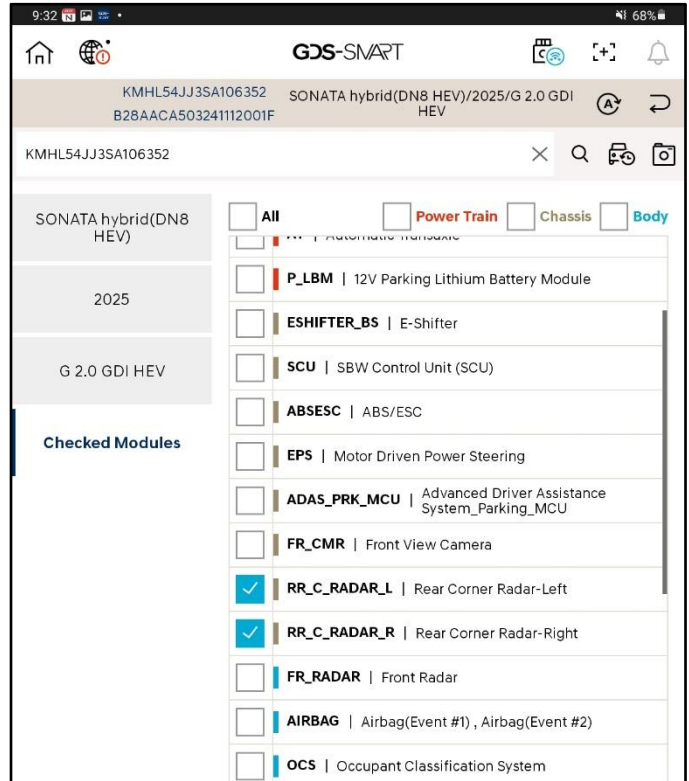
10. Perform a search for fault codes to verify all DTCs are cleared.

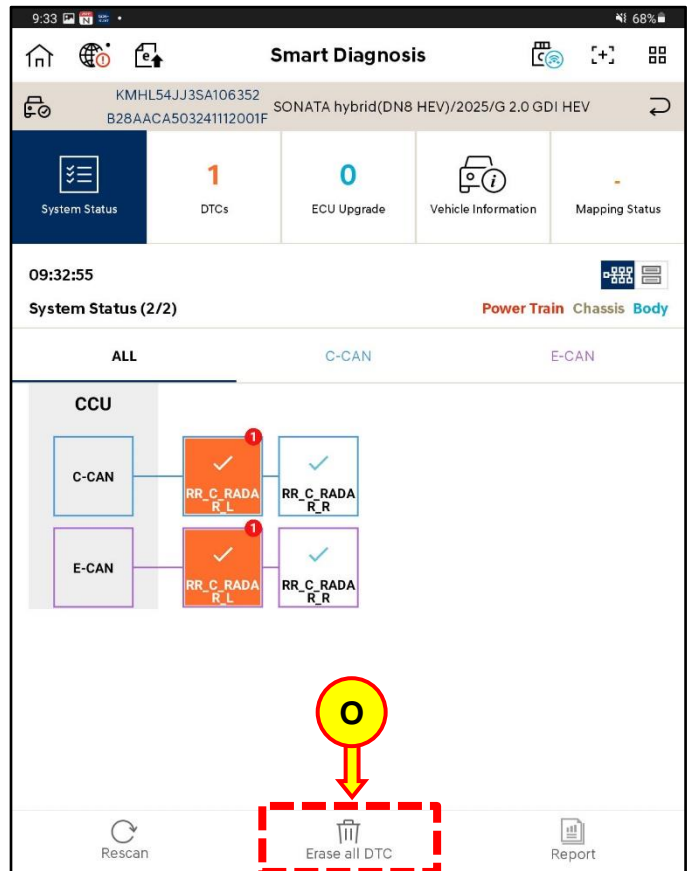
If any DTCs are found, select **Erase all DTC** (O) and perform another fault code check to verify they are now cleared.

Once all DTCs are verified to be cleared, proceed to step 11.

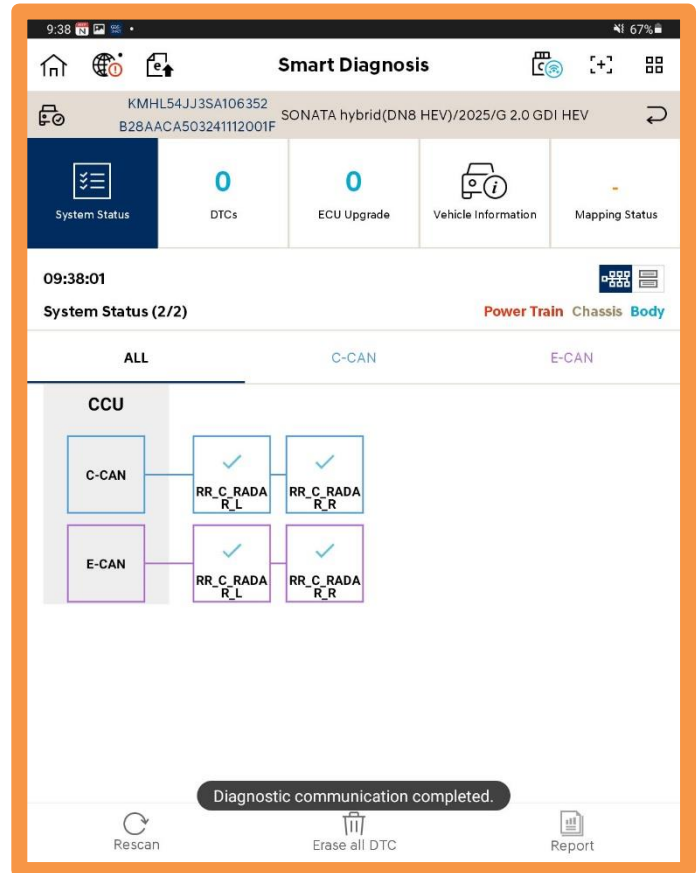
Take a screenshot of DTC check results using your tablet and upload to STUI.
