# INSTRUCTION TO SERVICE

| ITS61187 | | Dec 03, 2024 |
| SUBJECT: | PLC Update to prevent interlock activation when CAN speed messages are absent. | |
| SUMMARY: | Update PLC program to prevent interlock activation. | |

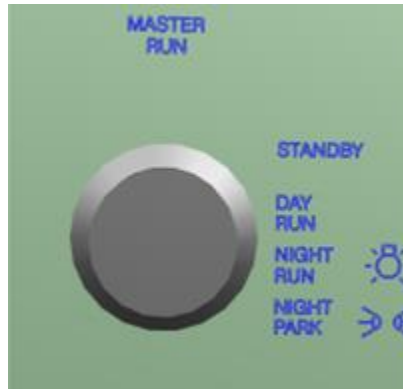
1. Ensure the Master Run Switch is in Day/Run position and hazard must be on.
