Service Action

Code: 93SG

Subject	High-Voltage (HV) Battery Charger Software																			
Document History	<table border="1"> <thead> <tr> <th style="background-color: #c00000; color: white;">Date</th> <th colspan="4" style="background-color: #c00000; color: white;">Summary</th> </tr> </thead> <tbody> <tr> <td>12/18/2024</td> <td colspan="4">Updated claiming instructions Included Appendix A with updated B200000 fault clearing instructions</td> </tr> <tr> <td>10/29/2024</td> <td colspan="4">Original publication</td> </tr> </tbody> </table>					Date	Summary				12/18/2024	Updated claiming instructions Included Appendix A with updated B200000 fault clearing instructions				10/29/2024	Original publication			
Date	Summary																			
12/18/2024	Updated claiming instructions Included Appendix A with updated B200000 fault clearing instructions																			
10/29/2024	Original publication																			
Affected Vehicles	<table border="1"> <thead> <tr> <th style="background-color: #c00000; color: white;">Country</th> <th style="background-color: #c00000; color: white;">Beginning Model Year</th> <th style="background-color: #c00000; color: white;">Ending Model Year</

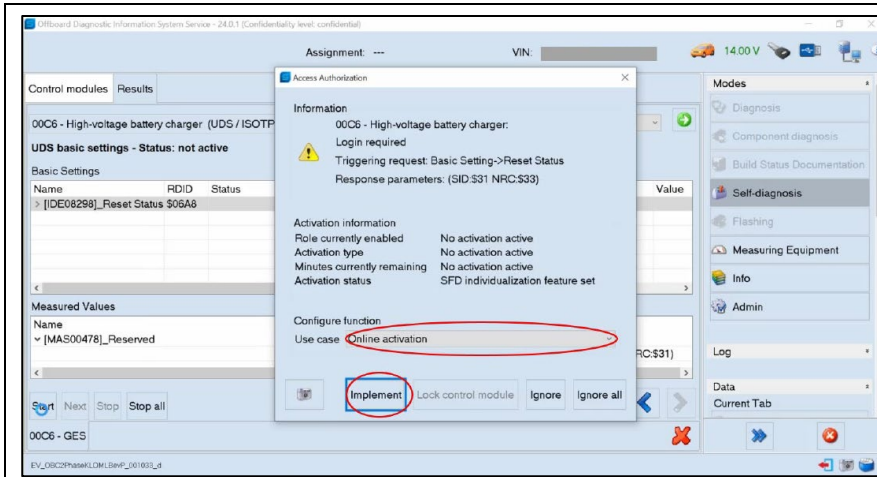
- An access authorization dialog-box should pop up.
- In the drop-down box next to “Use case”, select Online activation.
- Click on implement.
