# Technical Service Bulletin

<b>SUBJECT:</b>  <b>A/C VENT TEMPERATURE INCREASES FOR SEVERAL SECONDS WHEN USING BRAKE PEDAL FOR DECELERATION</b>			No: <b>TSB-24-55-002</b>
			DATE: <b>November 2024</b>
			MODEL: <b>Outlander</b>
<b>CIRCULATE TO:</b>	<input type="checkbox"/> GENERAL MANAGER	<input checked="" type="checkbox"/> PARTS MANAGER	<input checked="" type="checkbox"/> TECHNICIAN
<input checked="" type="checkbox"/> SERVICE ADVISOR	<input checked="" type="checkbox"/> SERVICE MANAGER	<input checked="" type="checkbox"/> WARRANTY PROCESSOR	<input checked="" type="checkbox"/> SALES MANAGER

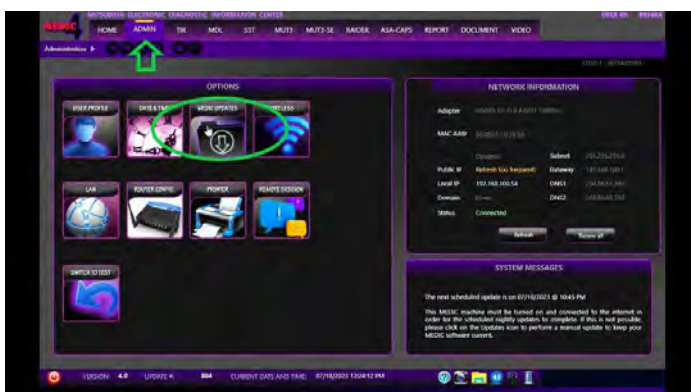
3. Select the MEDIC 3.5/4 Admin tab and click on "Updates".

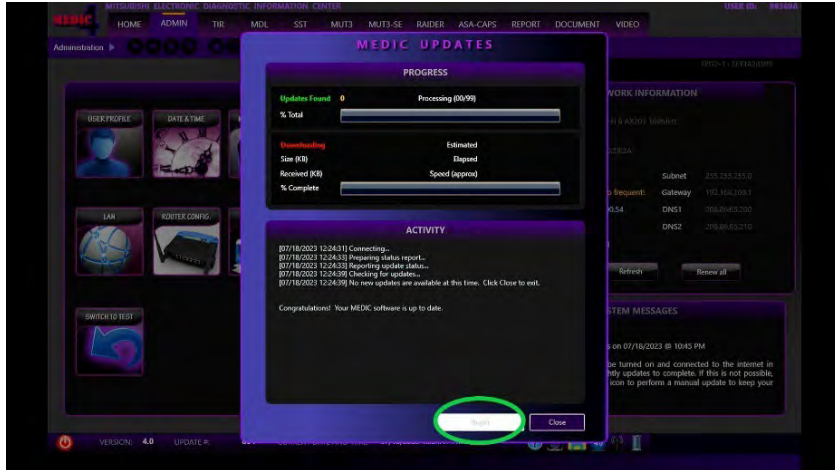
4. If the MEDIC update screen advises updates are available, click the "Begin" button. After all updates are complete, **GO TO THE REPROGRAMMING PROCEDURE.**

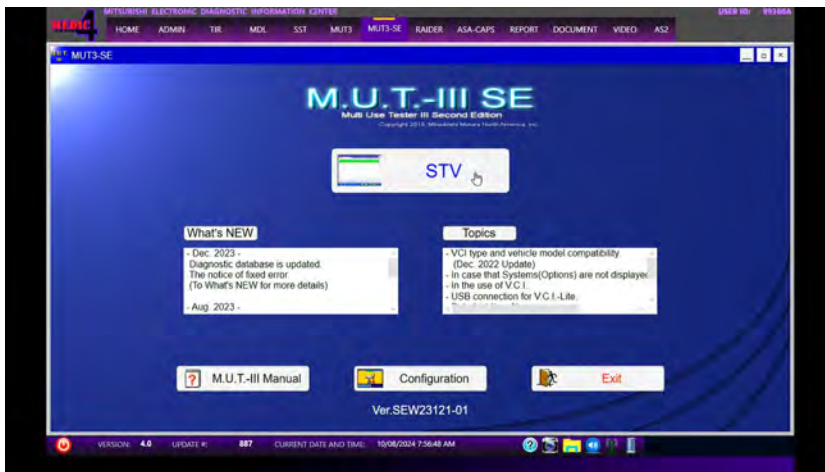
5. STANDALONE MUT-III SE SCAN TOOL VIEWER (STV) ONLY: (MEDIC 3.5 USERS – GO TO THE REPROGRAMMING PROCEDURE). Verify that your MUT-III SE has the most current version of the reprogramming database from the MUT-III SE Main Page.

- a. Press the MUT-III SE STV button.

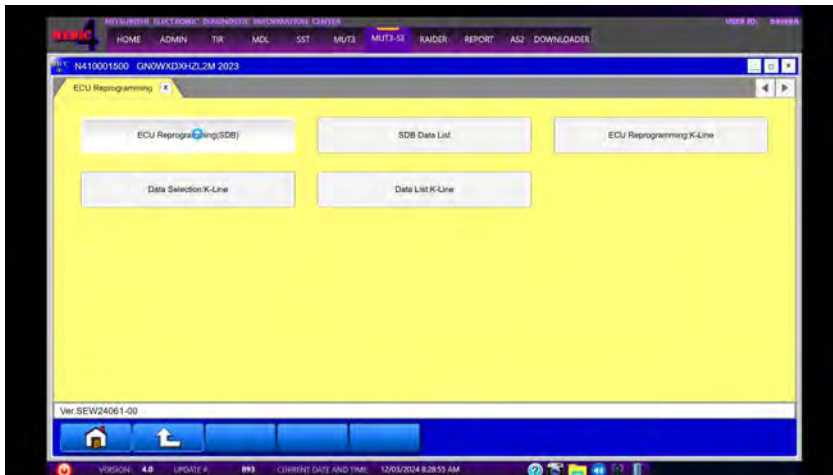
- c. Confirm the vehicle information displayed is complete/correct, after selecting the appropriate class. The class can be found on the B pillar. Next, press the "ECU reprogramming button".

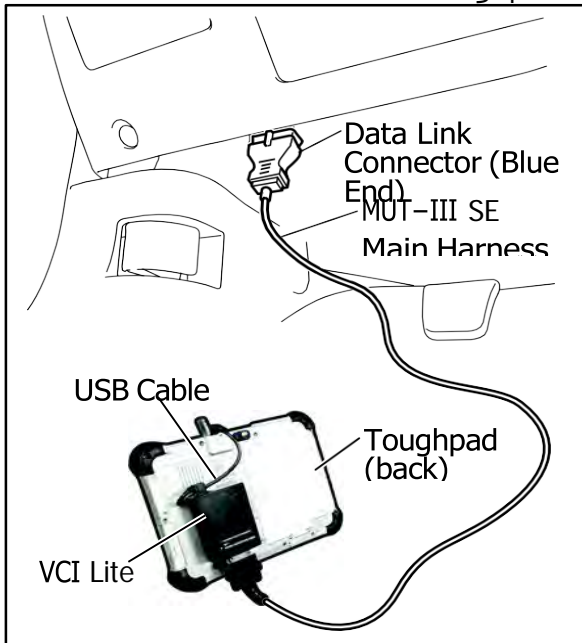
1. Connect the equipment as follows:

**NOTE: VCI Lite and MEDIC 4.0 Toughpad shown for illustration purposes only.**

- Turn the MEDIC PC/tablet on. If the battery indicator in the lower right hand corner of the screen does not show a full charge, it is recommended that either the battery be charged prior to beginning or be used with the A/C power adaptor connected.
- Connect the USB cable to the VCI/VCI Lite. When the laptop/tablet displays the MUT-III SE main screen, connect the USB cable to the device.
- Connect the MUT-III SE main harness with the blue DLC connection to the VCI/VCI Lite. Connect the blue connection of the MUT-III SE main harness to the vehicle's data link connector.
- For VCI only: Turn the VCI power switch ON. Verify that the indicator lamp in the upper right corner of the screen is green.

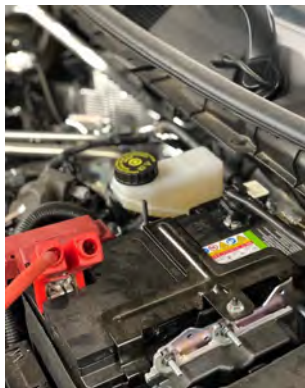
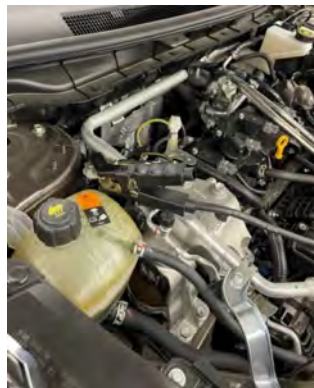
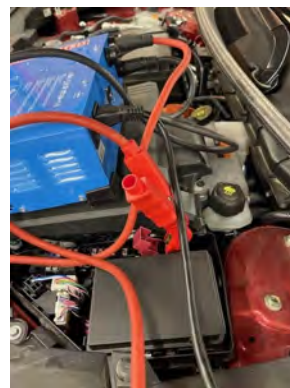
**NOTE:** Due to limited space it may be easiest to connect battery charger cable onto ground point.

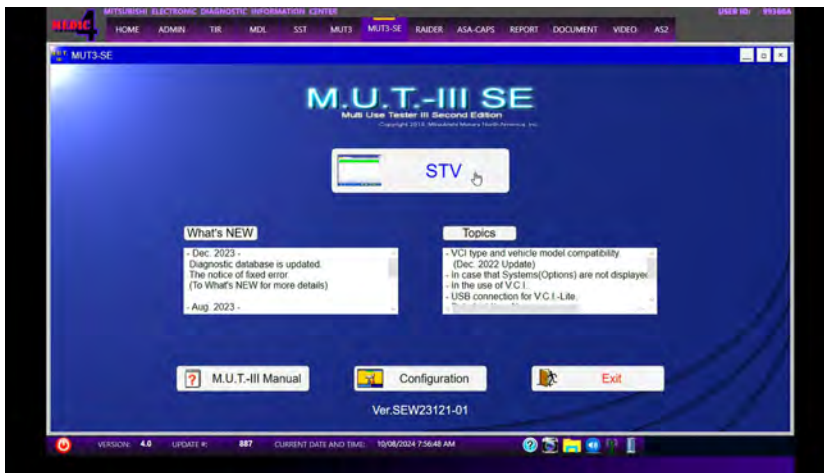
2. Turn the ignition switch to the "ON" position.
3. Turn on flashers to prevent vehicle from shutting/powering down.
4. Press the "MUT-III SE STV" button.

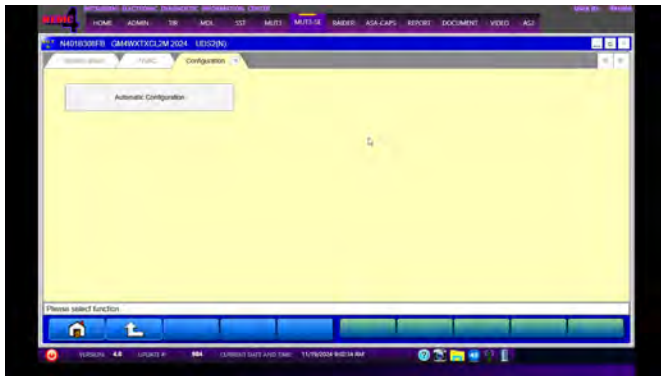
c. Press the "Automatic Configuration" button, verify the VIN is displayed properly and press the "OK" button.

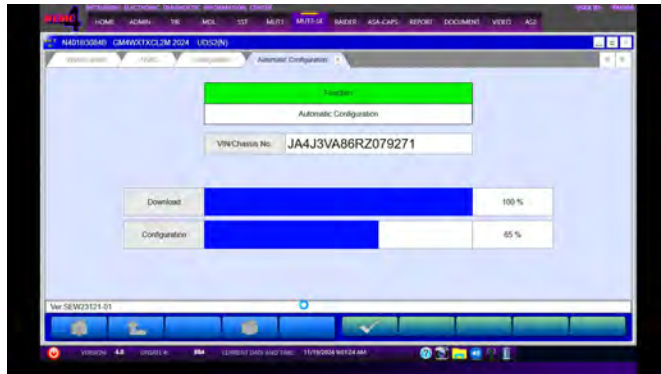
d. Progress of download and configuration will be shown followed by a completion notification. Press the "OK" button.

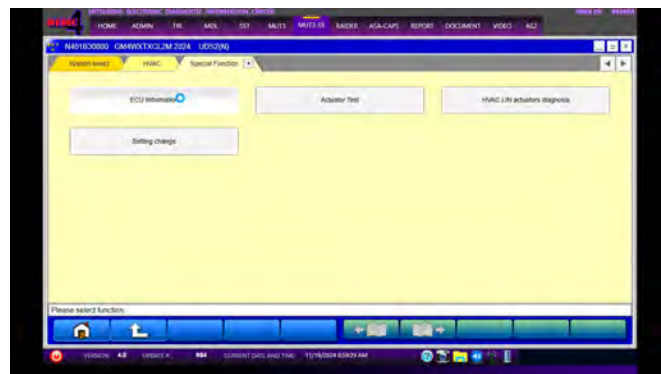
e. Press the "ECU Information" button. Verify the ECU Part number.

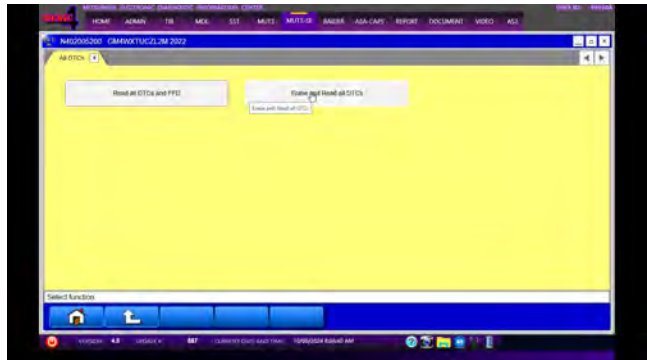
g. Press the "ALL DTCs" button followed by the "Erase and Read all DTCs" button.

**NOTE:** If DTCs are detected for the HVAC, please repeat the process to Erase and Read All DTCs.

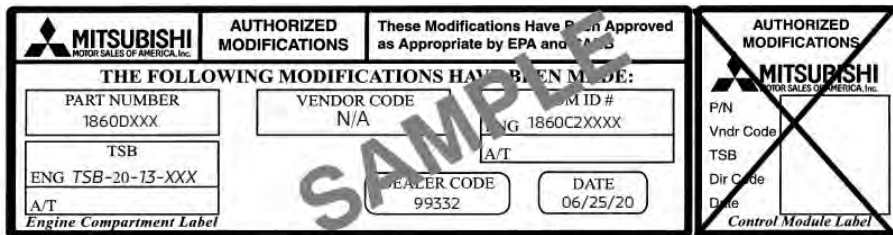
7. Using a ball-point pen, enter the appropriate ECU part number, Software Part Number (ROM ID#), this Technical Service Bulletin number, your dealer code, and the current date on the Engine Compartment/Control Module Label (p/n MSSF024G00). The Vendor Code is not applicable. The label is available from your facing PDC.
