Technical Service Bulletin

SUBJECT: COOL AIR EXPELLED WHEN A/C SWITCH IS TURNED OFF WHILE IN ECO DRIVE MODE - REVISED		NO: TSB-23-55-002REV
		DATE: December 2024
		MODEL: 2022-23 Outlander
CIRCULATE TO:	<input type="checkbox"/> GENERAL MANAGER	<input checked="" type="checkbox"/> PARTS MANAGER
<input checked="" type="checkbox"/> SERVICE ADVISOR	<input checked="" type="checkbox"/> SERVICE MANAGER	<input checked="" type="checkbox"/> WARRANTY PROCESSOR
		<input checked="" type="checkbox"/> TECHNICIAN
		<input type="checkbox"/> SALES MANAGER

This bulletin provides instructions to reprogram the HVAC ECU software for the A/C Auto Amplifier.

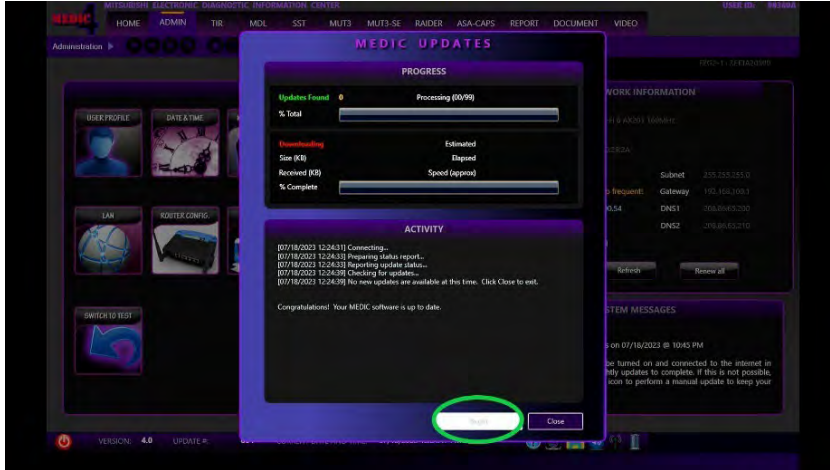
4. If the MEDIC update screen advises updates are available, click the "Begin" button. After all updates are complete, **GO TO THE REPROGRAMMING PROCEDURE.**

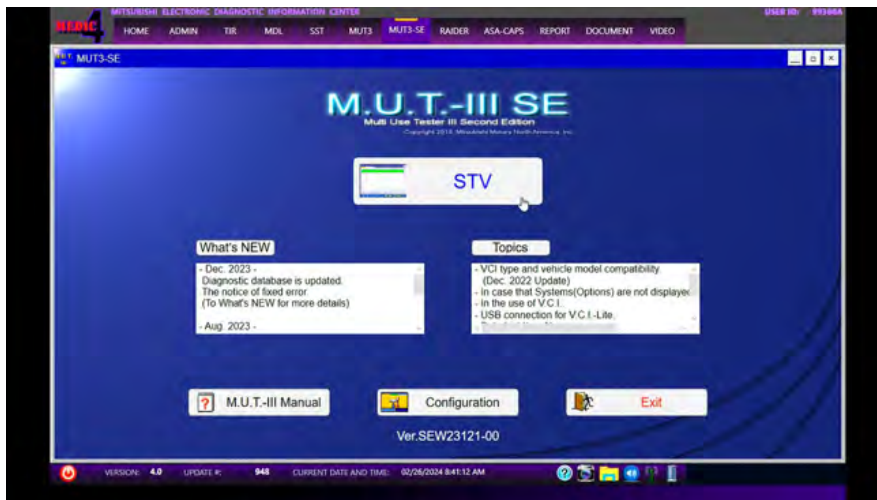
- a. Press the MUT-III SE STV button.

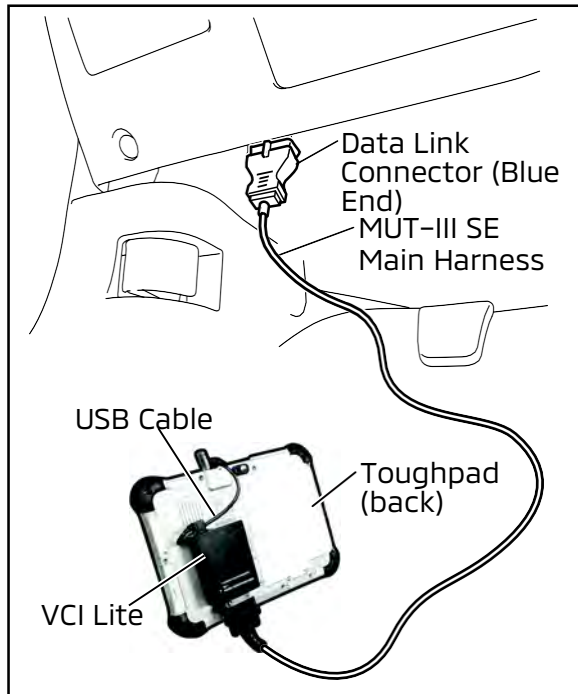
1. Connect the equipment as follows:

NOTE: VCI Lite and MEDIC 4.0 Toughpad shown for illustration purposes only.

- Turn the MEDIC PC/tablet on. If the battery indicator in the lower right hand corner of the screen does not show a full charge, it is recommended that either the battery be charged prior to beginning or be used with the A/C power adaptor connected.
- Connect the USB cable to the VCI/VCI Lite. When the laptop/tablet displays the MUT-III SE main screen, connect the USB cable to the device.
- Connect the MUT-III SE main harness with the blue DLC connection to the VCI/VCI Lite. Connect the blue connection of the MUT-III SE main harness to the vehicle's data link connector.
- For VCI only (p/n MB991824): Turn the VCI power switch ON. Verify that the indicator lamp in the upper right corner of the screen is green.

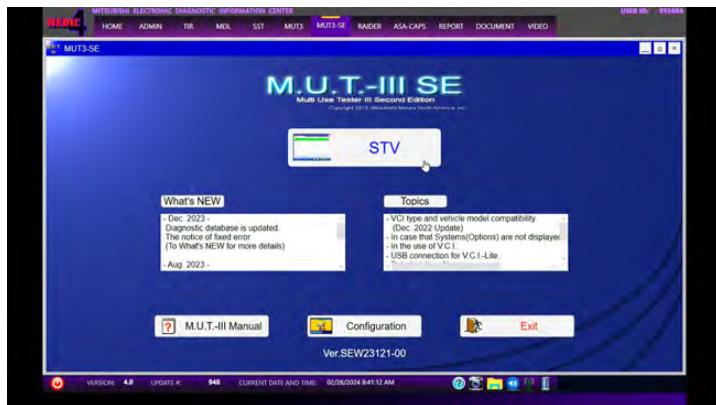
3. Turn the ignition switch to the "ON" position.
4. Turn on flashers to prevent vehicle from shutting/powering down.
5. Press the "MUT-III SE STV" button.

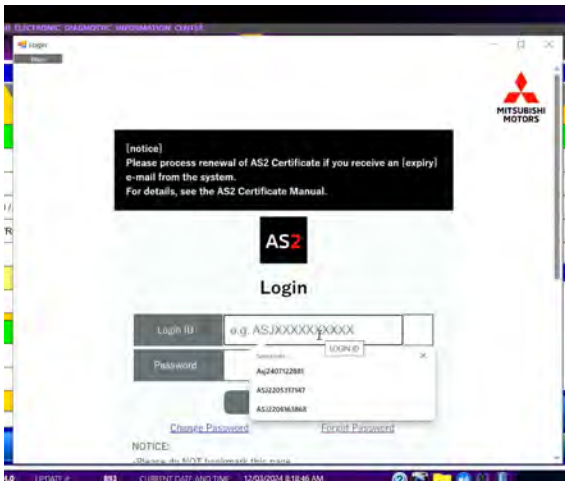
c. Log into AS2.

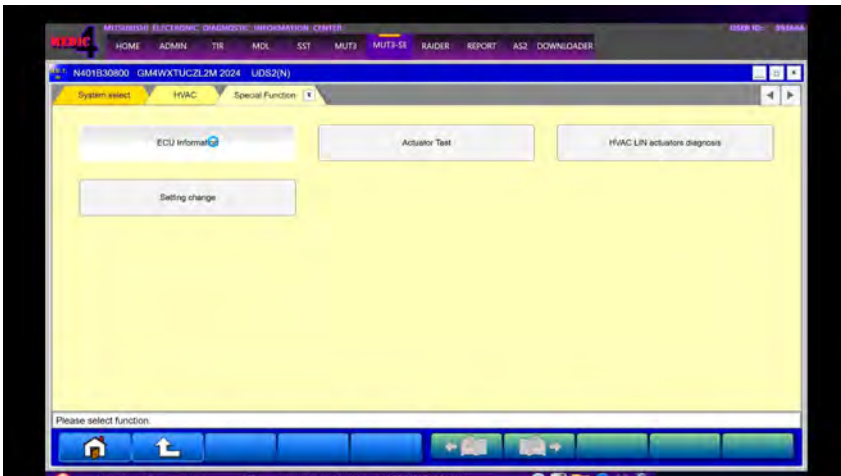
d. Select "ECU Information" from the Special Function tab.

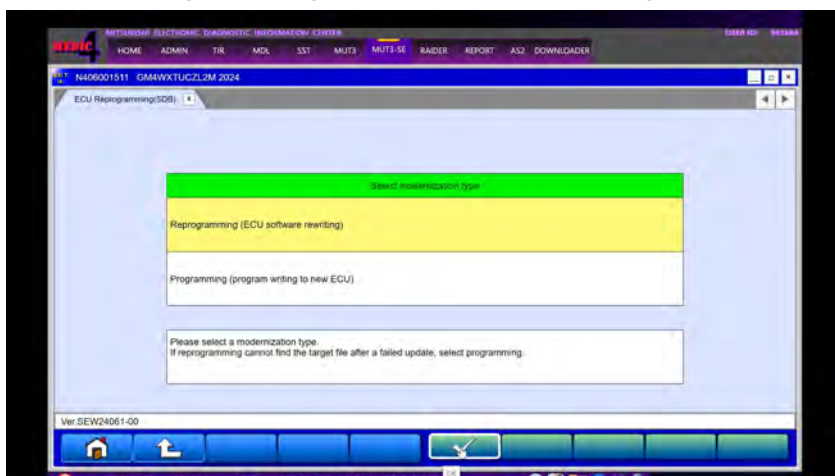
h. Select "Reprogramming (ECU software rewriting)" and press the "OK" button.

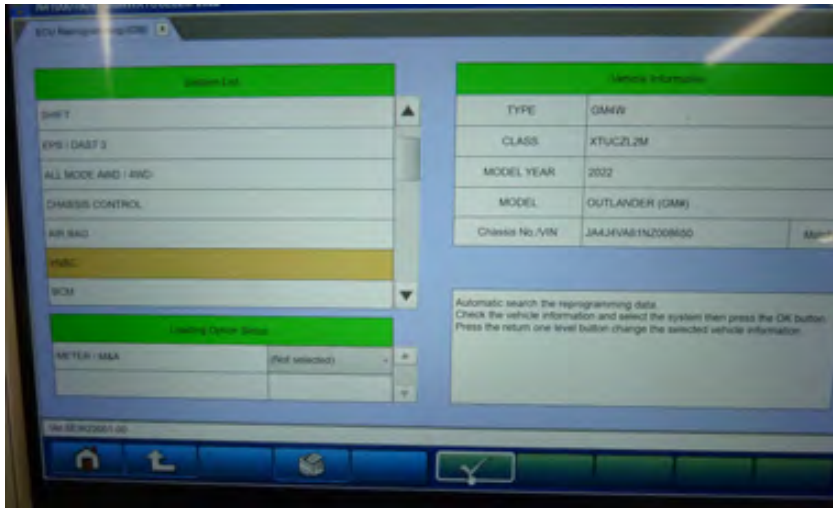
- i. Select "HVAC" from the System List and press the OK button.

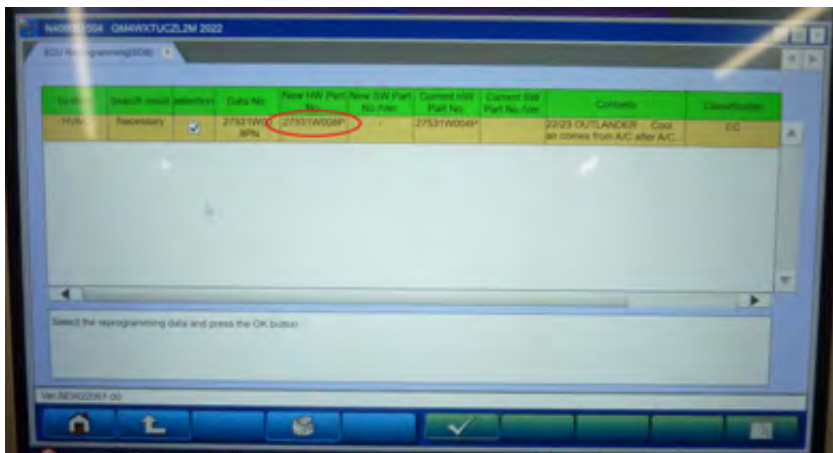
- j. The Automatic ECU Reprogramming (SDB) database screen will display. Press the OK button.

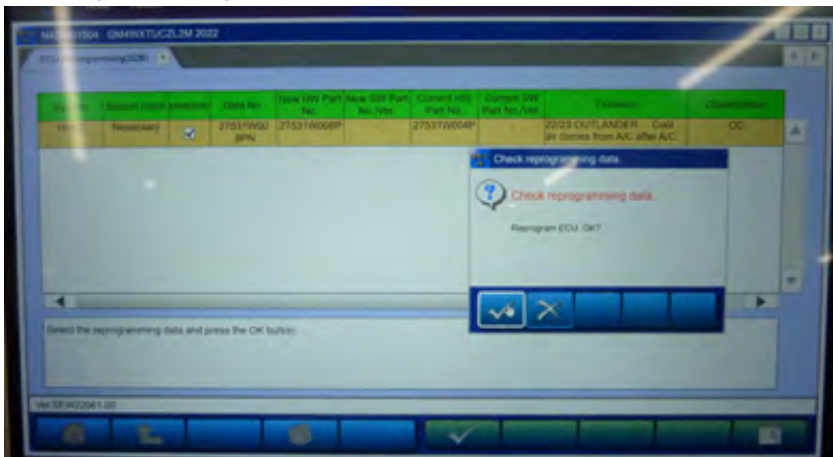
- k. Type AS2 account information (if applicable) and press the OK button to start the reprogramming.

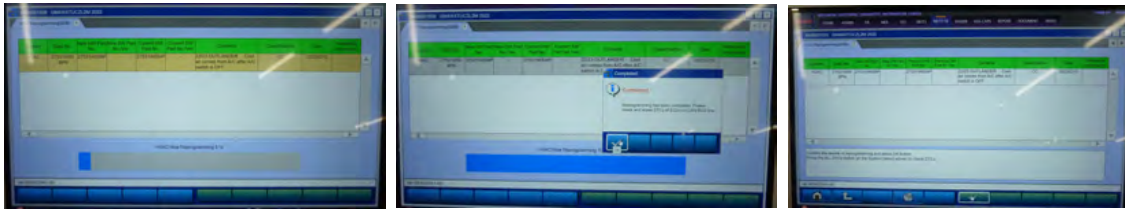
- l. Once the reprogramming is initiated the screen will display the reprogramming progress. Verify that the software version has been updated.

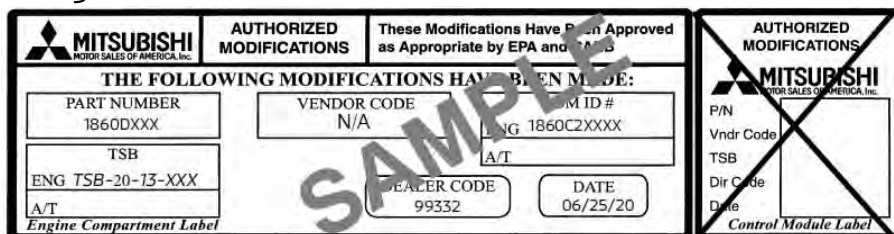
6. Using a ball-point pen, enter the appropriate ECU part number, Software Part Number (ROM ID#), this Technical Service Bulletin number, your dealer code, and the current date on the Engine Compartment/Control Module Label (p/n MSSF024G00). The Vendor Code is not applicable. The label is available from your facing PDC.
