Service Bulletin

Bulletin No.: 24-NA-193

Subject: Radio Software Update W52E-176.1.2-M170-SQBR5-250.2

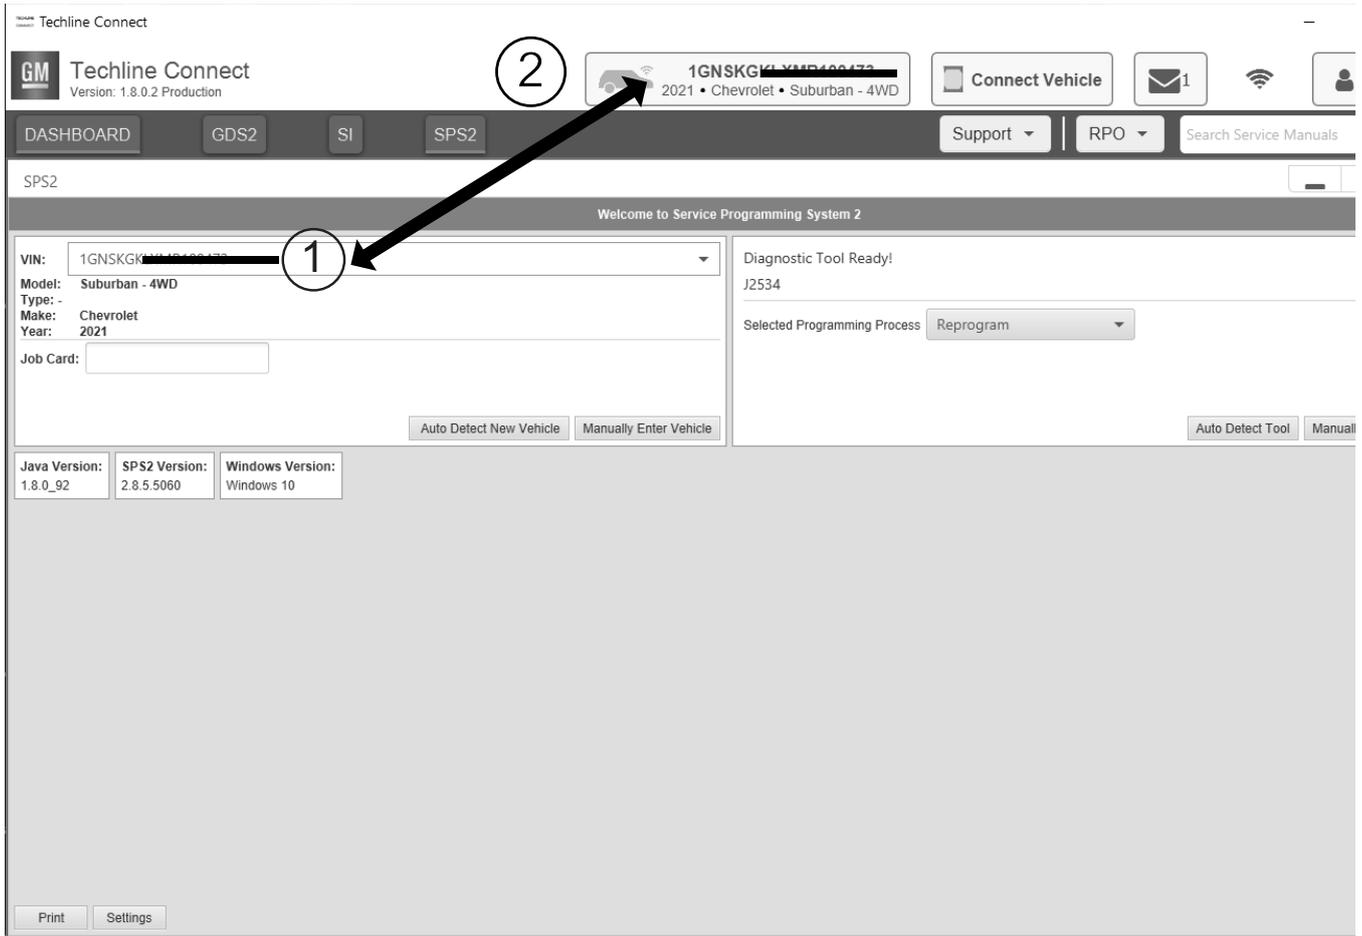
5743643

Caution: Be sure the VIN selected in the drop down menu (1) is the same as the vehicle connected (2) before beginning programming.
