Service Bulletin

Bulletin No.: 21-NA-142

Subject: Front Brake Grind/Groan Noise After Sitting Overnight

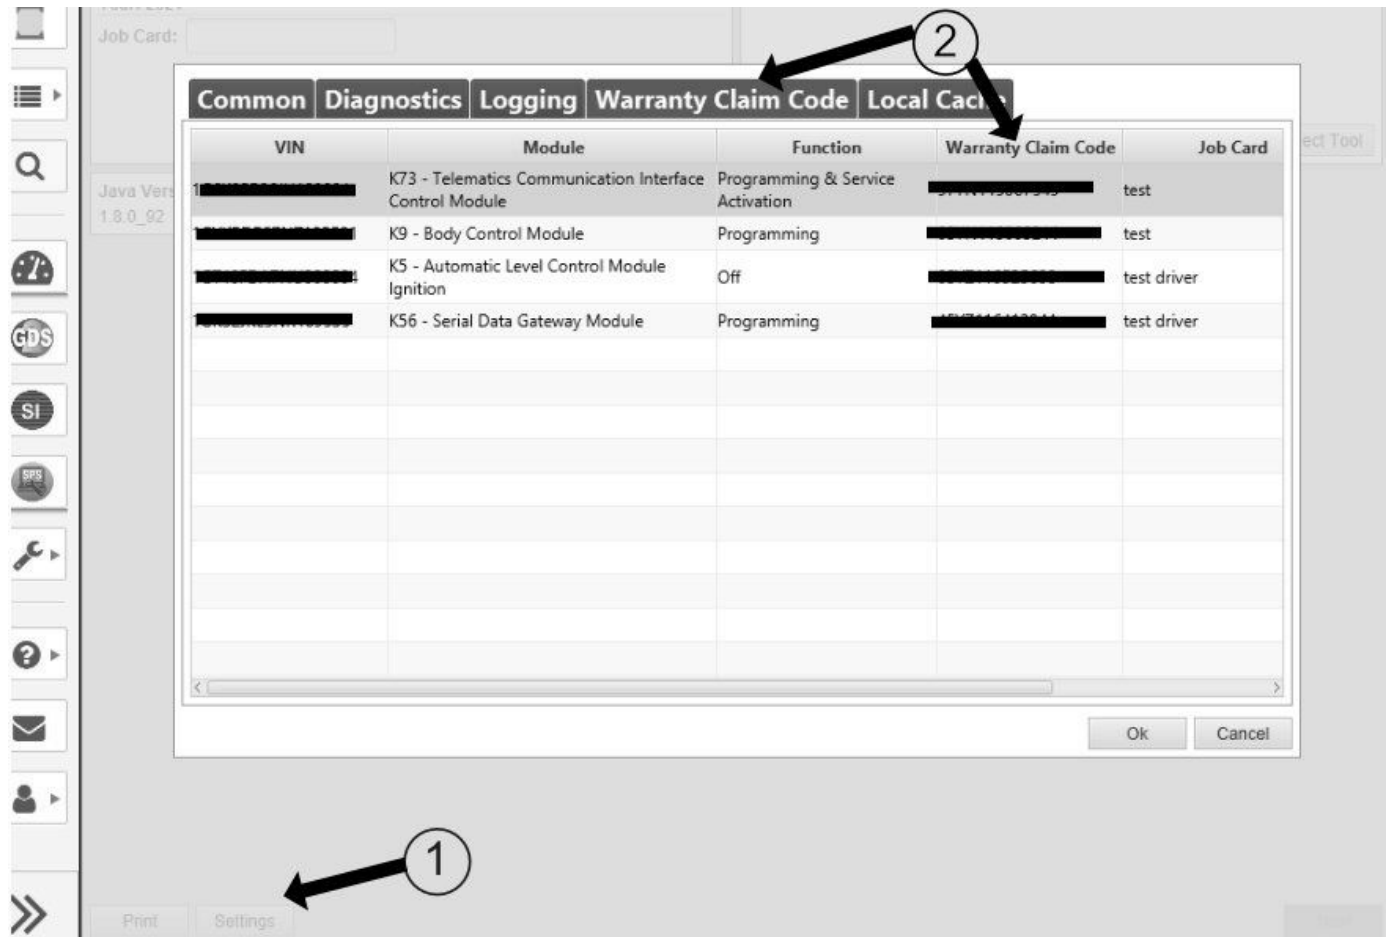
6125774

Warranty Claim Code Information Retrieval

If the Warranty Claim Code was not recorded on the Job Card, the code can be retrieved in the SPS2 system as follows:

The VIN, Warranty Claim Code and Date/Time will be listed on a roster of recent programming events. If the code is retrievable, dealers should resubmit the transaction making sure to include the code in the SPS Warranty Claim Code field.
