Technical Service Bulletin (TSB)
USB update to U35.18 for UUN radio

REFERENCE:	TSB: 08-005-25 GROUP: 08 - Electrical	Date:	January 14, 2025	REVISION:	—
VEHICLES AFFECTED:	2021 - 2023 (M6) Jeep Compass This bulletin applies to vehicles equipped with a Uconnect 5 NAV W 10.1" Display (ROW+DAB) (Sales Code UUN).			MARKET APPLICABILITY: <input type="checkbox"/> NA <input type="checkbox"/> MEA <input type="checkbox"/> SA <input checked="" type="checkbox"/> IAP <input type="checkbox"/> EE <input type="checkbox"/> CH	
CUSTOMER SYMPTOM:	The customer may describe the following: <ul style="list-style-type: none"> Uconnect Navigation Traffic Sign Recognition (TSR) stuck on Miles Per Hour, (MPH) no Kilometers Per Hour (KMH). 				
CAUSE:	Radio software

This bulletin involves inspecting and if required, updating the radio software level to U35.18. Depending on the radio's current software level the radio may need a one, two or three step USB update.

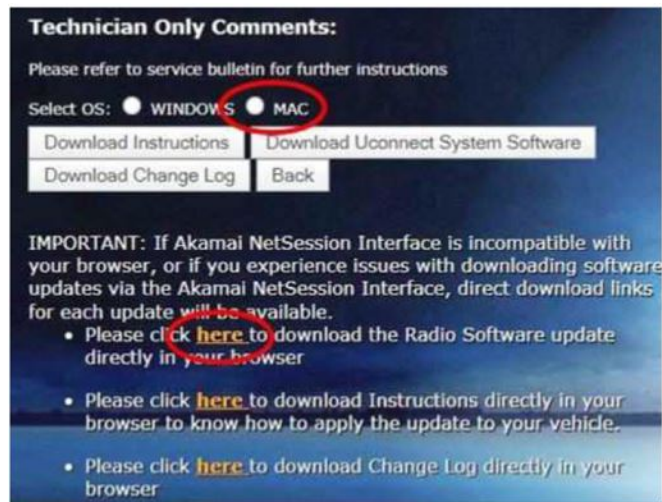
Fig. 3
MAC Radial Button

7. Download the software update file to your local PC's desktop. Make sure to select the “MAC” radial button for all downloads [Fig. 2](#), [Fig.3](#).

NOTE: When downloading the software file, always select the MAC version, regardless of the computer being used.

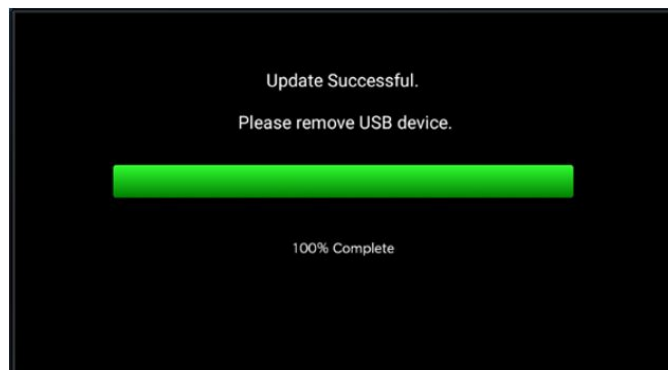
Fig. 7
Update Successful

15. The radio will reboot and the update will begin. The update should take around 60 minutes Fig. 7.

NOTE: Do Not turn off the engine when the software update is completed and told to remove the USB flash drive.

16. **Do Not** turn off the engine at this point. The update is still in process, wait until the radio restarts and the home screen is displayed. This should take around five minutes.
