GROUP	MODEL
ELE	2022-2024MY EV6 (CV1)
NUMBER	DATE
367	January 2025

## TECHNICAL SERVICE BULLETIN

### SUBJECT: SERVICE ACTION: LIMP-HOME MODE OPERATION LOGIC IMPROVEMENT (SA599)

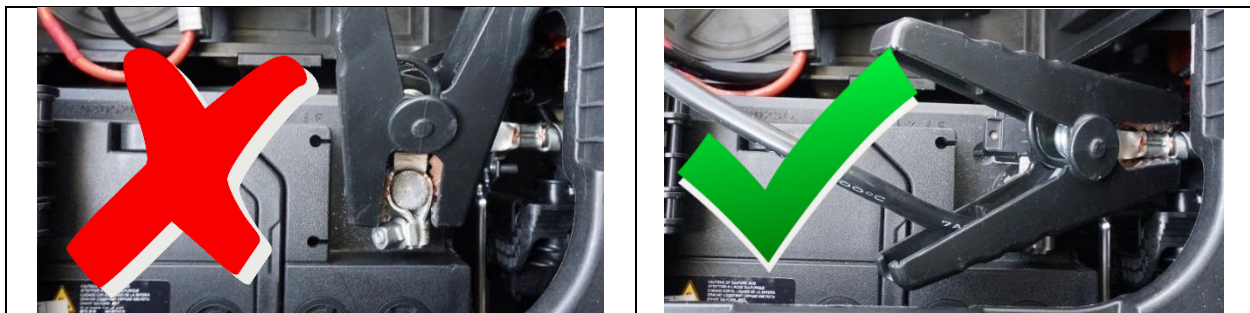
[Connect the negative \(-\) terminal to the battery as shown below.](#)
