GROUP	MODEL
ELE	2024-2025MY EV9 (MV1, MV1a)
NUMBER	DATE
369	January 2025

TECHNICAL SERVICE BULLETIN

SERVICE ACTION: REAR MOTOR CONTROL UNIT SOFTWARE UPGRADE (SA601)

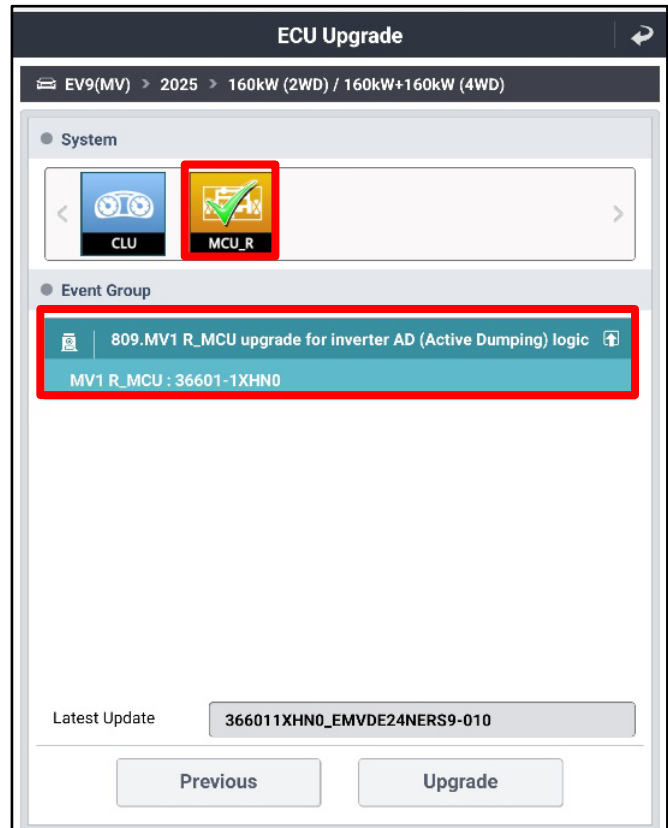
Select the applicable **'MCU_R'** 'system' module and **'Event Group'** number in the ECU Upgrade.

- **2024-2025MY EV9 (MV1) - Korea Built**
809.MV1 R_MCU upgrade for inverter AD (Active Dumping) logic

- **2025MY EV9 (MV1a) - US Built**
810.MV1a R_MCU upgrade for inverter AD (Active Dumping) logic"
