**SIB 34 01 24**

Service Action: Distance Recorder Integrated Brake System (IB)

This Service Information Bulletin (Revision 2) replaces SI B34 01 24 **dated January 2025**.

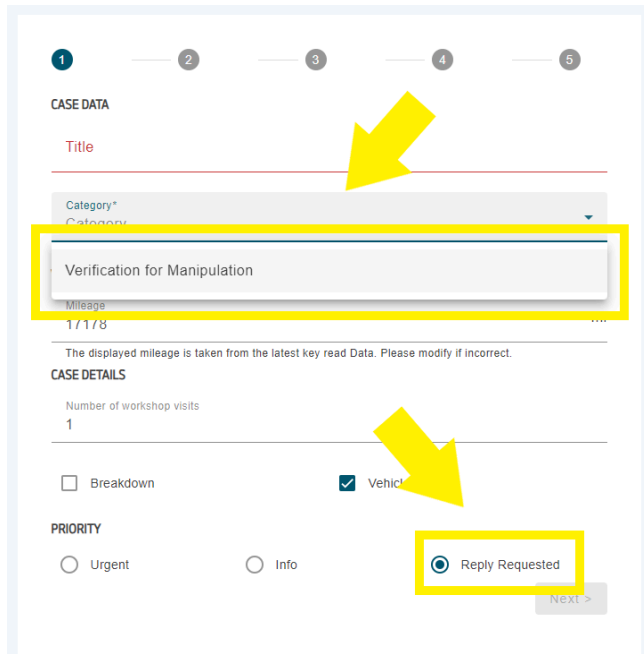
- a. When creating the TSARA case, choose the “Repair Clearing” case type. Any other case type will cause a delay in case response.

TTS

Repair Clearing
