GENERAL MOTORS
DCS7128
URGENT - DISTRIBUTE IMMEDIATELY

Subject: N242450630 - Service Update
Fuel Injector Flow Rate

Models: 2021-2023 Cadillac CT4
2022 Chevrolet Silverado 1500
2022 GMC Sierra 1500

N242450630 Fuel Injector Flow Rate

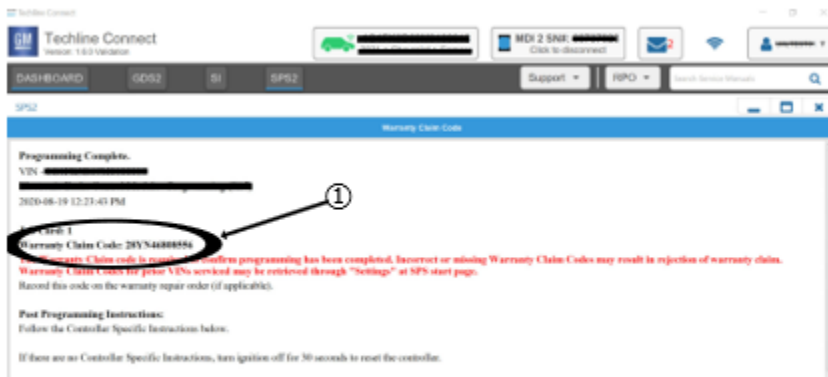
5644478

1. Reprogram the Engine Control Module. Refer to *K20 Engine Control Module: Programming and Setup* in SI.

Note: The screenshot above is an example of module programming and may not be indicative of the specific module that is being programmed. Module selection and VIN information have been blacked out.
