GENERAL MOTORS
DCS7129
URGENT - DISTRIBUTE IMMEDIATELY

Subject: N242438530 - Service Update
ECM Does Not Properly Clear DTC U1962

Models: 2024 Chevrolet Corvette

N242438530 ECM Does Not Properly Clear DTC U1962

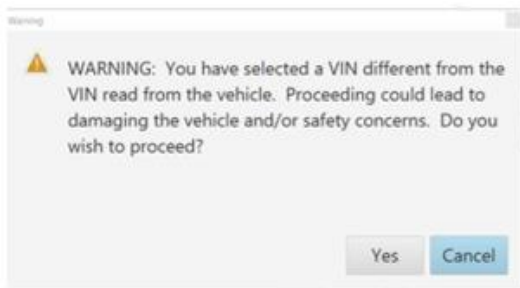
5877000

Important: If the vehicle VIN DOES NOT match, the message below will be shown.

Important: Techline Connect screens shown above.

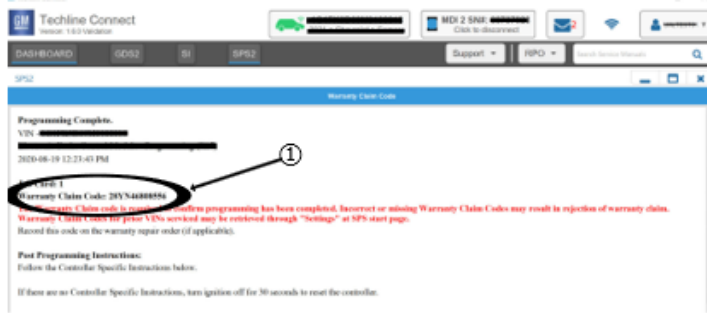
5644478

Note: The screenshot above is an example of module programming and may not be indicative of the specific module that is being programmed. Module selection and VIN information have been blacked out.
