Service Bulletin

Bulletin No.: 21-NA-293

Subject: Poor Engine Performance in Extremely Cold Weather Conditions, Charge Air Cooler Icing - Malfunction Indicator Lamp (MIL) Illuminated, DTC P0299, P0234, P0236, P00C7 Set

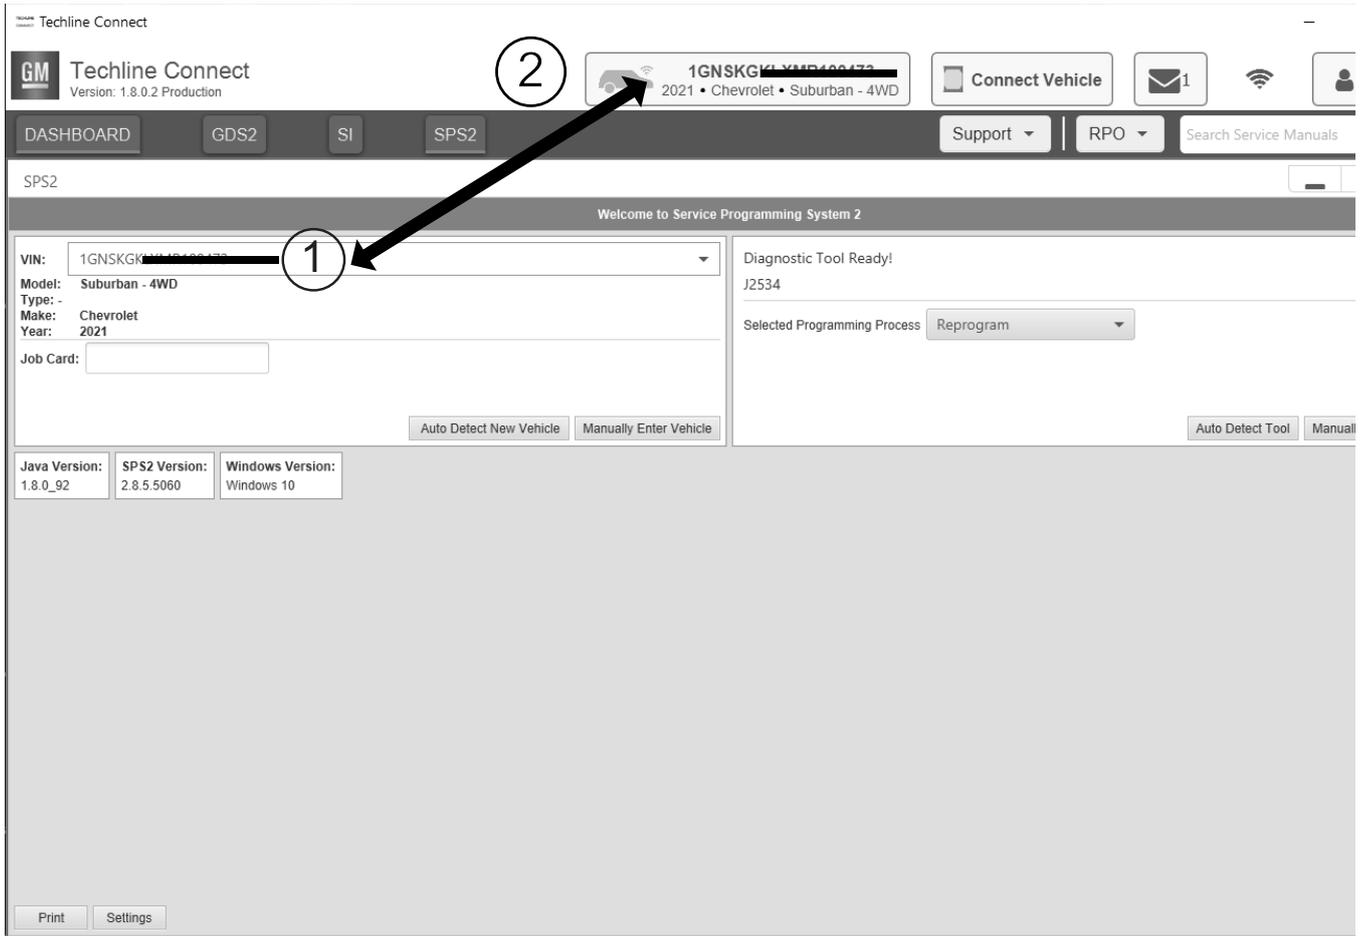
5743643

Caution: Be sure the VIN selected in the drop down menu (1) is the same as the vehicle connected (2) before beginning programming.

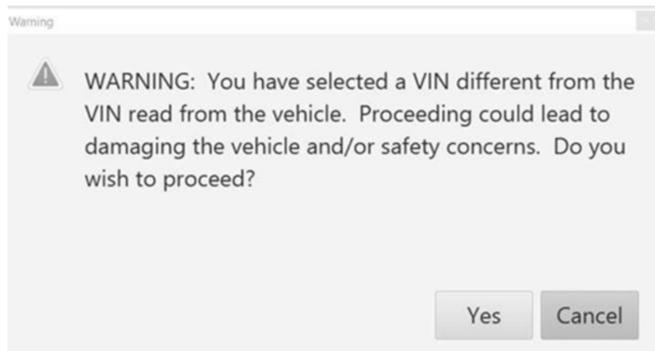
5877000

Important: If the vehicle VIN DOES NOT match, the message below will be shown

The screenshot shows the Techline Connect software interface. At the top, there is a navigation bar with 'DASHBOARD', 'GDS2', 'SI', and 'SPS2' buttons. A search bar for 'Search Service Manuals' is on the right. Below this is a 'Programming' window with a table of calibration data. A dialog box is overlaid on the table, displaying a warning message: 'M4521: You are attempting to reprogram with the same calibration. Select OK to continue, Cancel to Stop!'. The table has columns for Controller, ID, Current #, and Description. The VIN is visible at the bottom right of the window.

Important: Techline Connect and TIS2WEB screens shown above.

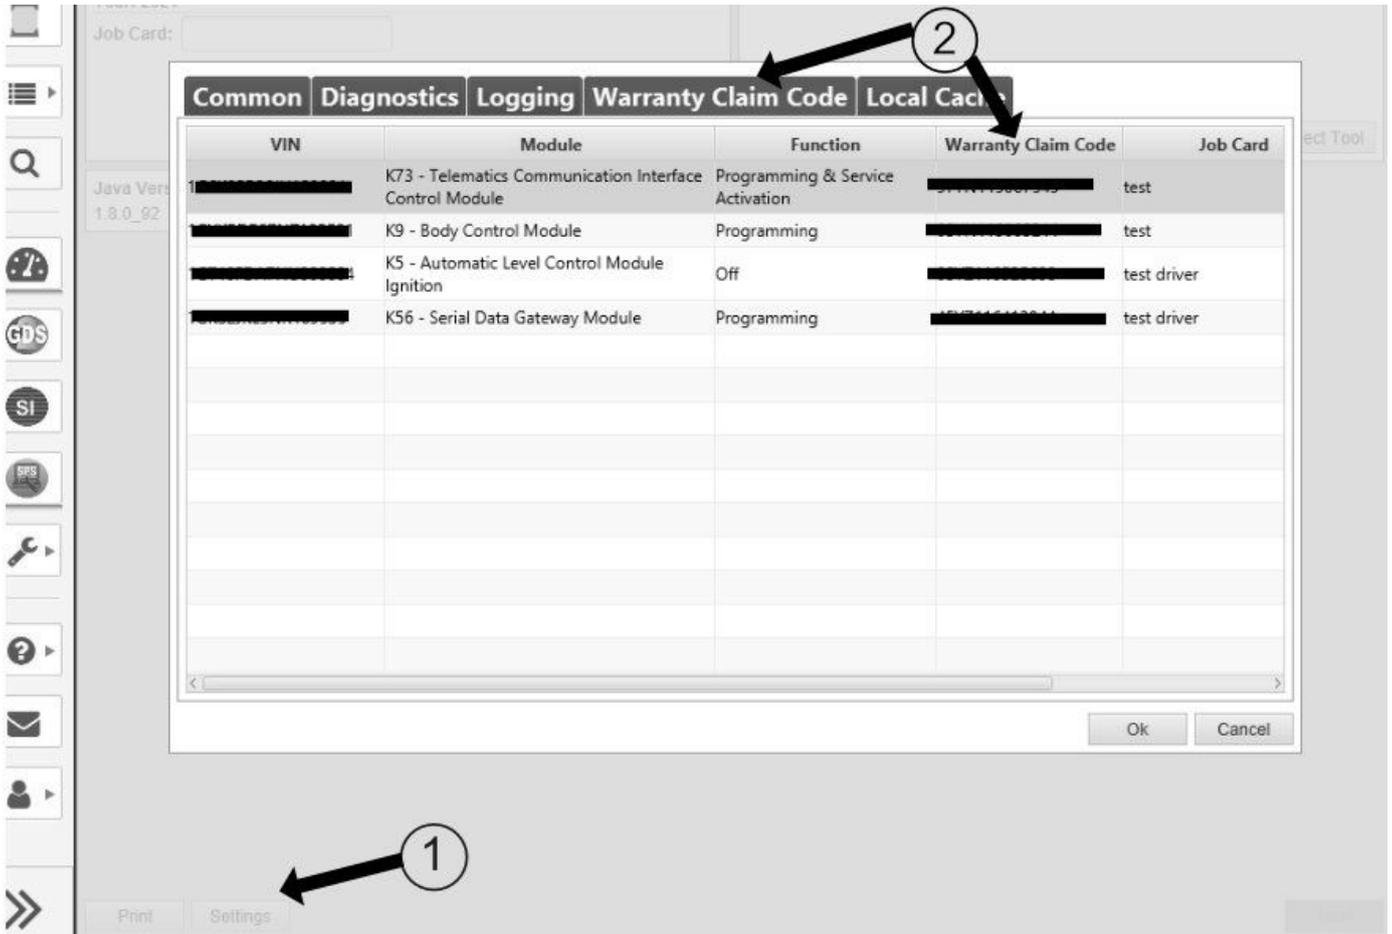
6125774

If the Warranty Claim Code was not recorded on the Job Card, the code can be retrieved in the SPS2 system as follows:

The VIN, Warranty Claim Code and Date/Time will be listed on a roster of recent programming events. If the code is retrievable, dealers should resubmit the transaction making sure to include the code in the SPS Warranty Claim Code field.
