# TECHNICAL SERVICE BULLETIN

Classification: DA21-003B	Reference: NTB21-040B	Date: January 21, 2025
------------------------------	--------------------------	---------------------------

## DTCS B2740-87, B2744-87, AND/OR B274D-87 STORED

**APPLIED VEHICLES:** 2021 Rogue (T33)  
**APPLIED DATES:** 11th character of VIN is W – Built on or before October 19, 2021  
11th character of VIN is C – Built on or before March 8, 2021

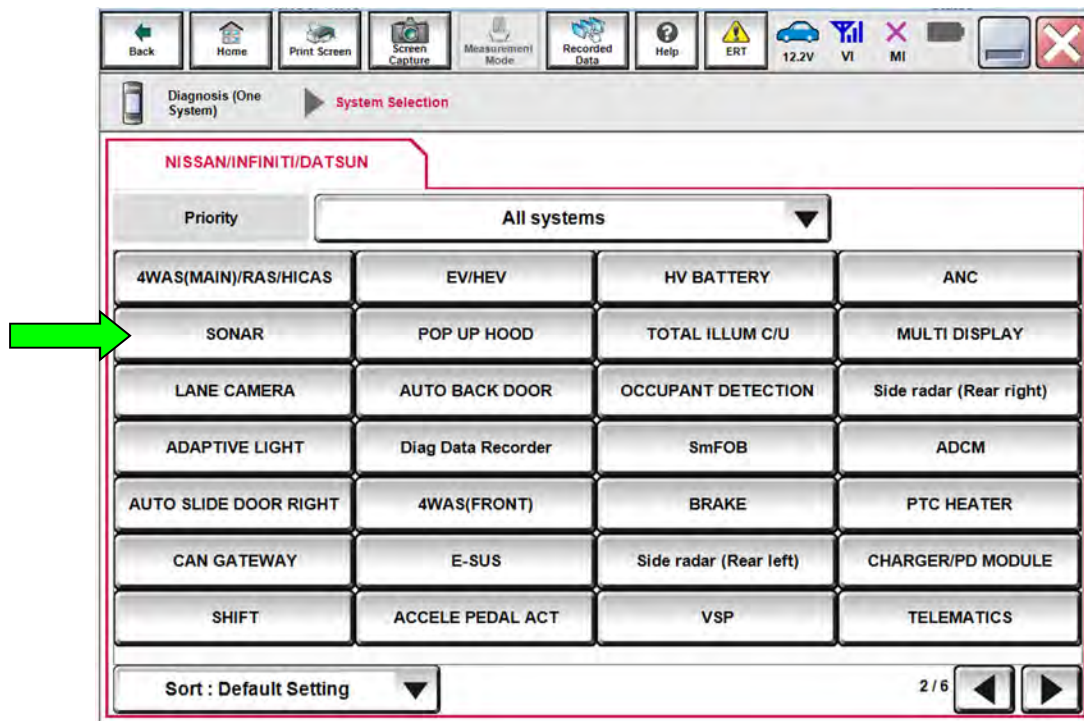
Figure 2

14. Select **SONAR**.

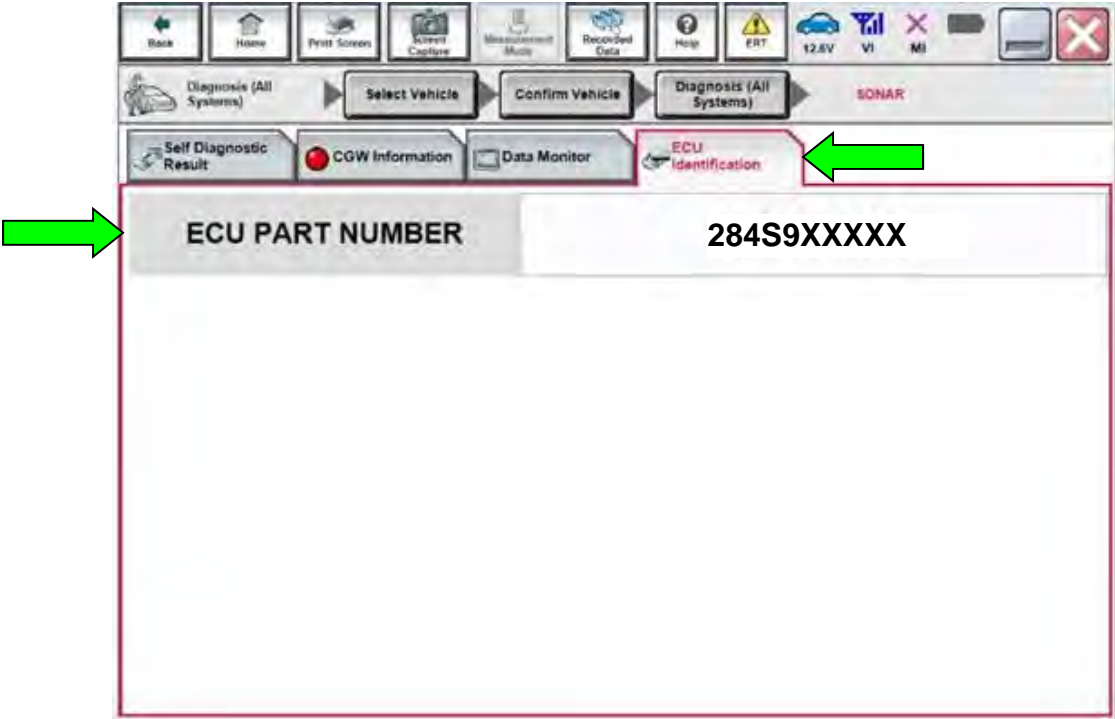
Figure 3

15. Select **ECU Identification**.

- If the **ECU PART NUMBER** is 284S9-1517R, this bulletin does not apply. See the Electronic Service Manual (ESM) for further diagnostic information.
- If the the **ECU PART NUMBER** is not 284S9-1517R, proceed to step 16.

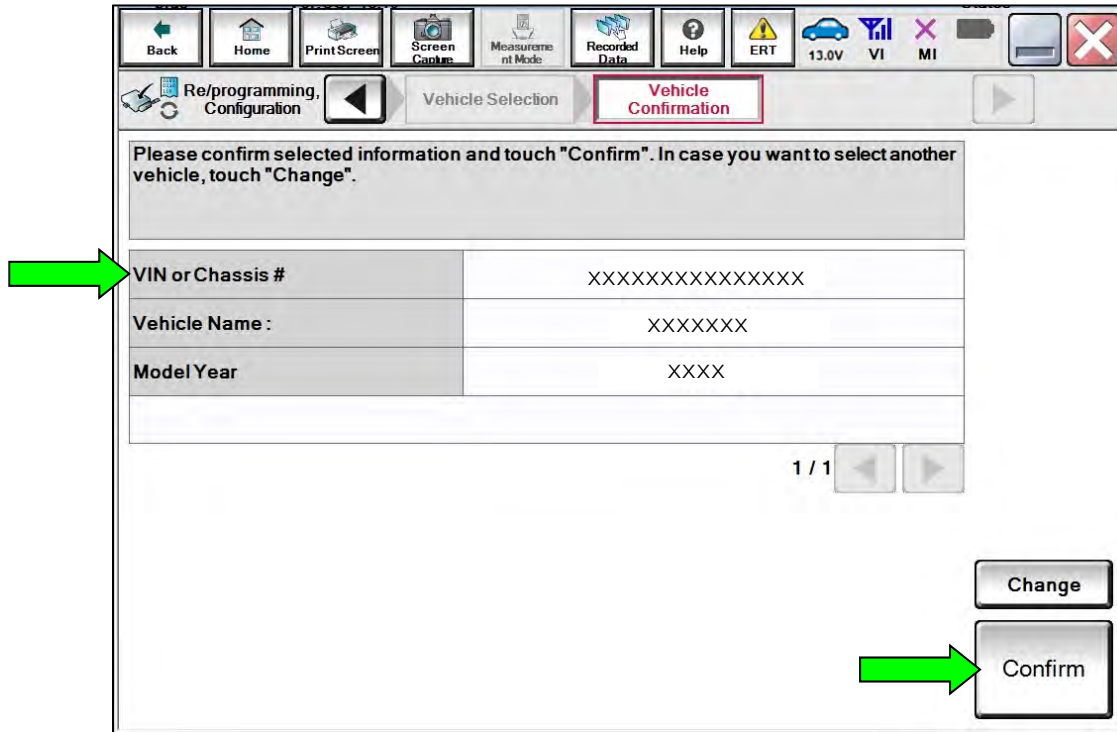
Figure 9

21. Confirm the **VIN or Chassis #** is correct, and then select **Confirm**.

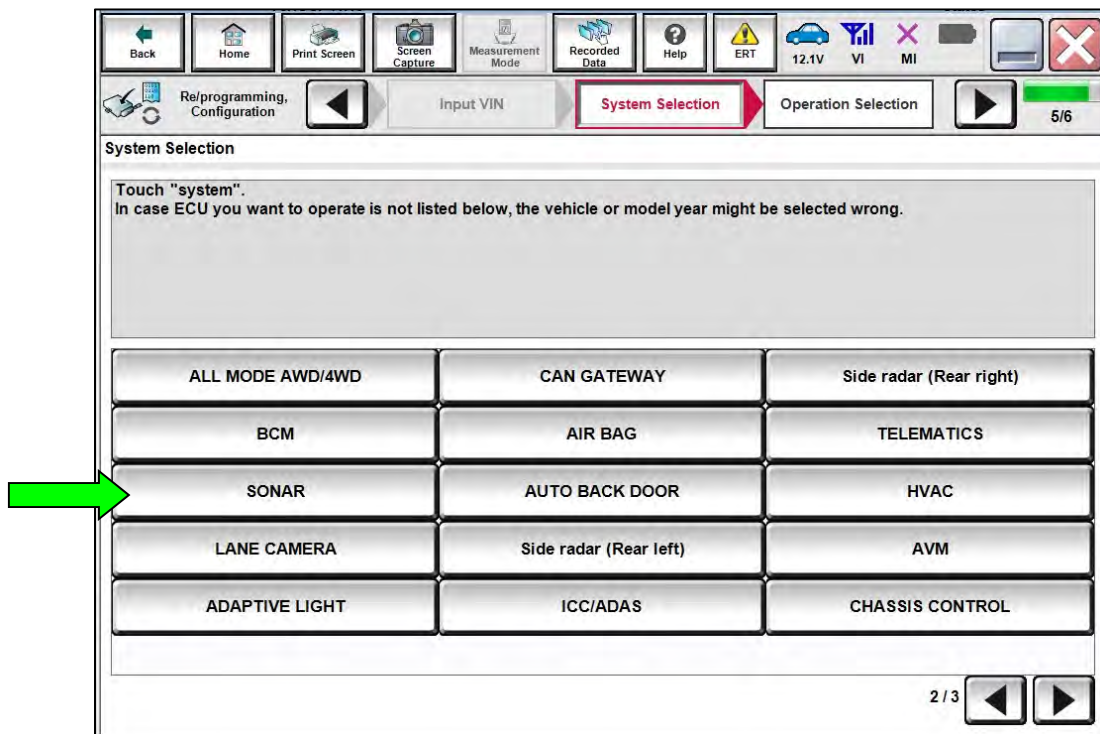
Figure 12

24. Select **SONAR**.

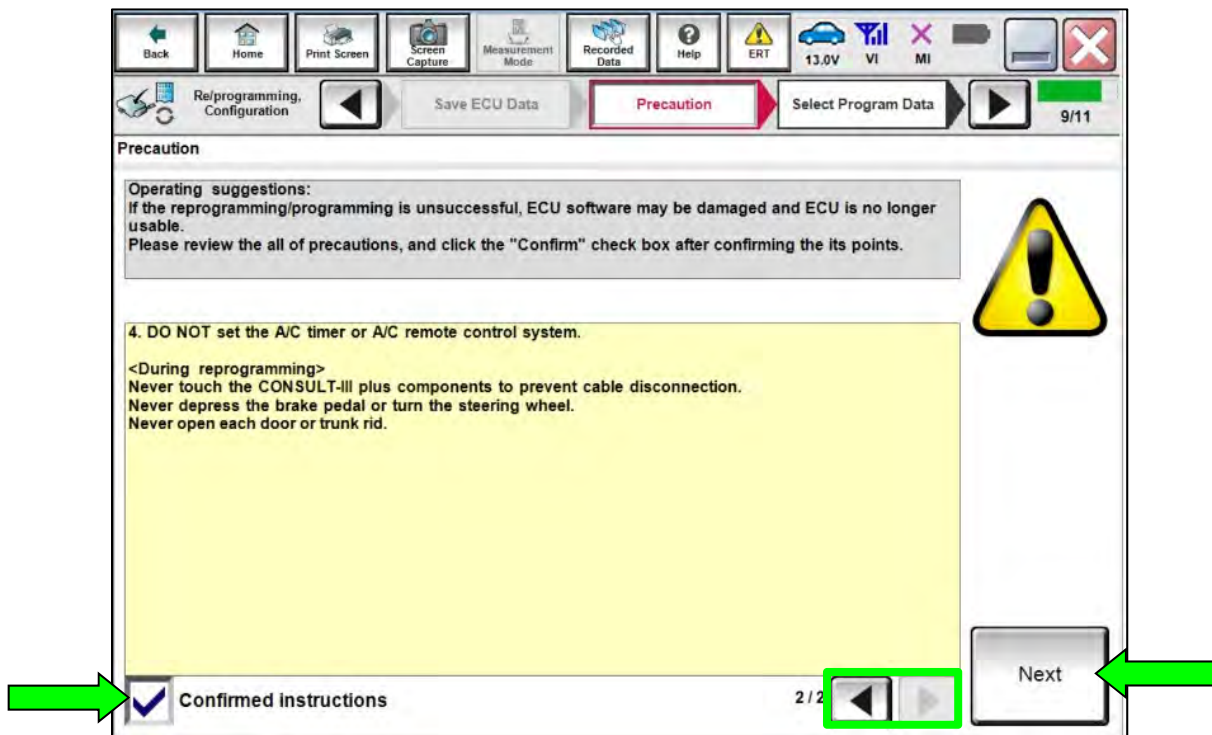
Figure 16

29. Check the box to confirm the precaution instructions have been read, and then select **Next**.

**HINT:** Use the arrows (if needed) to view and read all the precautions.

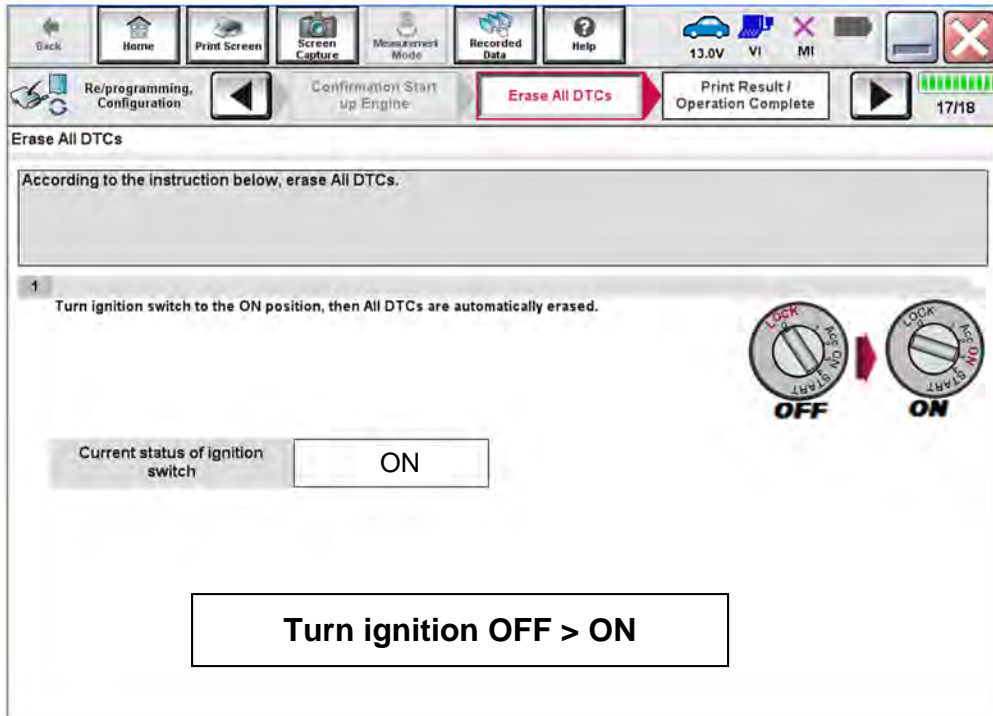
Figure 25

- 39. Erase all DTCs as follows:
  - a. Turn the ignition OFF.
  - b. Turn the ignition ON.

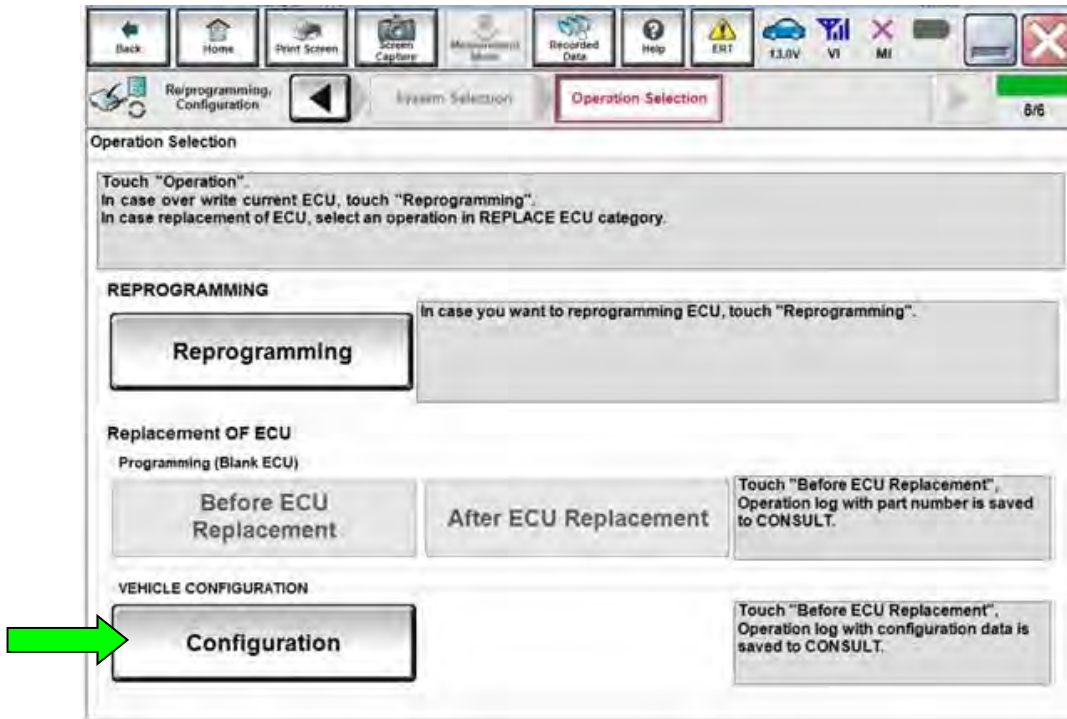
Figure 29

50. Select **Configuration**.

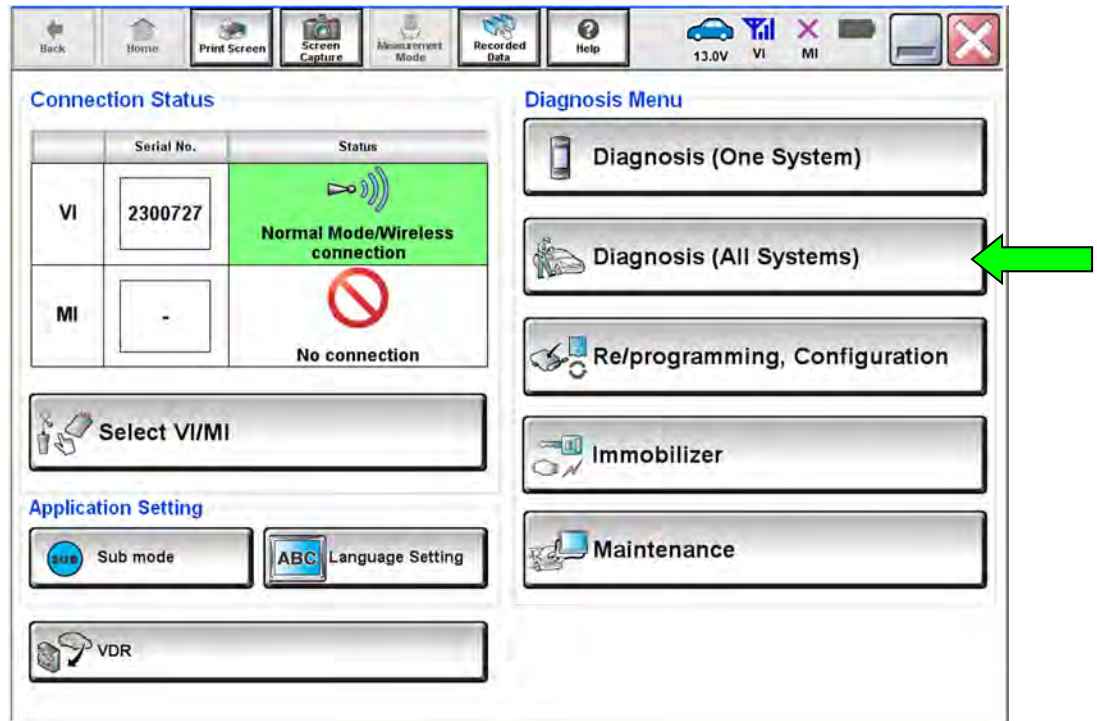
Figure 32

54. Select **Diagnosis (All Systems)**.
