TECHNICAL SERVICE BULLETIN

| Subject: | 800 Volt 2170 CMB6 Pack Cell Balancing Retrofit |
| Service Bulletin #: | SC-21-149 |

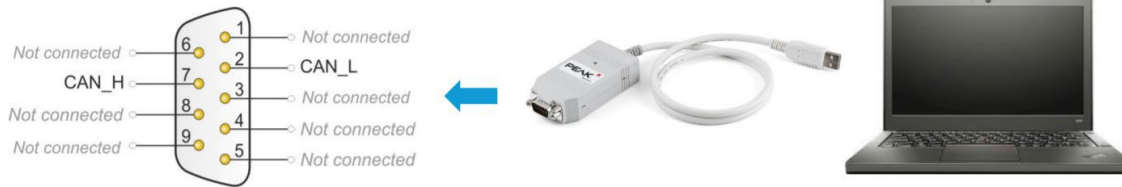
1. Connect the CAN side of the PCAN-USB Adaptor Octopus Cable to the system's BCAN network. Then connect the USB side of the PCAN-USB adaptor to the laptop.
