D24R7

Subject: Emission Recall DD8 EGR Monitor Software Reprogramming

Models Affected					
Make	Model	Model Yr. Start	Model Yr. End	Prod. Start Date	Prod. End Date
Detroit Diesel Corporation	936.913	2022	2024	January 1, 2022	September 17 th , 2024
Identifying Feature	DD8 Single Stage Turbo

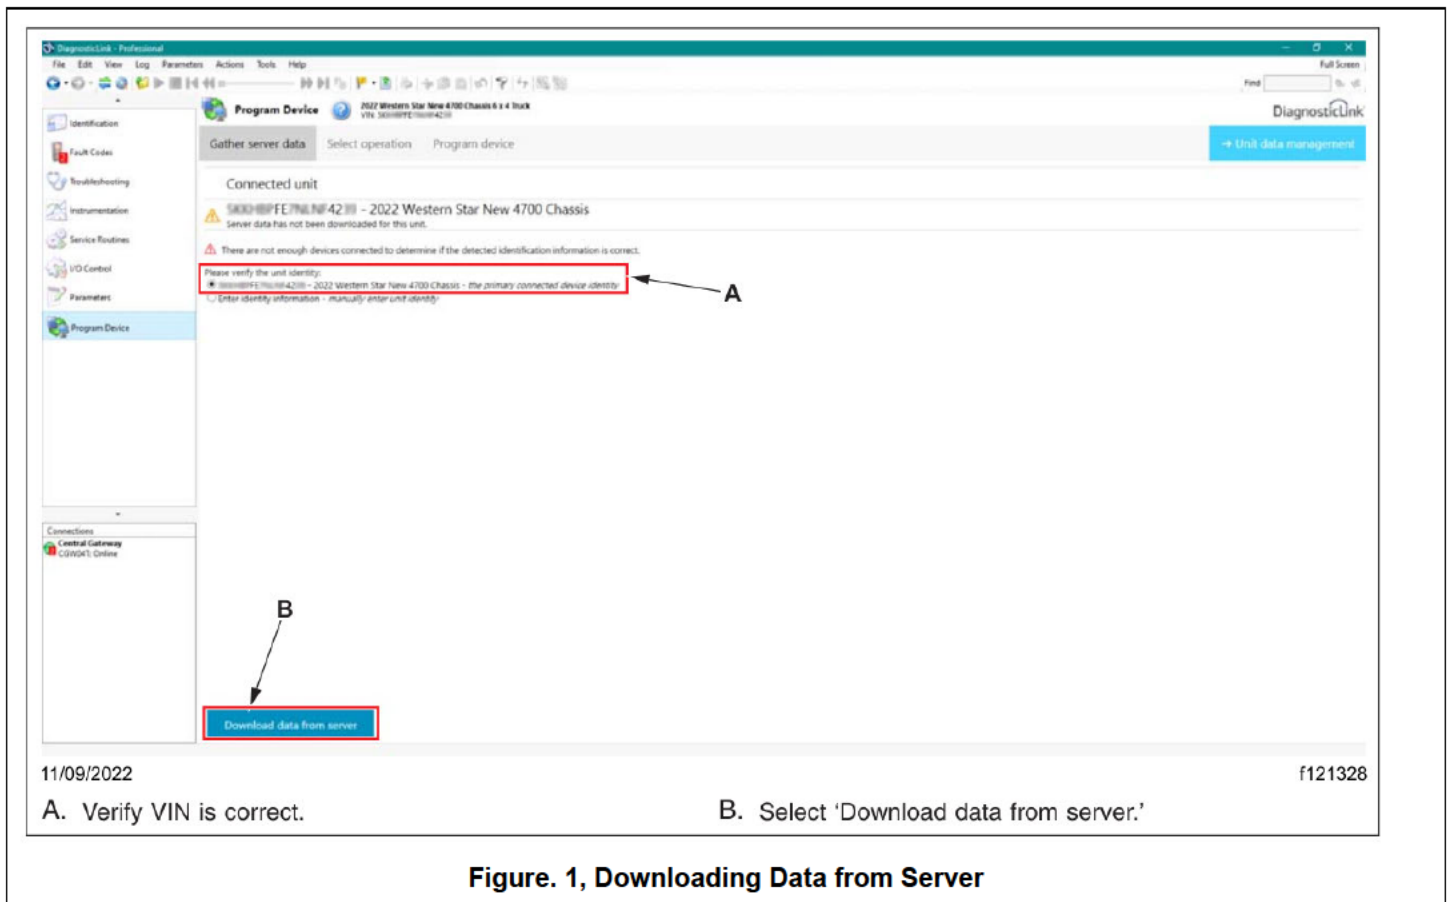
7. Make sure the VIN is correct in all modules (ACM, CPC, MCM, and if applicable the TCM) by looking at the 'Identification' screen in DiagnosticLink. Is the VIN incorrect in any modules?
 - a. Yes, correct the VIN under the 'Actions' dropdown menu in DiagnosticLink by selecting the 'Check VIN Synchronization' item. Select 'Start' from this panel and follow the prompts. Cycle the key, as prompted, until the routine is complete. Turn the keyswitch back ON (key ON, engine OFF) and continue with the download process once the synchronization is complete.
 - b. No, go to step 8.
8. Go to the 'Program 'Device' tab, and make sure the vehicle identification number (VIN) is correct. Select 'Download data from server.' See Fig. 'Downloading Data from Server.'

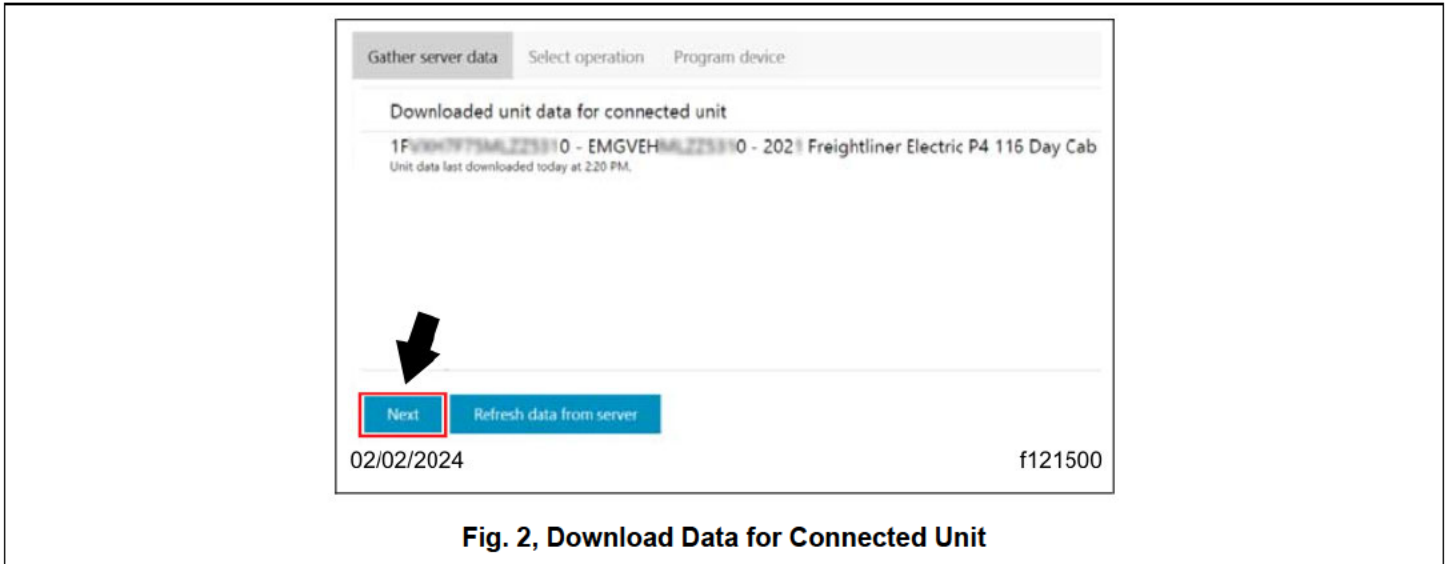
Fig. 2, Download Data for Connected Unit

- Once the data download is complete, select 'Next.' See Fig. 'Download Data for Connected Unit.' Devices with available software are listed.

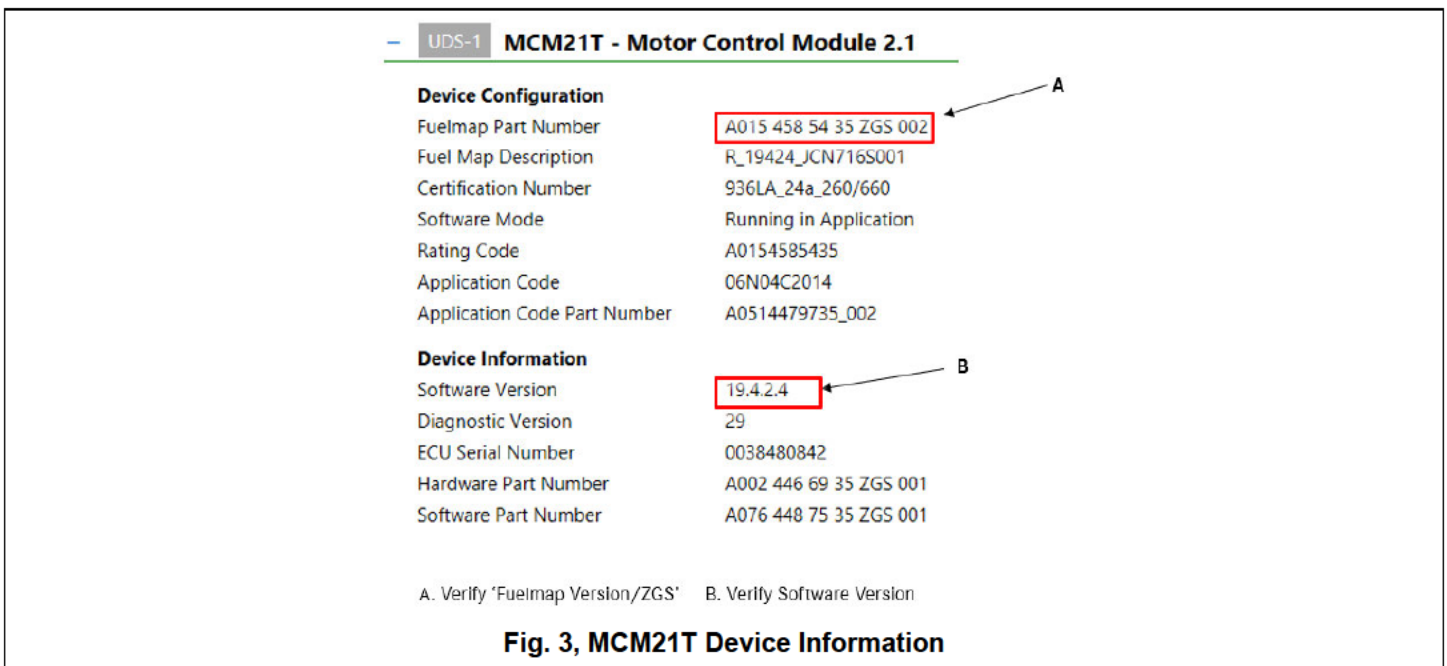
Fig. 3, MCM21T Device Information

- Before programming the MCM, check the software version and the fuel map part number. Go to the 'Identification' tab, then select and expand the 'MCM21T – Motor Control Module 2.1' information.
- Verify the MCM21T software version and the fuel map part number. See Fig. 'MCM21T Device Information.'
