ISSUE DATE:	11/22/2023
SERVICE BULLETIN SUBJECT:	ZX5.A0 Limited Vehicle Controller Release 3.8.16
VINs or MODELS AFFECTED:	Service Specified Buses
COMPLETE BY:	Next Service Opportunity
SERVICE BULLETIN #:	SC-23-160
LABOR OPERATION CODE:	EN66Z
LABOR TIME	.5 Hours

ZX5.A02 Limited Vehicle Controller Release 3.8.16

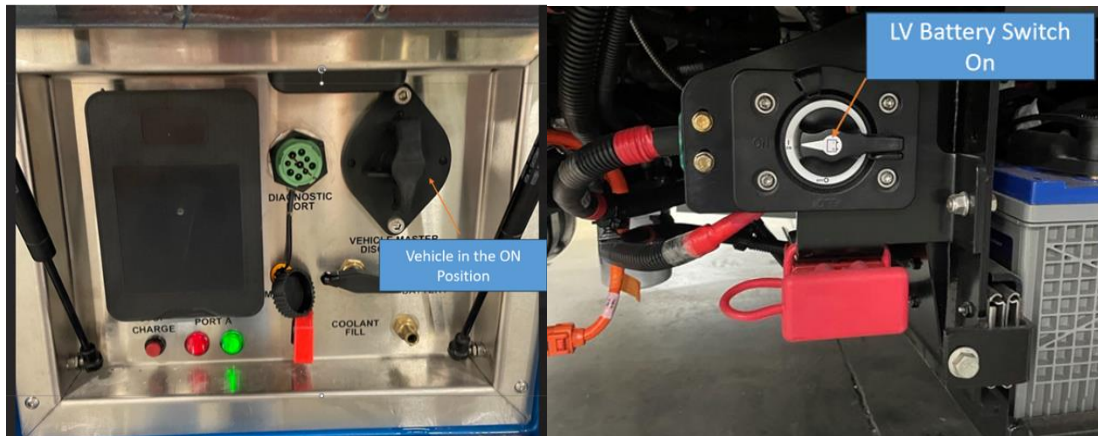
1. Connecting to the vehicle, Power up and login to the Proterra-Supplied laptop or a comparable PC that has the Proterra Diagnostics Tool software installed with a valid license.
2. Turn ON the 12/24V rear Vehicle Master Disconnect located at the curbside rear charge port access panel and the LV Battery Saver Switch near the LV batteries.

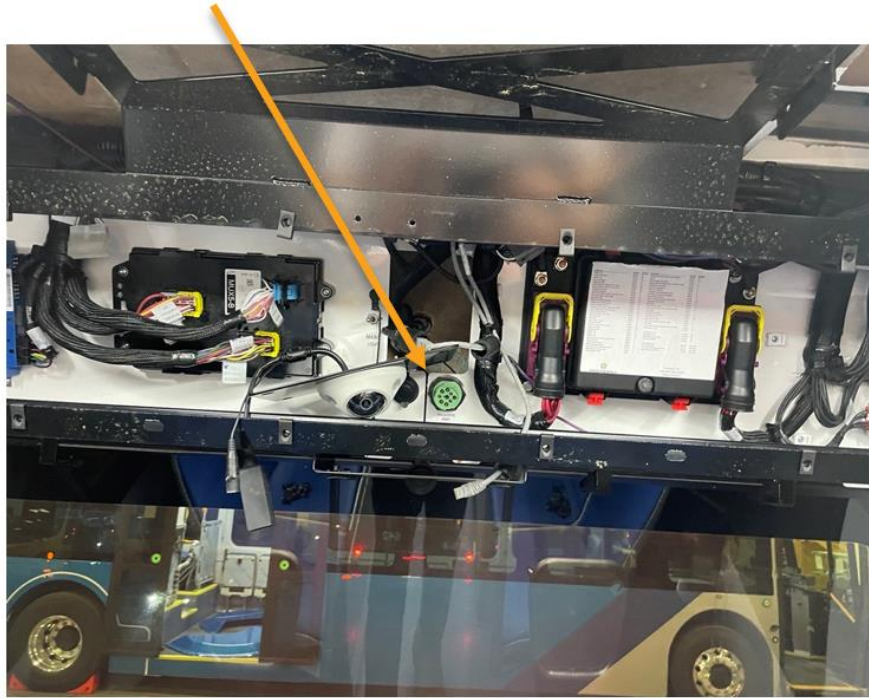
3. Connect the Nexiq USB Link2 device to the laptop and to the OBDII Diagnostic Port located in the rear deck above the rear window.

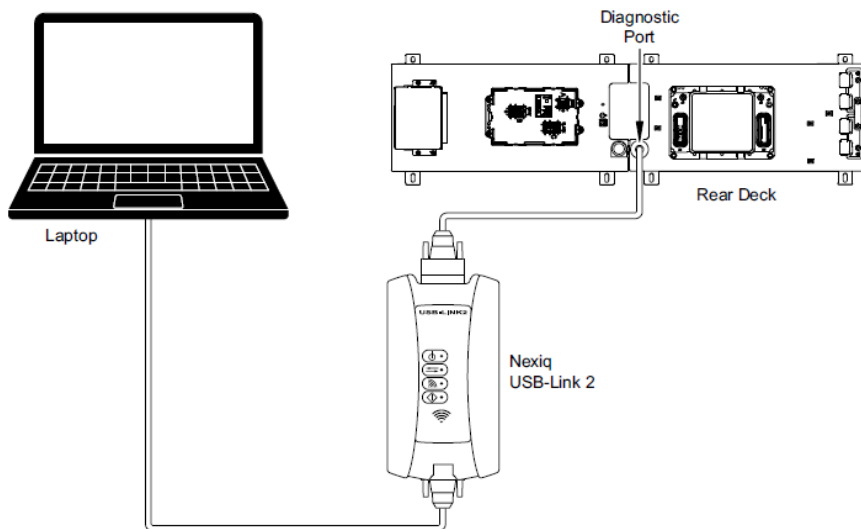
Note: Laptop Configuration should look like the following.

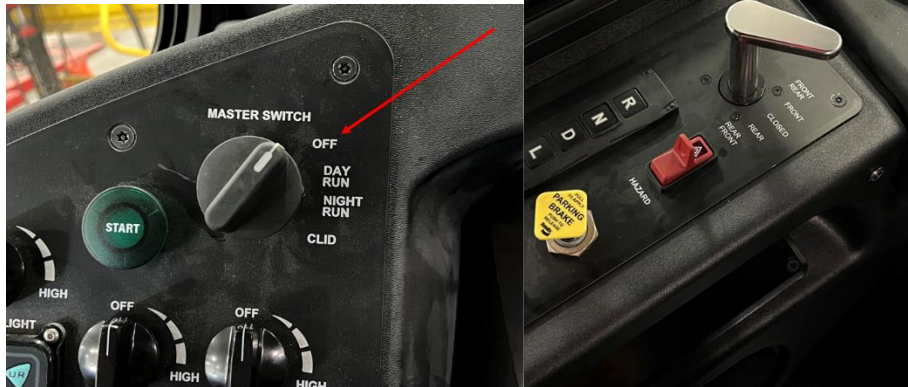
4. Make sure the Master Switch is in the “**OFF**” position and the Hazard Switch is **ON**.
 - a. **NOTE** – Other systems may cause the hazard **lights** to be on. Ensure the Hazard **Switch** is on for flashing purposes.

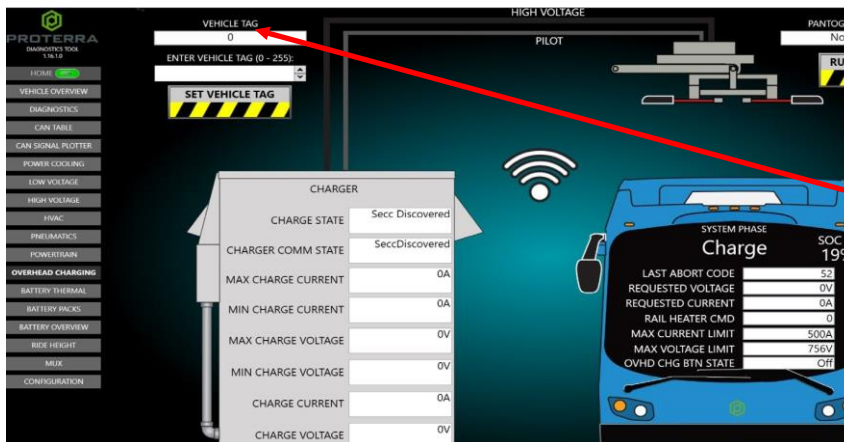
Record Vehicle Tag

11. Record the value displayed in the “Vehicle Tag” data field. This will be re-entered into the controller after the software update.

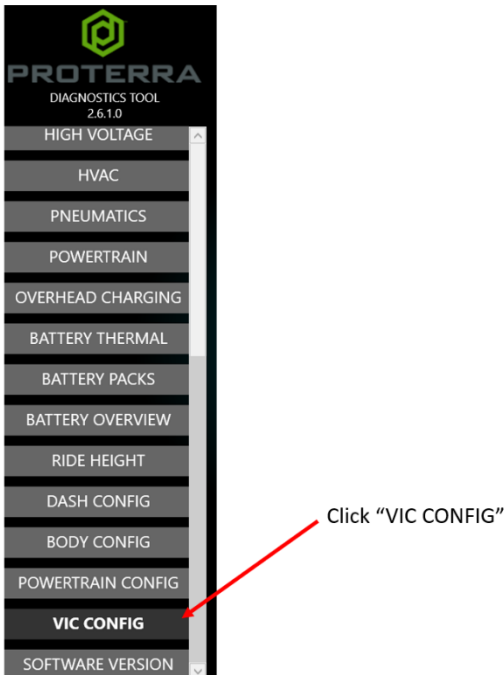
12. Navigate to the “VIC CONFIG” tab in the left menu.

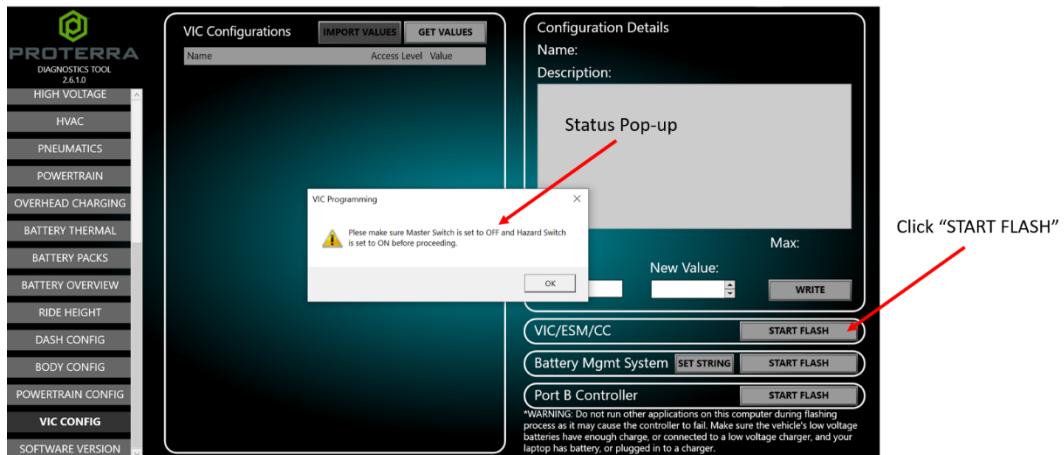
13. Select the option for Vehicle Controller “START FLASH”. There will be a status pop-up to confirm that the Master Switch is OFF, and the Hazard Switch is ON.
 NOTICE: The “INITIAL FLASH” button is only for offline programming of the Vehicle Controller with an Offline Programming Kit.

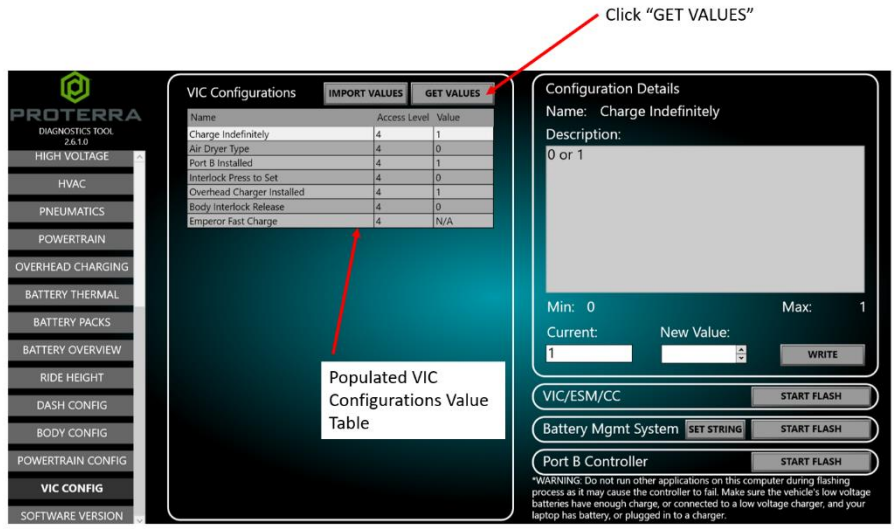
14. After pressing OK, it will prompt you to press the “START FLASH” button again. **BEFORE YOU DO THAT**, press the “GET VALUES” button to get the current controller configuration values. Save these values in case the automatic restore does not work.

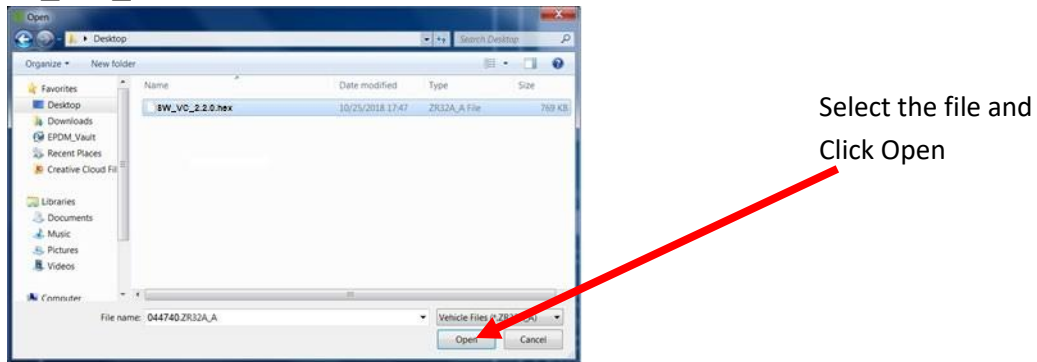
- Now, press the "START FLASH" button once more and a pop-up window should appear. In the pop-up window, select the software flash file to load the controller. The correct file is named 065727 SW_VIC_3.8.16.hex.

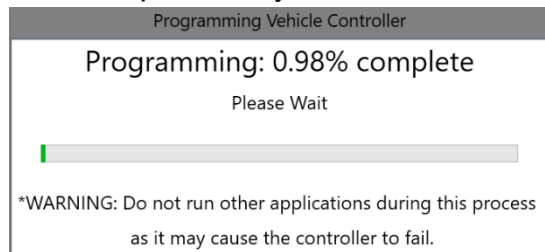
- The Programming window will come up and may take a few minutes to complete.

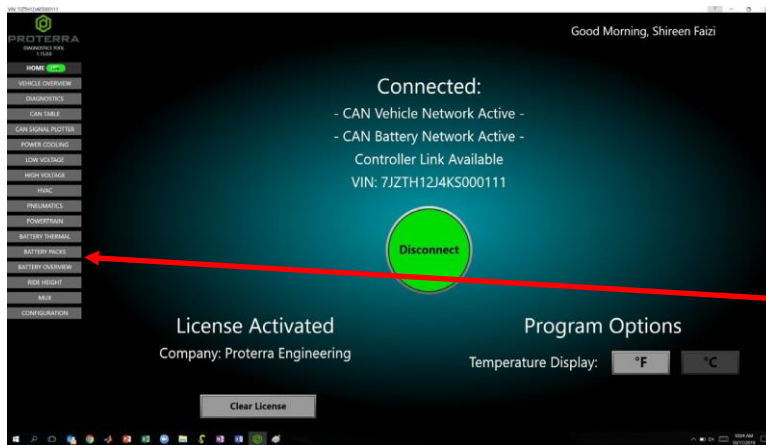
Click "Overhead Charging"

- Click on the "Overhead Charging" button on the left side of the screen.
 NOTE: If the bus that you are working on is not capable of overhead charging, skip to step 19.

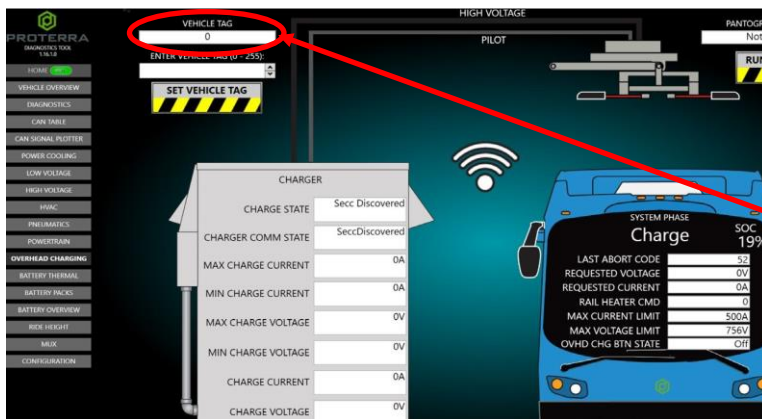
Click "Button"

- The following screen will appear. Enter the "Vehicle Tag" that you recorded previously into the field circled in red below. Click the button under the field. This will populate the "Vehicle Tag" into the field above and into the controller.

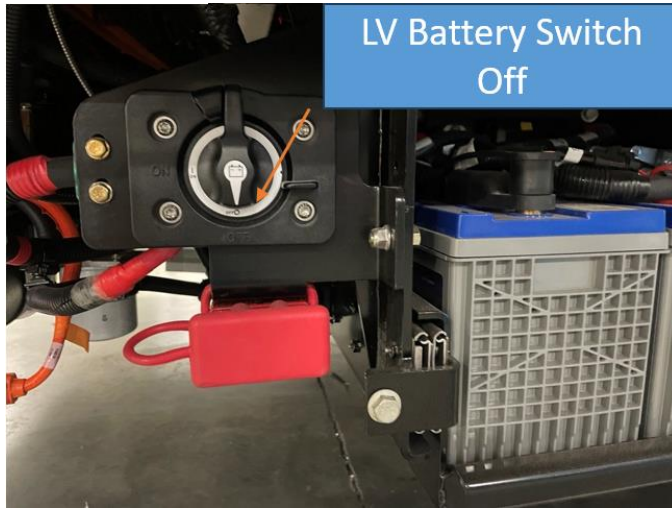
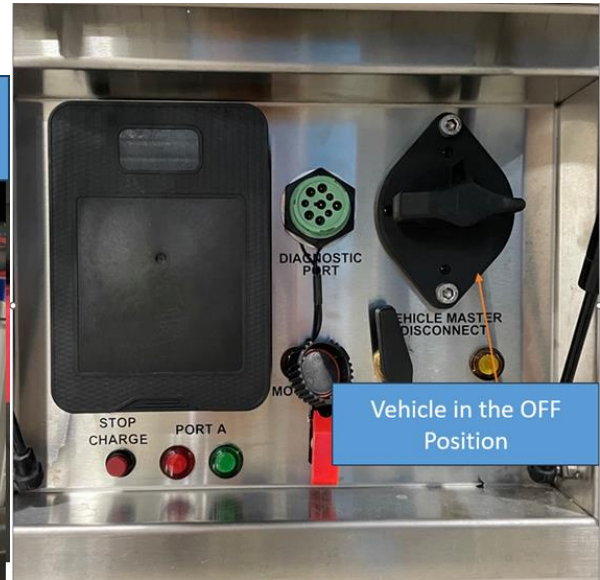
- Turn the Hazard Switch **OFF**.
- Turn OFF the 12/24V rear Vehicle Master Disconnect located behind the vehicle curbside rear charge port access panel and the LV Battery Saver Switch near the LV batteries. Wait ten seconds, and then turn both back to ON.
