<b>Release Date</b>	01/10/2025	<b>Technical Service Bulletin</b>	
<b>OIJ9 - Over-the-Air (OTA) Software Update (SW Level 3.2.13)  Dealer Recovery Process - OTA Software Update Not Successful</b>

<b>Applicable Vehicles</b>			
<b>Country</b>	<b>Beginning Model Year</b>	<b>Ending Model Year</b>	<b>Vehicle</b>
USA	2021	2022	ID.4
CAN	2021	2022	ID.4

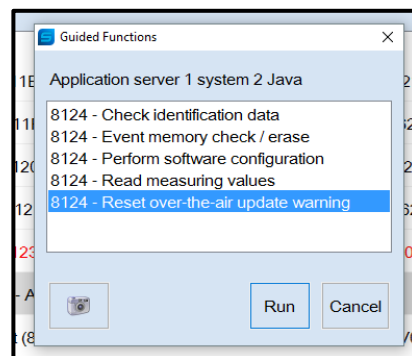
- Open the hood.
- Open the battery cover.
- Attach the battery charger to the 12V battery charging posts.
- Connect the VAS6150X/VAS6160X Diagnostic Tester to the vehicle.
- Start the ODIS program.
- In diagnostic address 8124, select the test plan, “8124 – Reset over-the-air update warning.”
- Follow the test plan instructions to restore vehicle operation.
- Activate bus sleep:
  - Remove battery charger
  - Remove diagnostic interface from vehicle
  - Close all doors and hood
  - Lock vehicle with remote and leave vehicle locked for at least five minutes.
- Switch on ignition.
- Reconnect diagnostic interface.
- Continue to Step 2.

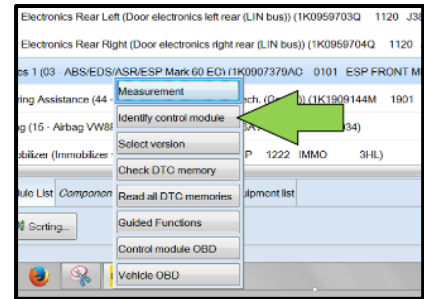
- The above module(s) are updated during the OTA update.
- Select the control module tab.
- Find the listed control module(s) in the control module list.
- Right click on the module(s) and select "Identify control module" for all modules listed above.
- Continue to Step 3.

Control Unit	Diagnostic address	New Part Number	New Software Version
Application Server 1 System 1 Adaptive	8123	V04-007-006	0299
Application Server 1 System 2 Java	8124	V04-007-006-A	0299
Software Cluster Embedded 1	C002	V04-007-006-B	0299
Software Cluster Housekeeping 1	C003	V04-007-006-C	0299
Data Bus OBD Interface	0019	1EA-937-012-AB	0299

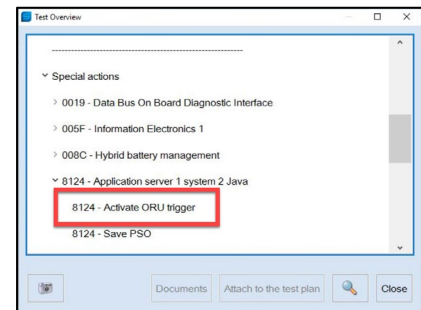
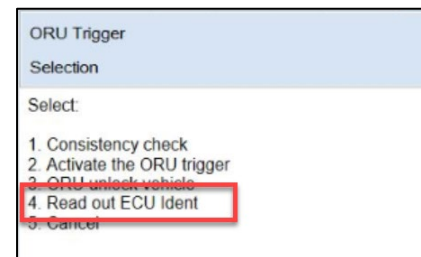
## Step 3 - Read out identification data

- Read out the required extended identification data as follows:
  - Select the "Test Plan" tab.
  - Select "Self test."
  - Select "Software version management."
  - Select "Special actions."
  - Select "8124 – Application server 1 system 2 Java."
  - Select "8124 – Activate ORU trigger."
  - Attach to the test plan and start the test plan.
- Select the option to "Read out ECU ident."
- When prompted, enter the diagnostic address that has not yet been updated via OTA.
- Ensure the diagnostic log is sent to GFF Paperless.
- Continue to Step 4.

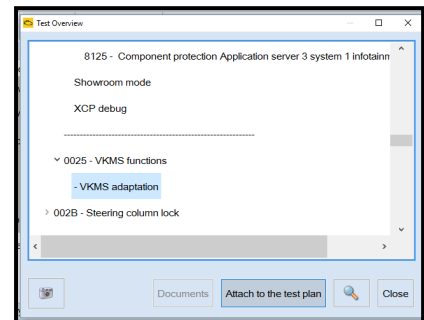
After selecting “Self Test,” use the search function and enter “VKMS” to aid in finding the test plan.

- Follow the on-screen prompts.
- Pay close attention to all steps outlined in the test plan and follow them exactly as described.
- Continue to Step 9.
