Technical Service Bulletin

SUBJECT:		NO: TSB-25-54-001	
HEAD UP DISPLAY (HUD) MAY NOT FUNCTION WITH INTERNAL TEMPERATURE BELOW 14° F		DATE: January 2025	
		MODEL: Outlander and Outlander Plug-in Hybrid	
CIRCULATE TO:	<input type="checkbox"/> GENERAL MANAGER	<input checked="" type="checkbox"/> PARTS MANAGER	<input checked="" type="checkbox"/> TECHNICIAN
<input checked="" type="checkbox"/> SERVICE ADVISOR	<input checked="" type="checkbox"/> SERVICE MANAGER	<input checked="" type="checkbox"/> WARRANTY PROCESSOR	<input type="checkbox"/> SALES MANAGER

This bulletin provides instructions to reprogram the to revise the low temperature control of the HUD-ECU driver software.

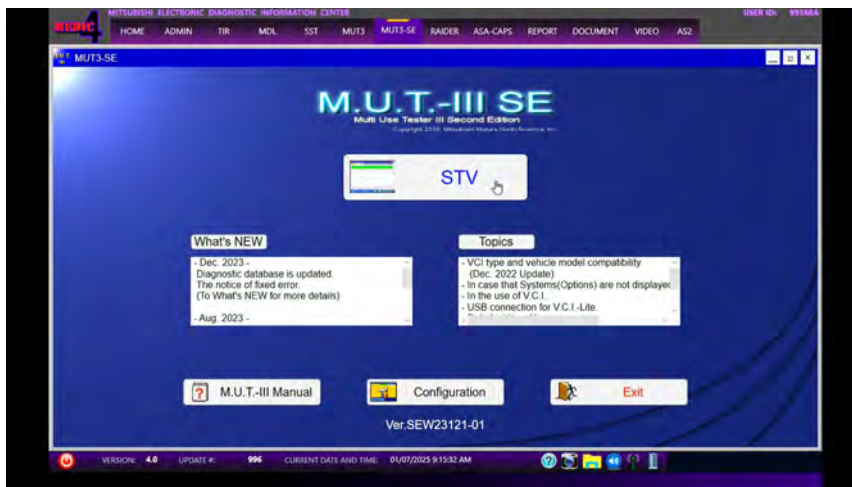
5. STANDALONE MUT-3 SE SCAN TOOL VIEWER (STV) ONLY: (MEDIC 3.5 USERS - GO TO THE REPROGRAMMING PROCEDURE). Verify that your MUT-3 SE has the most current version of the reprogramming database from the MUT-3 SE Main Page.

- a. Press the STV button.

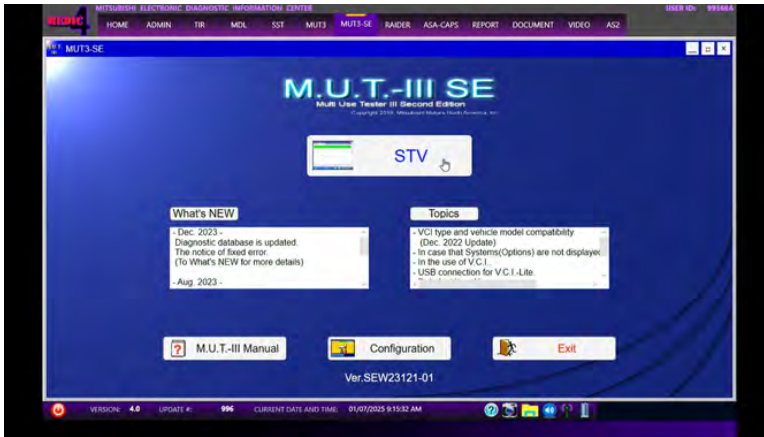
3. Turn on flashers to prevent vehicle from shutting/powering down.
4. Press the "STV" button.

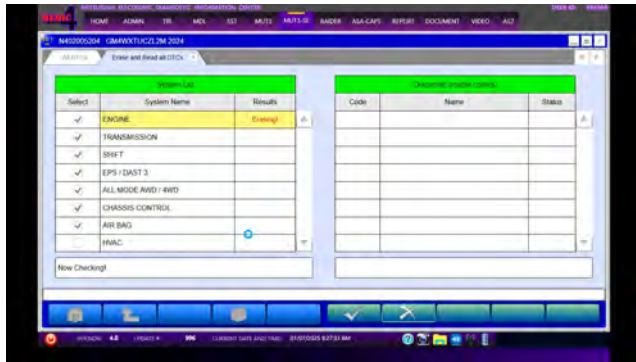
- l. Press the "Erase and Read all DTCs" button followed by the "OK" button. Allow erasing and checks to complete, then press the "OK" button.
