# Technical Service Bulletin

SUBJECT: <b>CHECK ENGINE LIGHT ILLUMINATES OR ENGINE MALFUNCTION POWER REDUCED SERVICE NOW WARNING MESSAGE APPEARS WHILE IDLING OR DRIVING - REVISED</b>		NO: <b>TSB-22-13-001REV</b>
		DATE: <b>January 2025</b>
		MODEL: <b>Outlander</b>
<b>CIRCULATE TO:</b>	<input type="checkbox"/> GENERAL MANAGER	<input checked="" type="checkbox"/> PARTS MANAGER
<input checked="" type="checkbox"/> SERVICE ADVISOR	<input checked="" type="checkbox"/> SERVICE MANAGER	<input checked="" type="checkbox"/> WARRANTY PROCESSOR
		<input checked="" type="checkbox"/> TECHNICIAN
		<input type="checkbox"/> SALES MANAGER

## PURPOSE

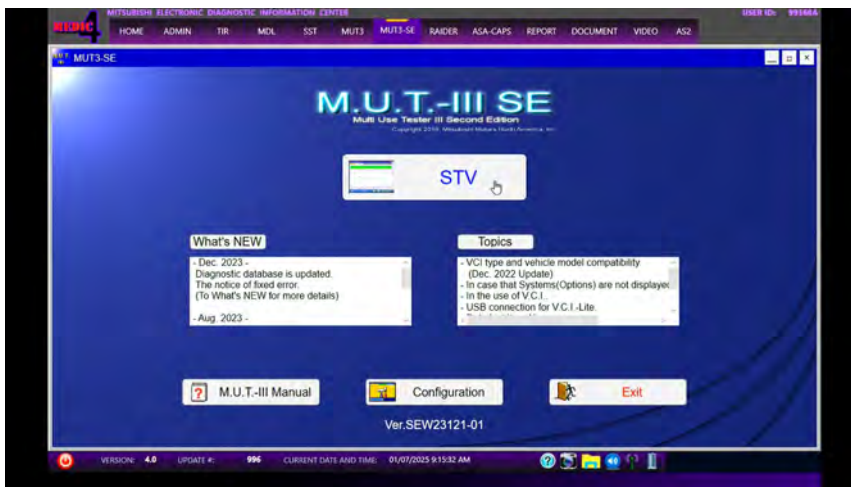
- a. Press the STV button.

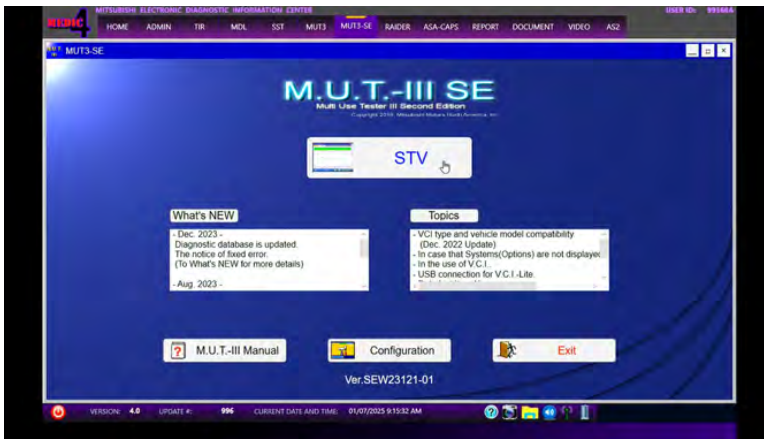
3. Turn on flashers to prevent vehicle from shutting/powering down.
4. Press the "STV" button.

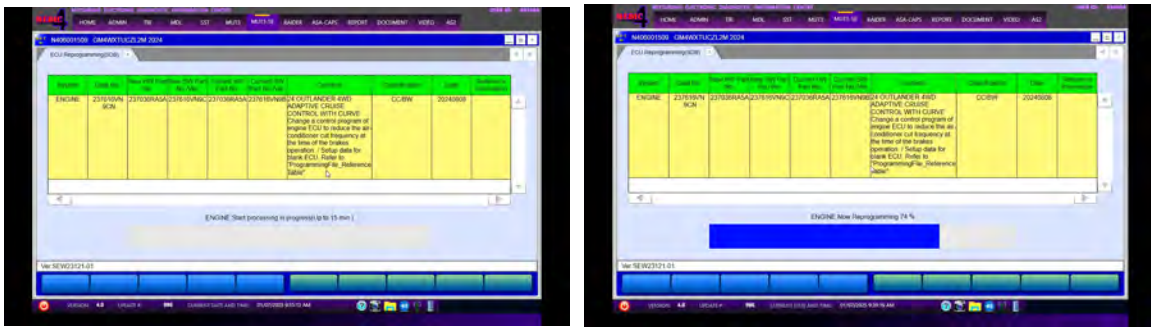
f. Allow up to 15 minutes for processing and reprogramming.

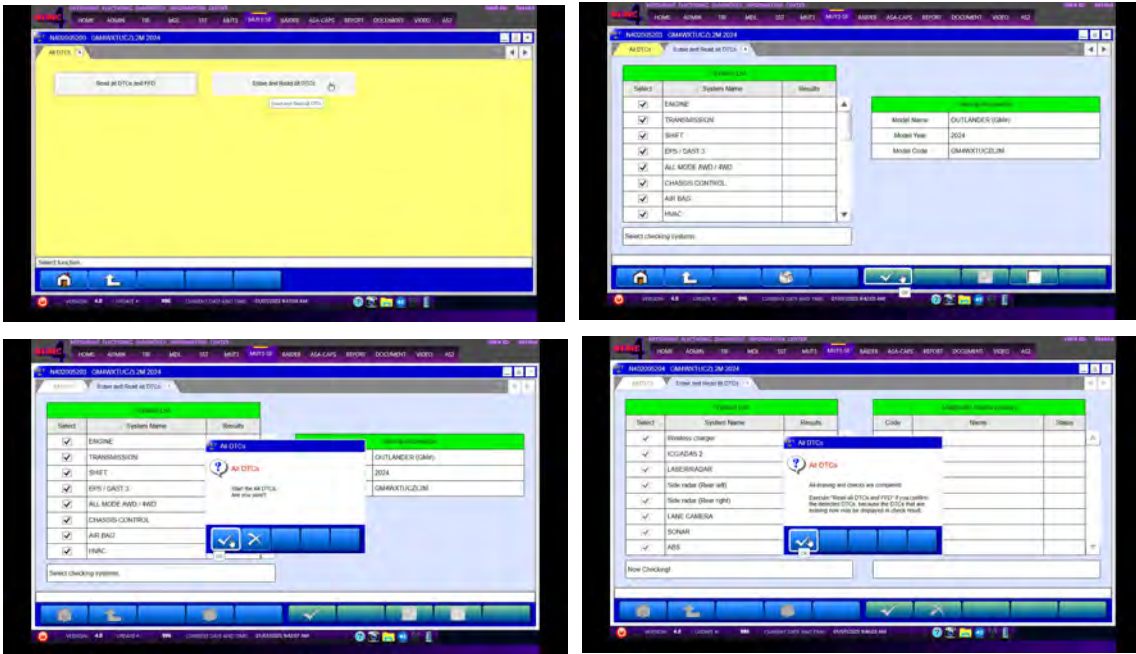
j. Press the "Erase and Read all DTCs" button. Press the "OK" button when prompted.
