Technical Service Bulletin

GROUP CAMPAIGN	NUMBER 25-01-009H
DATE FEBRUARY 2025	MODEL(S) SANTA FE (MX5A)

SUBJECT: IN-CABIN CAMERA (ICC) LOGIC UPDATE
(SERVICE CAMPAIGN TCR)

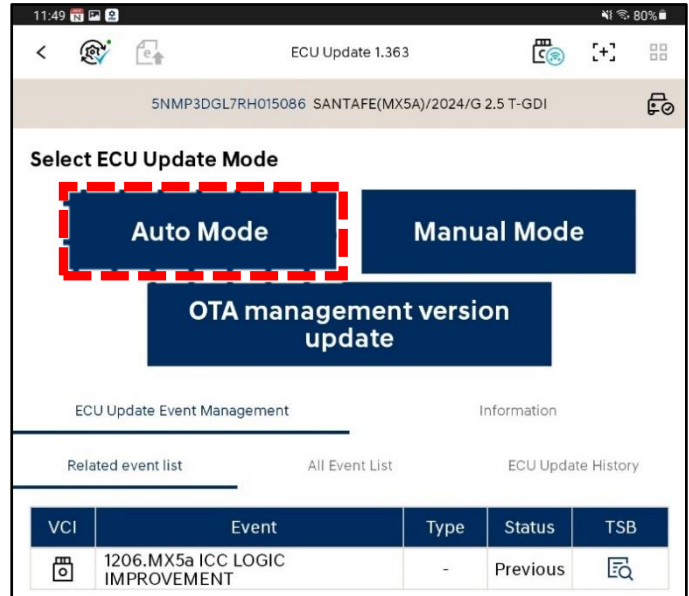
2. Select the **ICC** system to scan the vehicle’s current ROM ID.

Check the current ROM ID version and compare it to the ROM ID Information table before attempting to perform the software update.

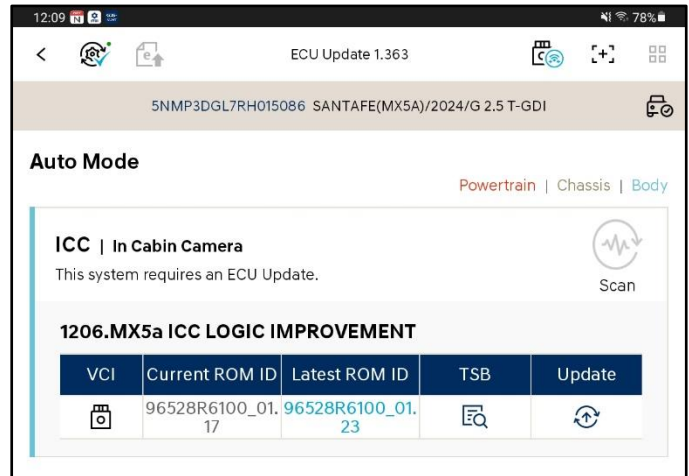
- After the ECU update process shows **100%** complete, follow the prompts on the screen to cycle the ignition **OFF** for at least **10 seconds** to reset the control unit (certain models may take up to **30 seconds**).

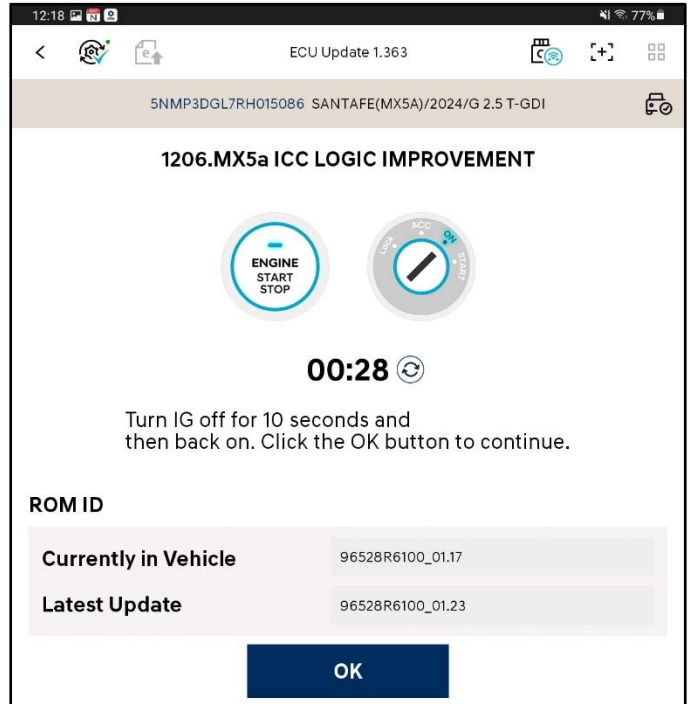
Use the **Refresh** button to reset the timer.

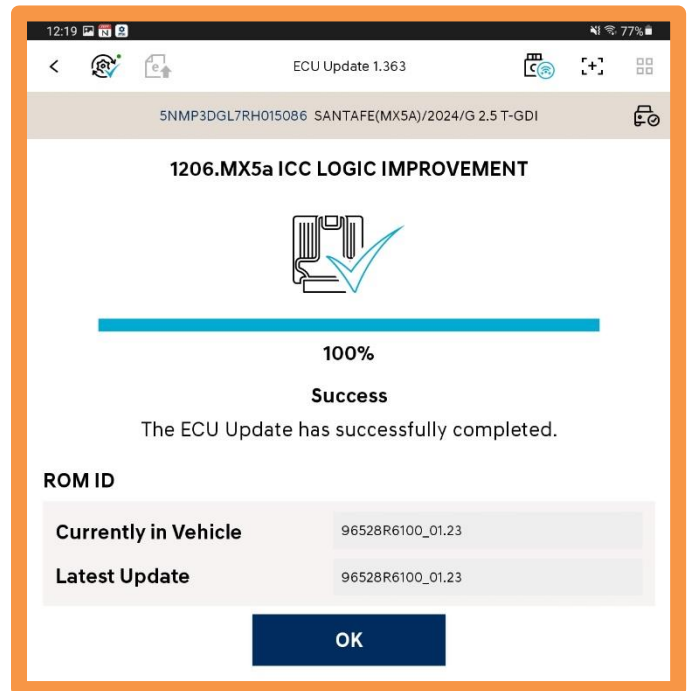
Take a screenshot of the ECU update complete screen using your tablet and upload to STUI.

NOTE 3: Op times include VIN, Mileage, and photo capture of the “ECU update complete” screen as outlined in the Digital Documentation Policy.
