# HYUNDAI

## Technical Service Bulletin

| GROUP<br><b>CAMPAIGN</b> | NUMBER<br><b>25-01-013H</b> |

**SUBJECT:** SOFTWARE UPDATE FOR MULTIMEDIA KEYBOARD (MKBD)  
LOGIC IMPROVEMENT (SERVICE CAMPAIGN TCLA)

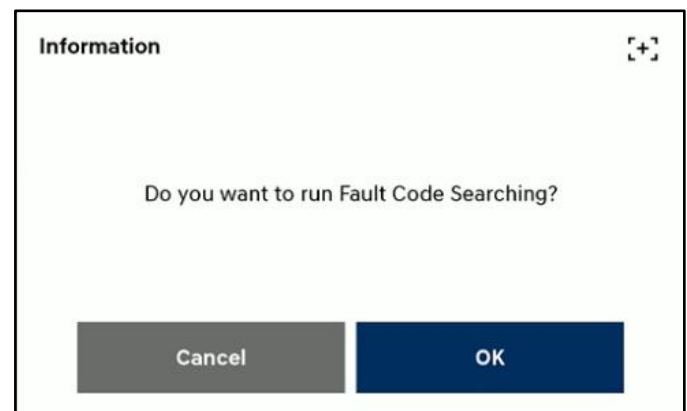
7. Perform an **All Systems Fault Code** search and erase any DTC history that had incidentally occurred from the ECU update.
