CAMPAIGN BULLETIN ECM Reprogram - Long Crank

Reference: P4A43

P4A43 - 2025 QX80 ENGINE CONTROL MODULE(ECM) REPROGRAMMING

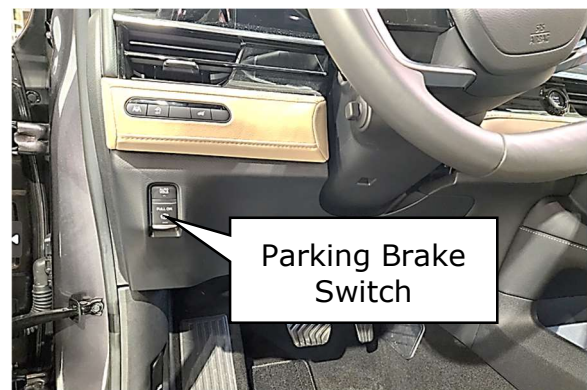
Figure 2

3. Apply the parking brake. (Figure 2)
 - Pull back on the parking brake switch (red indicator on switch will illuminate).

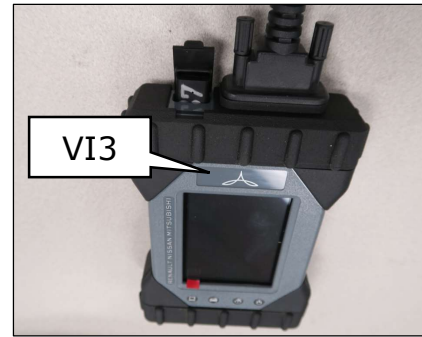
Figure 3

4. Connect the VI3 to the vehicle data link connector. (Figure 3)
- Connect the provided USB cable to the VI3 and the CONSULT PC
