CAMPAIGN BULLETIN ECM Reprogram - Long Crank

Reference: P4A43

P4A43 - 2025 QX80 ENGINE CONTROL MODULE(ECM) REPROGRAMMING

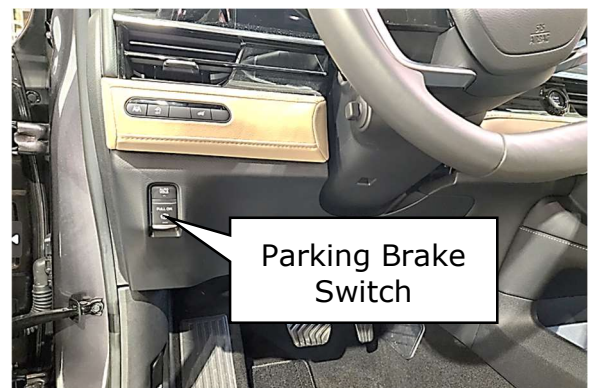
Figure 2

3. Apply the parking brake. (Figure 2)
 - Pull back on the parking brake switch (red indicator on switch will illuminate).

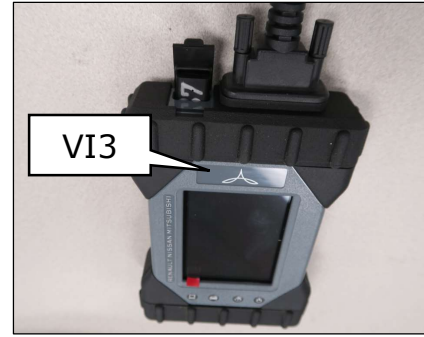
Figure 3

4. Connect the VI3 to the vehicle data link connector. (Figure 3)
 - Connect the provided USB cable to the VI3 and the CONSULT PC

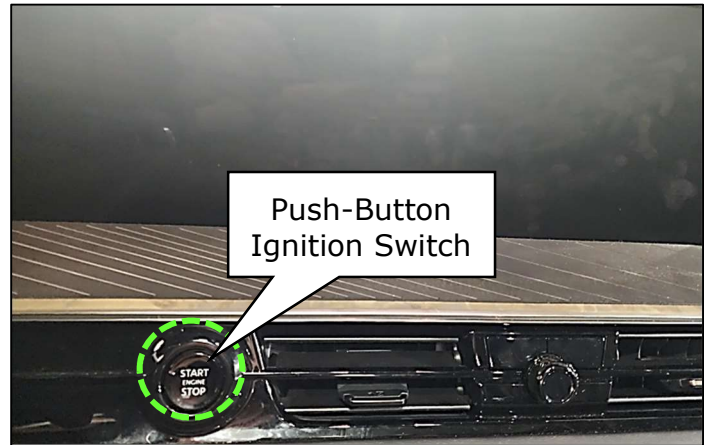
Figure 4

5. Turn the ignition ON (Engine OFF).
 - Turn the ignition ON (Engine OFF) by pressing the push-button ignition switch without depressing the brake pedal (Figure 4)

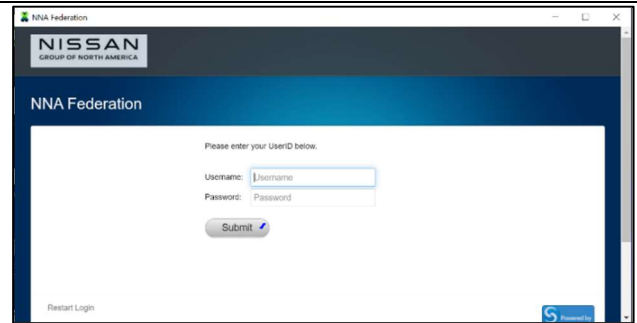
Figure 5

8. Enter login information and select **Submit**. (Figure 5)
 - If prompted, select **USA/CANADA Dealers** from the drop-down menu, and then select **OK** (Figure 6)

- If not prompted to enter your username and password, the CONSULT PC may not be connected to Wi-Fi.
- Close CONSULT-4, confirm the CONSULT PC is connected to Wi-Fi, and then reopen CONSULT-4.

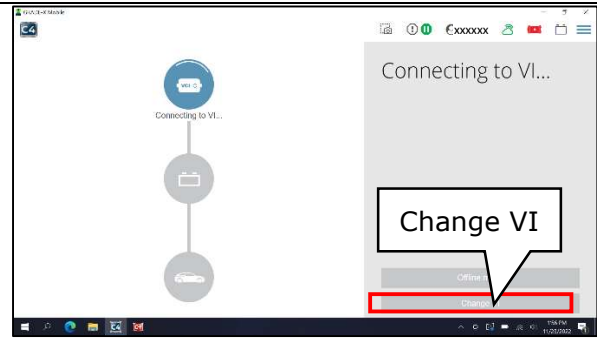
Figure 7

9. Allow C4 to connect to VI3 and perform vehicle system call. (Figure 7 and Figure 8)

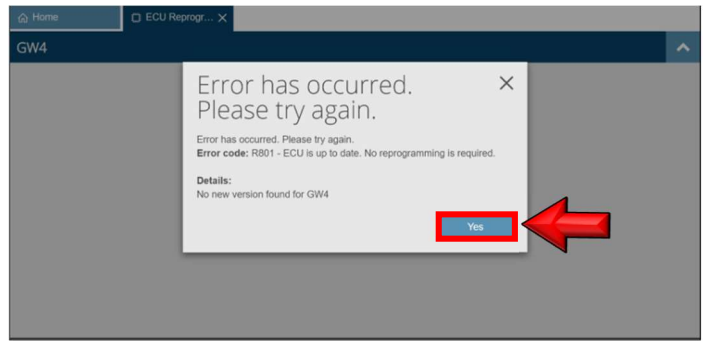
Figure 12

12. Error code R801 indicates no reprogramming is available, select **Yes** (Figure 12), and then select **ECU identification** (Figure 13) in **ENGINE**.

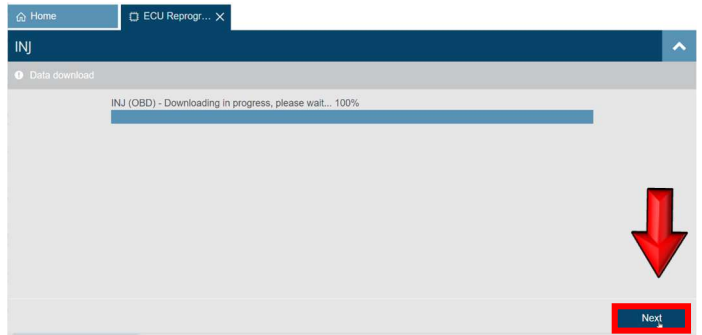
Figure 15

15. Once software download has completed, select **Next** (Figure 15).

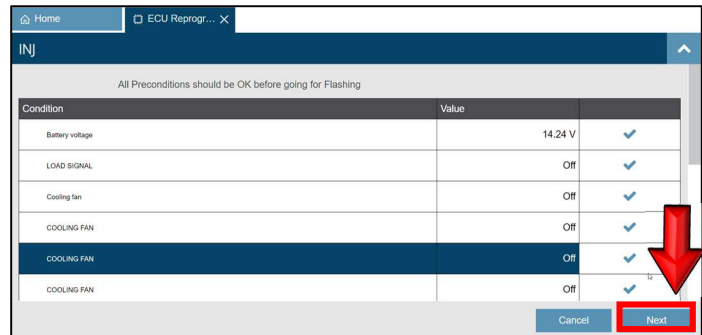
Figure 16

16. Verify all preconditions show a check mark in the far right column and select **Next**. (Figure 16)

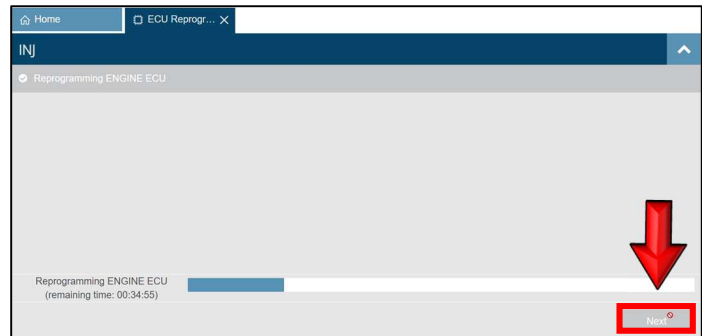
Figure 17

17. Allow the reprogramming process to complete and select **Next**. (Figure 17)

NOTE:
This process will take 15-30 minutes.

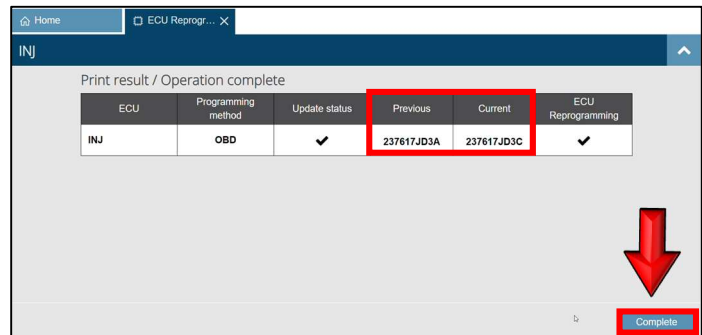
Figure 18

18. Verify "Current" (new) part number is different than the "Previous" part number. (Figure 18)

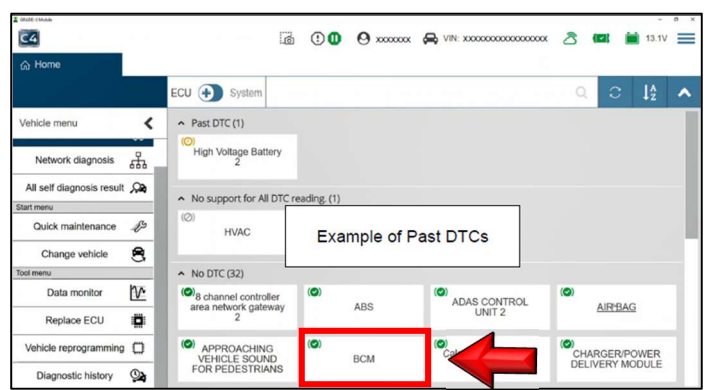
Figure 19

19. Locate and Select **BCM**. (Figure 19)

This will help prevent CONSULT-4 from disconnecting from the vehicle when the ignition is turned off.

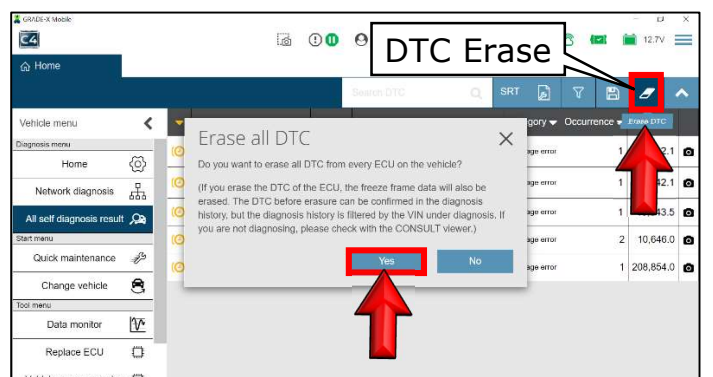
Figure 21

22. Select the erase DTC icon, and select **Yes** to erase DTC's. (Figure 21)

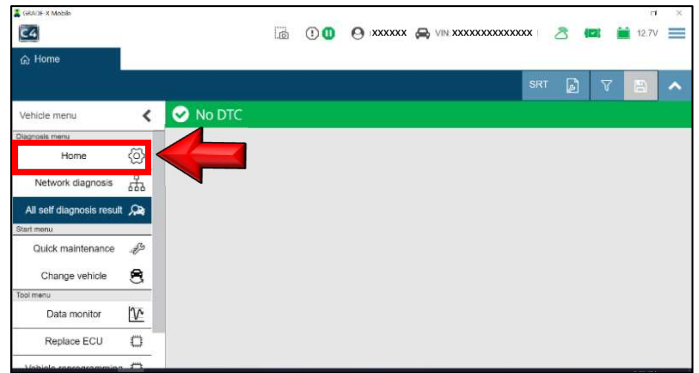
Figure 22

23. Verify all DTCs have erased, select **Home**. (Figure 22)

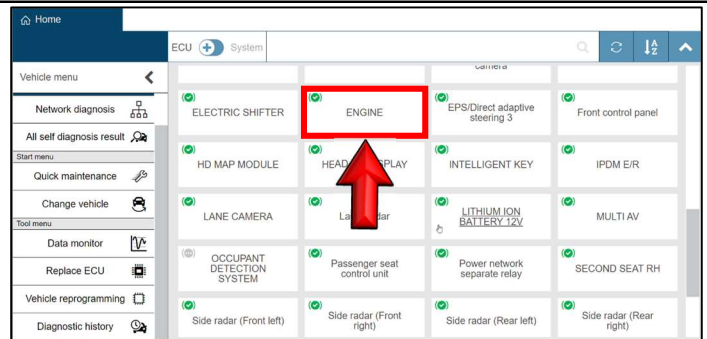
Figure 23

24. Locate and select **ENGINE**. (Figure 23)

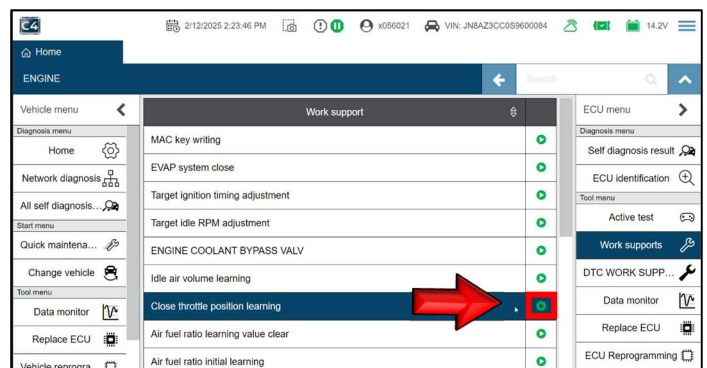
Figure 25

26. Locate and select the **"Play"** button for **Close throttle position learning**. (Figure 25)

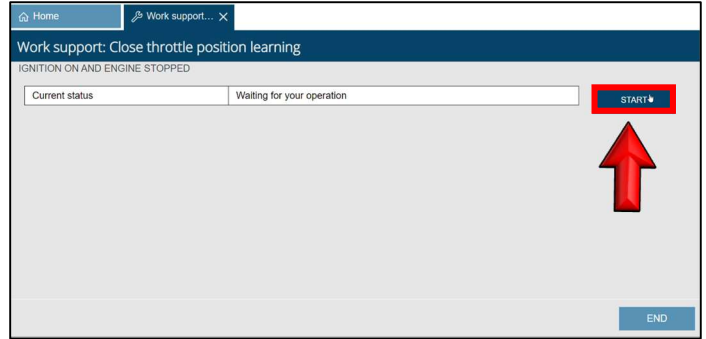
Figure 26

27. Select **Start** and wait until the "Completed" is displayed. (Figure 26)

- Turn the ignition OFF by pressing the push button ignition switch (1) one time
- Wait 10 seconds
- Turn the ignition ON (Engine OFF) by pressing the push-button ignition

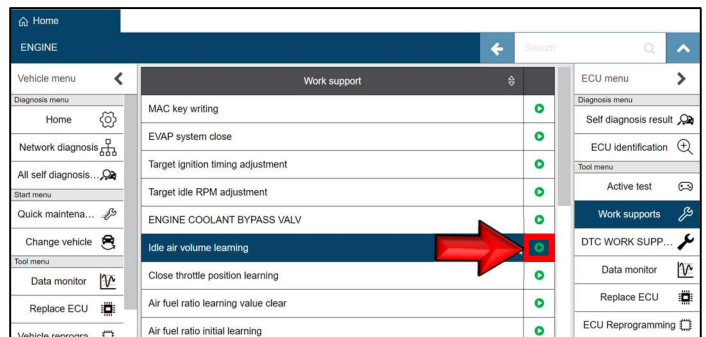
Figure 27

28. Locate and select the "Play" button for **Idle Air Volume Learning**. (Figure 27)

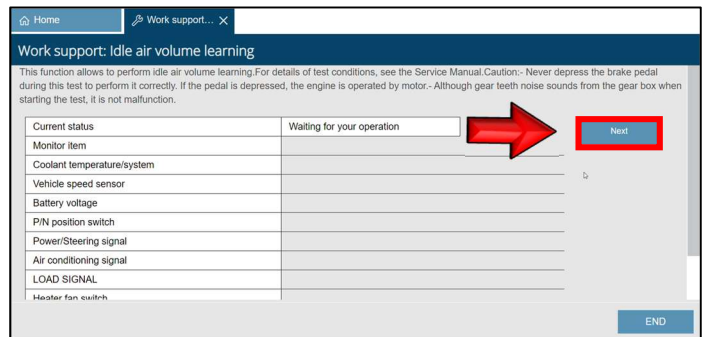
Figure 28

29. Select **Next**. (Figure 28)

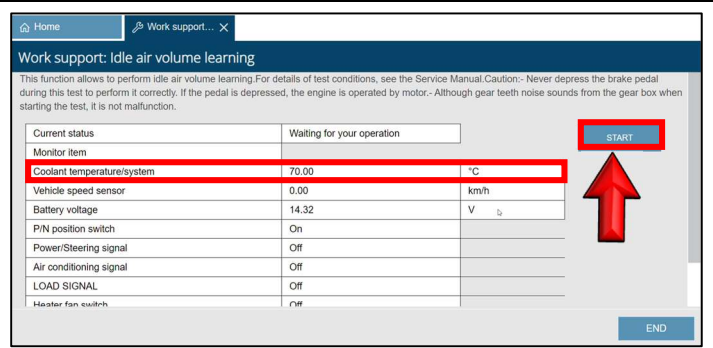
Figure 29

31. Allow the engine to idle while monitoring "**Coolant temperature/system**". (Figure 29)

- Once the coolant temperature reaches 70°C, Select **Start**
- Once Current status changes to "Completed", select **END**

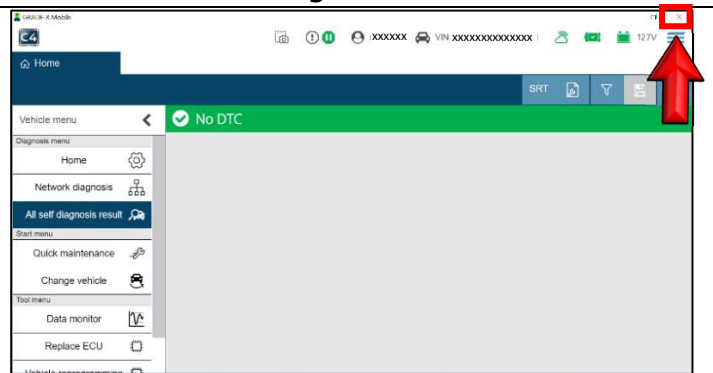
Figure 32

- Close C4 by selecting the "**X**" in the upper RH corner (Figure 32)
