GROUP	MODEL
ELE	2024-2025MY EV9 (MV1, MV1a)
NUMBER	DATE
369 (Rev 1, 2/25/2025)	January 2025

TECHNICAL SERVICE BULLETIN

SERVICE ACTION: REAR MOTOR CONTROL UNIT SOFTWARE UPGRADE (SA601)

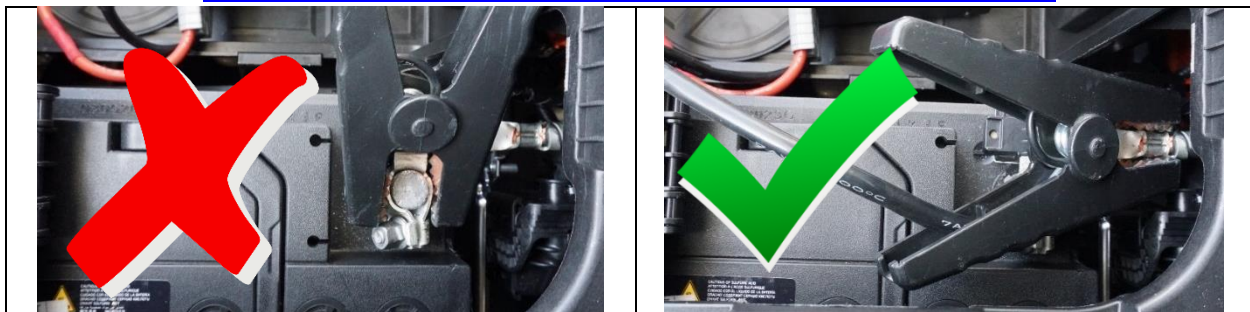
[Connect the negative \(-\) terminal to the battery as shown below.](#)

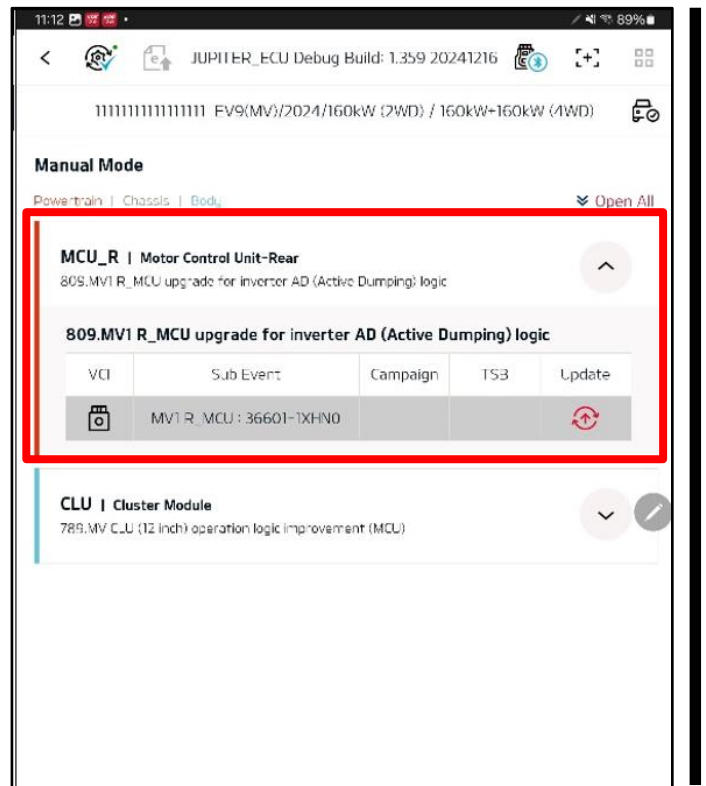
Select the applicable **'MCU_R'** 'system' module and **'Event Group'** number in the ECU Upgrade.

- **2024-2025MY EV9 (MV1) - Korea Built**
809.MV1 R_MCU upgrade for inverter AD (Active Dumping) logic

- **2025MY EV9 (MV1a) - US Built**
810.MV1a R_MCU upgrade for inverter AD (Active Dumping) logic"
