SERVICE BULLETIN

APPLICABILITY: 2019MY Legacy & Outback
2019-21MY WRX/STI

NUMBER: 15-318-24R

SUBJECT: Data Communication Module (DCM) Bypass Box

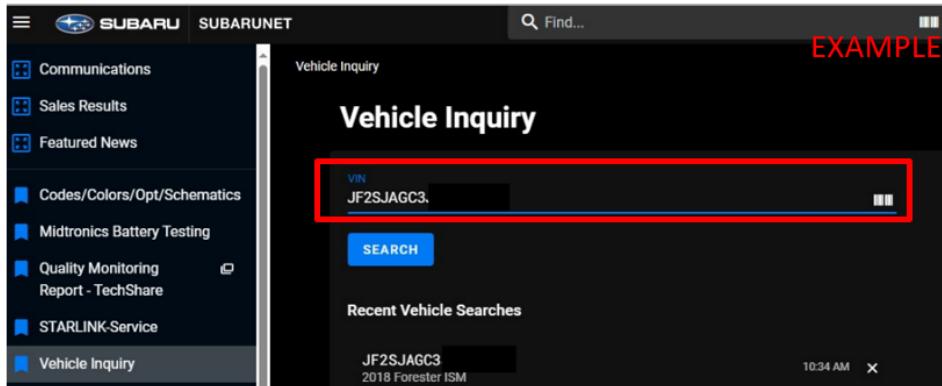
1. Enter the subject Vehicle Identification Number (VIN) into the VIN search box and click the search button.

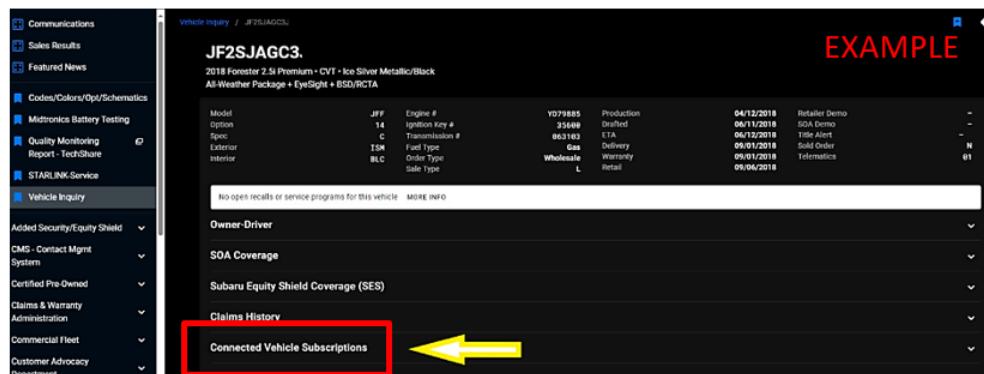
2. Select the Connected Vehicle Subscriptions drop down.

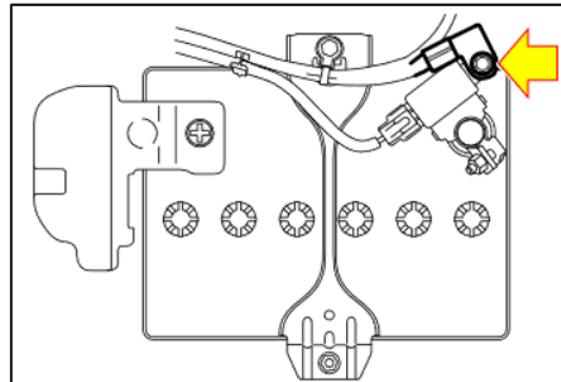
STEP 2: CAREFULLY disconnect the battery sensor from the negative ground terminal and wait at least 60 seconds before continuing.

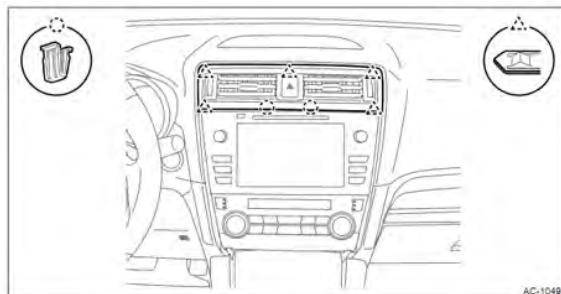
STEP 3: Remove the Center Grille Assembly.

- Release the clips and claws.
- Disconnect the connector and remove the Grille Assembly.
- Disconnect and remove the hazard switch.

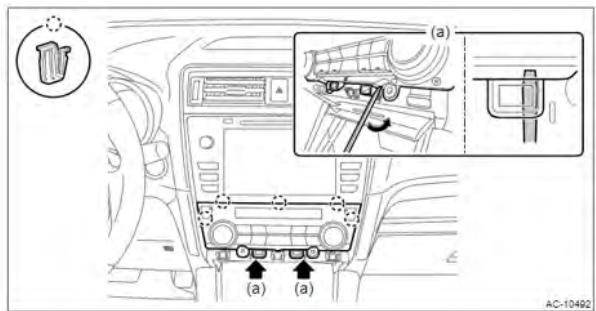
STEP 4: Remove the Heater Control Assembly.

- A. Release the clips and claws.
- B. Remove the panel.
- C. Remove the mounting screws.
- D. Detach the heater control assembly.

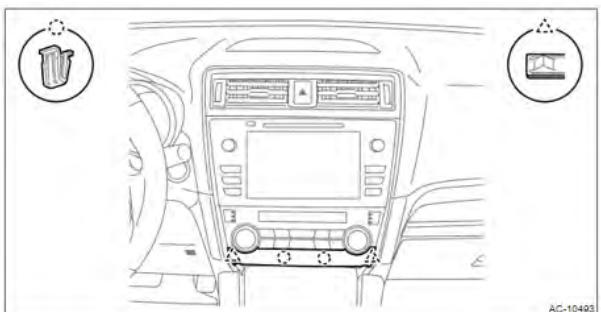
STEP 5: Remove the audio assembly.

- A. Remove the mounting screws.
- B. Release the mounting clips.
- C. Disconnect all electrical connections.
- D. The audio assembly can then be removed.

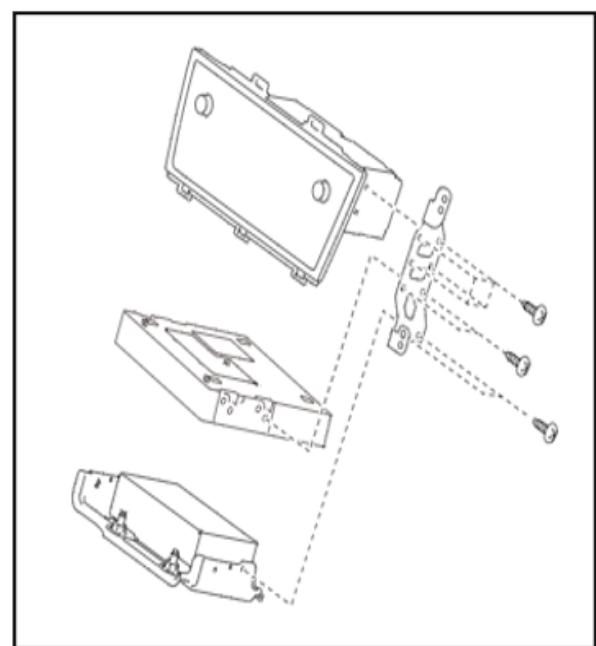
STEP 6: Remove the DCM.

- A. CAREFULLY remove the bracket mounting screws.
- B. Remove the DCM and the backup module assembly together.

CAUTION: Be mindful to not cause any damage to the mounting screws during removal. The mounting screws are to be reused.

STEP 7: Install the new DCM and reinstall all parts in the reverse order of disassembly.

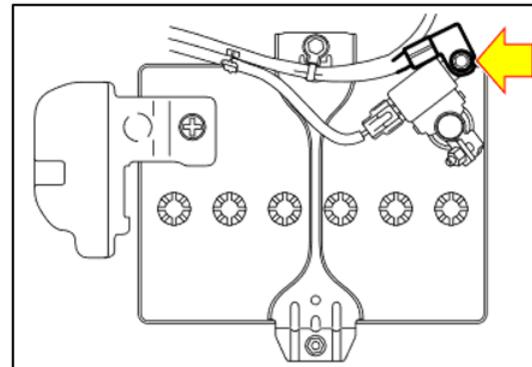
STEP 2: CAREFULLY disconnect the battery sensor from the negative ground terminal and wait at least 60 seconds before continuing.

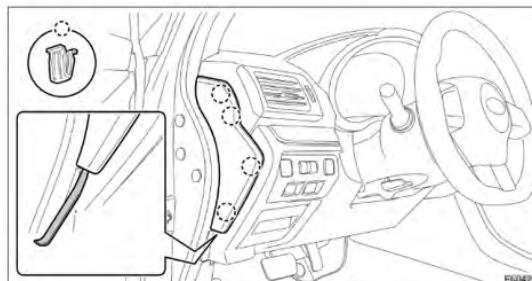
STEP 3: Using a plastic trim tool, remove the left side instrument panel cover.

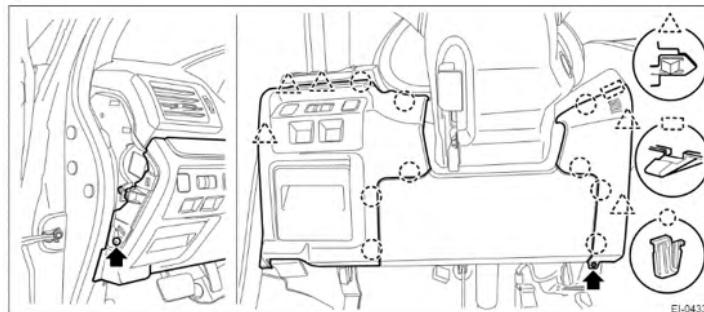
STEP 4: Remove the left inner and outer lower instrument panels.

- Remove the mounting screws.
- Release the mounting clips and claws.
- Pull both panels toward the rear of the vehicle.
- Disconnect all electrical connections.

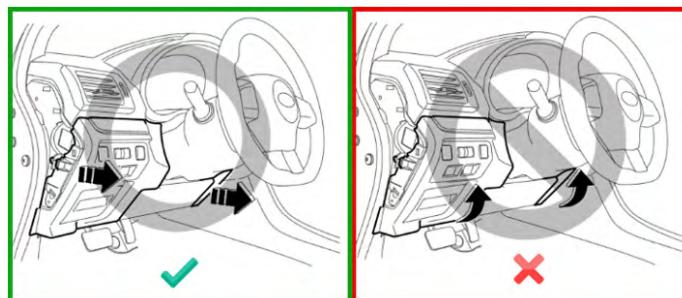
CAUTION: **ALWAYS** pull the panels **toward the rear of the vehicle**. Pulling in an upward or downward direction may cause damage to the mounting claws.

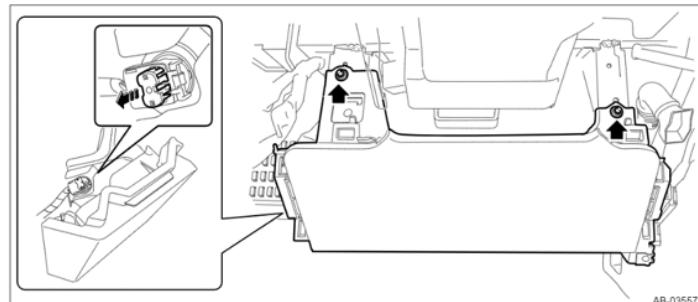
STEP 5: Remove the knee airbag module.

- A. Remove the mounting nuts.
- B. CAREFULLY disconnect the electrical connection.

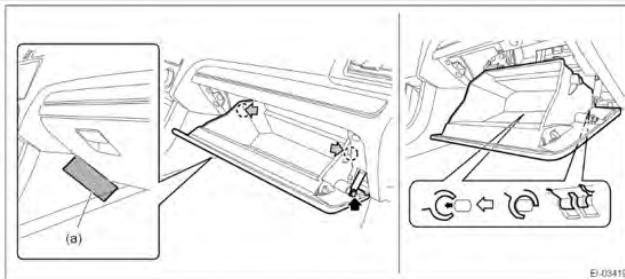
STEP 6: Remove the glove box assembly.

- A. Apply protective tape to the lower center panel section shown as (a) in the right image.
- B. Disconnect the damper from the glove box.
- C. Release the stoppers and pull the glove box toward the rear of the vehicle.

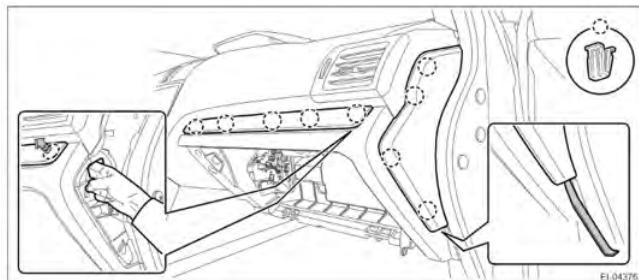
STEP 7: Remove the glove box backing panel.

- A. Using a plastic trim tool, remove the right side instrument panel cover.
- B. Release the clips and removed the instrument panel ornamental trim.

TIP: The instrument panel ornamental trim can be removed by applying pressure from the backside.

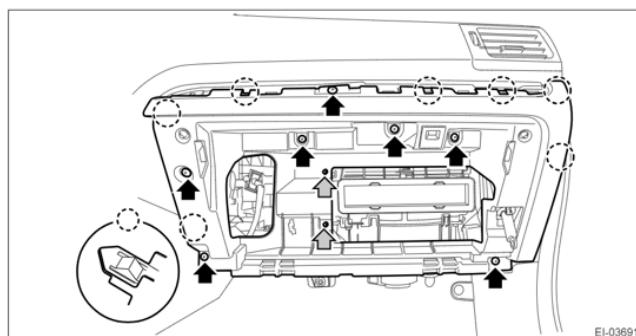
- C. Remove the glove box LED and disconnect the electrical connection.
- D. Removed the mounting screws.
- E. Release the claws and harness clamp.
- F. The glove box backing panel can then be removed.

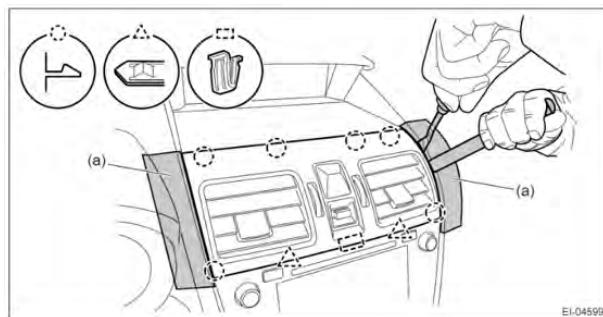
STEP 8: Remove the center grille assembly.

- A. Apply protective tape to the instrument panel section shown as (a) in the right image.
- B. Release the claw using a plastic trim tool or a clip removal tool with protective tape applied to the contact area.
- C. Disconnect the electrical connector and remove the center grille assembly.

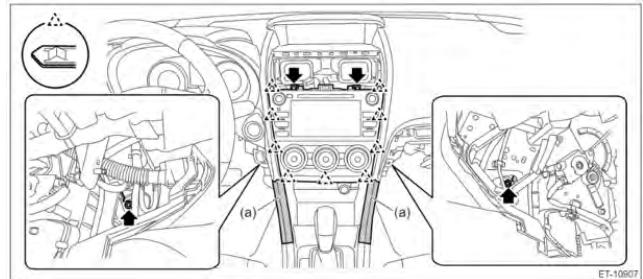
STEP 9: Remove the audio assembly.

CAUTION: If the antenna cable interferes with the removal side mounting bolts, move the antenna cable before attempting to remove the bolts.

- D. Disconnect the electrical connectors and remove the audio assembly.

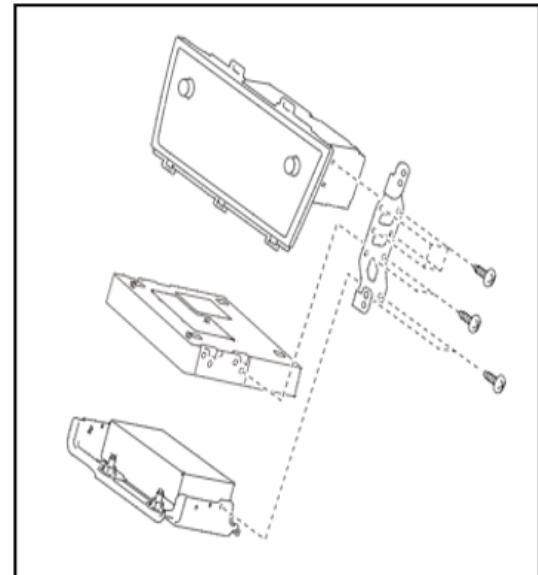
STEP 10: Remove the DCM.

- A. CAREFULLY remove the bracket mounting screws.
- B. Remove the DCM and the backup module assembly together.

CAUTION: Be mindful to not cause any damage to the mounting screws during removal. The mounting screws are to be reused.

STEP 11: **Install the new DCM and reinstall all parts in the reverse order of disassembly.**

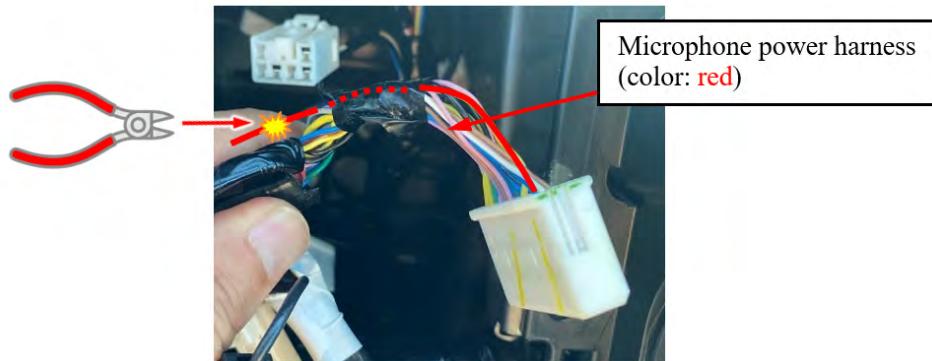
STEP 4: Remove the audio assembly.

- A. Remove the screws and release the clip.
- B. Disconnect the connector and remove the audio assembly.
- C. Cut the microphone power wire (color: red) at the end of connector i87 pin #4.

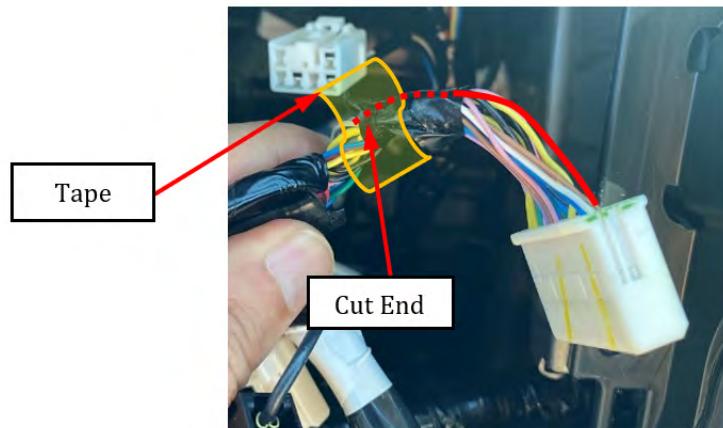
- D. Bundle the cut red wire for the microphone into the vehicle harness so the cut end is covered.

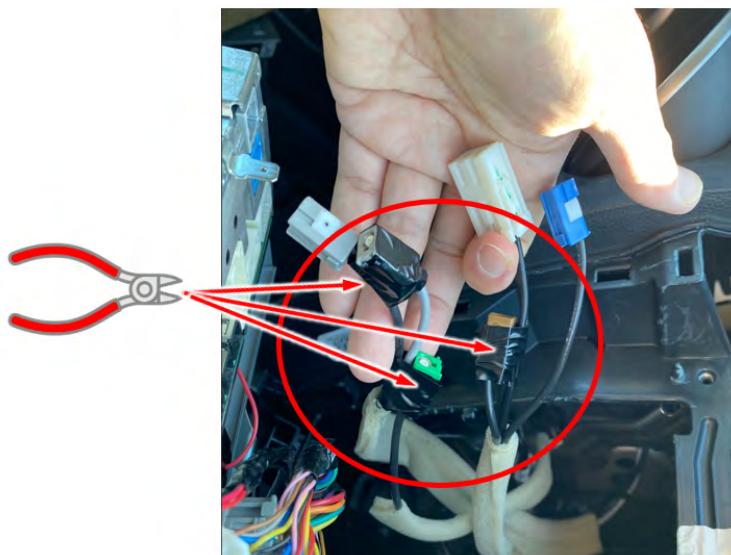
- E. Remove the tape from the three bundled antenna connectors.
