PRODUCT CAMPAIGN BULLETIN

NUMBER: WRA-24

SUBJECT: Safety Recall – ODS Sensor Replacement

Subaru of America, Inc. (Subaru) has initiated a safety recall for certain 2020-2022 model year Legacy and Outback vehicles to replace all (four) of the Occupant Detection System (ODS) sensors on the front passenger seat.

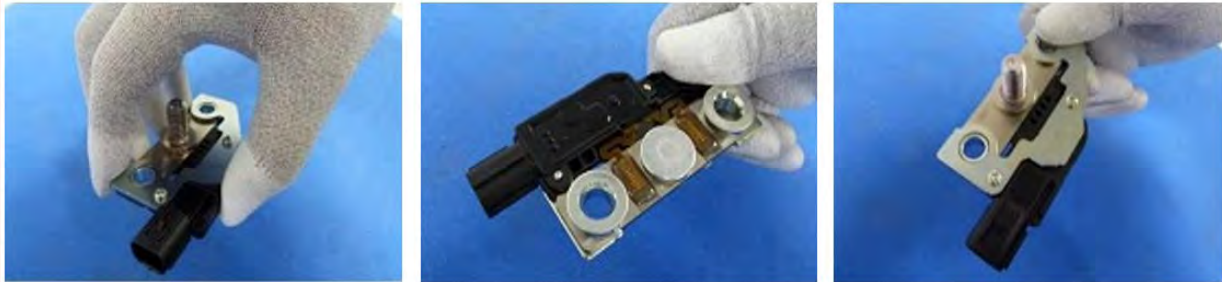
EXAMPLES OF PROPER SENSOR HANDLING:

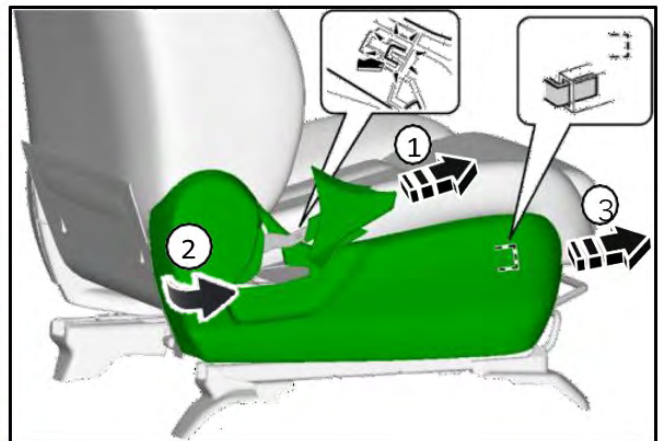
STEP 8: Pull up on the backrest adjustment handle and insert a small screwdriver or plastic trim tool into the handle cover locking tab. Once the tab is released pull the handle cover toward the front of the vehicle to remove. Once the handle cover is removed, release the rear section of the seat side cover. With all the holding clips released, the cover can then be removed by pulling towards the front of the vehicle.

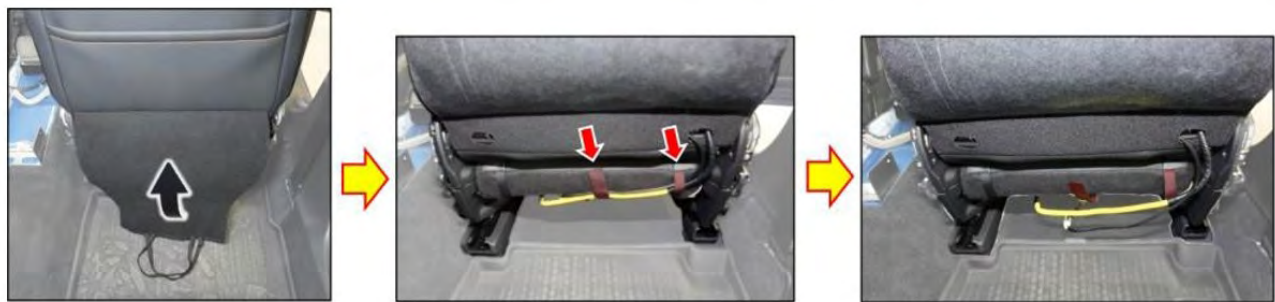
STEP 12: Tuck the hanging section of the cover into the rear pocket of the seat. Release the two Velcro straps and free the two harness sections.

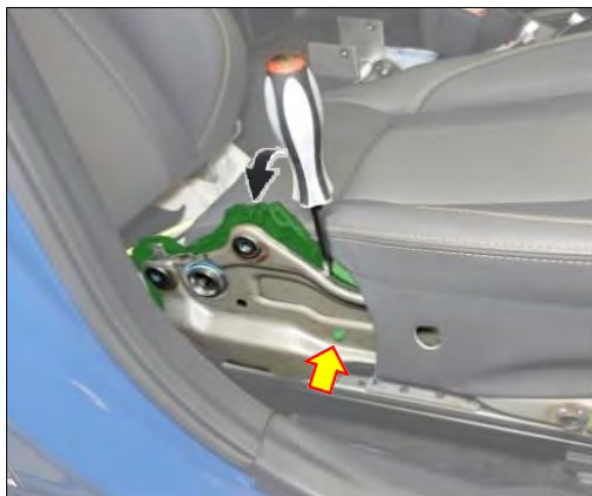
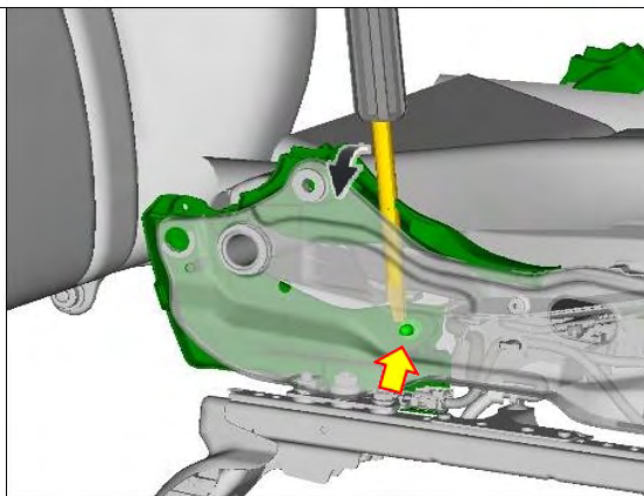
STEP 15: Starting with the outside cover, release the mounting clip using a large flat blade screwdriver or suitable plastic trim tool.

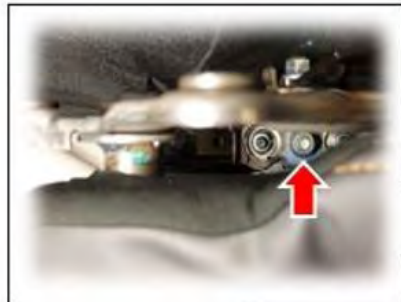
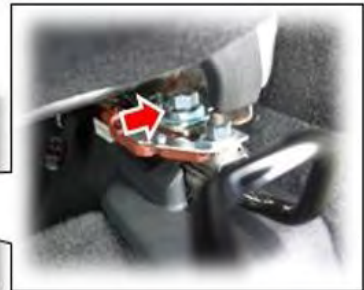
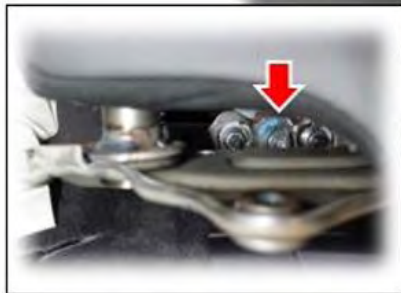
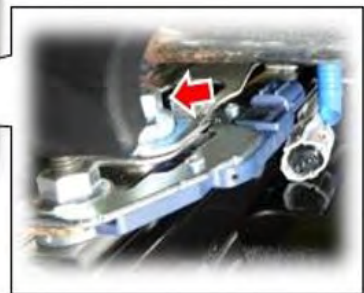
STEP 18: Remove the four 14mm (M10) nuts securing the cushion frame. The front nuts can be removed using an offset boxed wrench. The rear nuts can be removed with a 14mm socket, 3/8 in drive ratchet, and 3/8 in drive wobble extension. The nuts can be discarded after removal.

CAUTION: Avoid touching the seat adjustment lever with mounting nuts removed. This may cause the left and right rails to become misaligned and difficult to reassemble.

NOTE: Snap-on® tool # **FXWK8** is an example of a wobble extension suitable for usage.

Front →

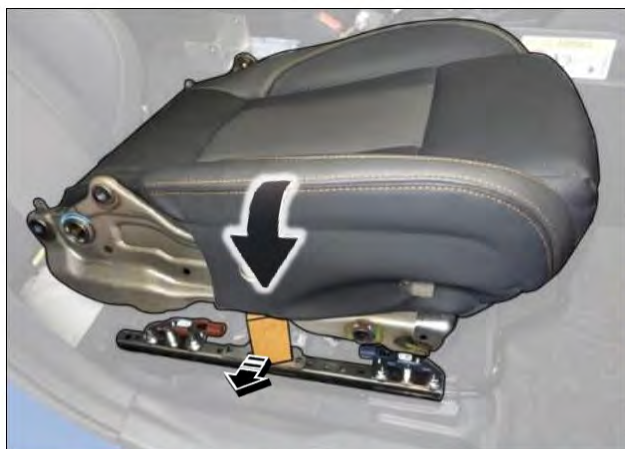
STEP 22: Remove the block and CAREFULLY lower the cushion frame.

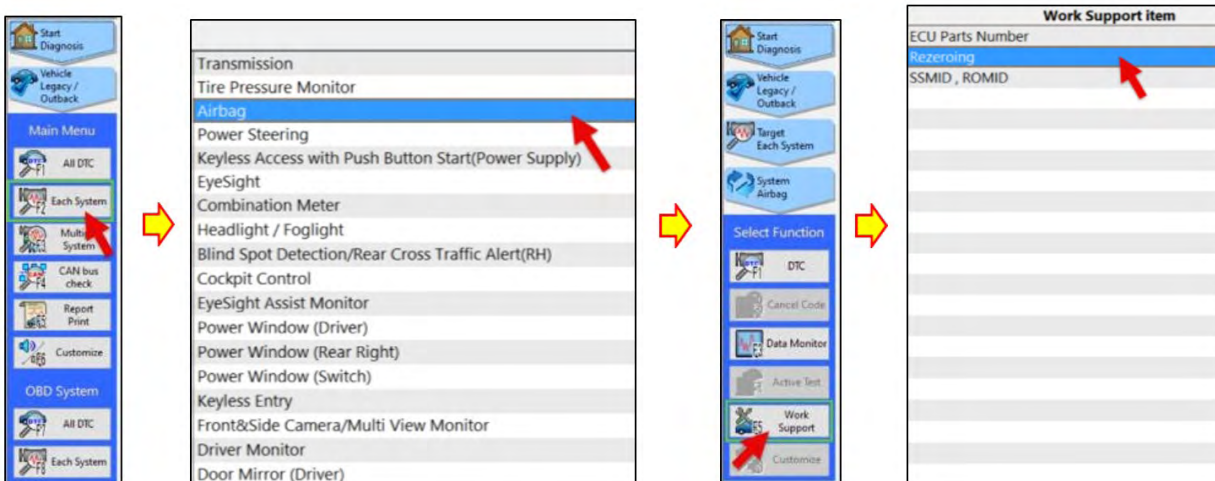
STEP 39: Using the SSM4, perform the “Rezeroing” procedure as per the applicable Service Manual.

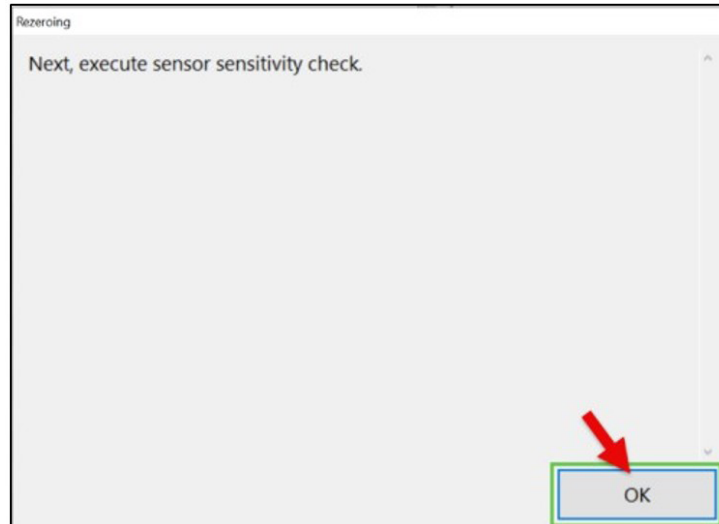
STEP 40: Once the “Rezeroing” procedure is successfully completed, you will be prompted to start a “Sensitivity Check”. Click the “OK” button to continue.

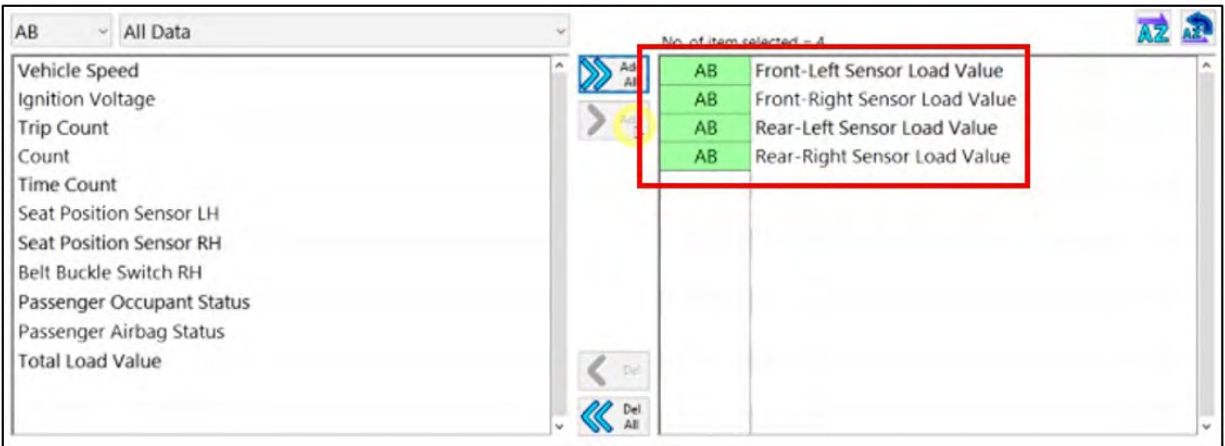
STEP 43: Once the “Sensitivity Check” is successfully completed, check the following data monitors: Front-Left Sensor Load Value, Front-Right Sensor Load Value, Rear-Left Sensor Load Value, Rear-Right Sensor Load Value.

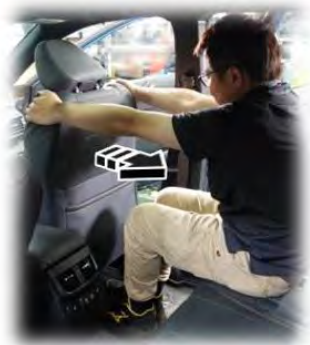
STEP 44: While sitting in the passenger rear seat, pull the backrest toward the rear of the vehicle and monitor the values. The front sensors should have a negative (-) value and the rear sensors should have a positive (+) value.

Item	Value	Unit	Maximum	Minimum	Average
<input checked="" type="checkbox"/>	AB Front-Left Sensor Load Value	-37.75	kg	-0.13	-37.75	-4.97
<input checked="" type="checkbox"/>	AB Front-Right Sensor Load Value	-35.90	kg	0.22	-35.90	-4.60
<input checked="" type="checkbox"/>	AB Rear-Left Sensor Load Value	45.33	kg	45.33	0.09	6.39
<input checked="" type="checkbox"/>	AB Rear-Right Sensor Load Value	35.23	kg	35.23	-0.31	4.53

Item	✓	✗		
	Case1	Case2	Case3	Case4
	Value	Value	Value	Value
Front-Left Sensor Load Value	- 37.75	45.33	- 37.75	45.33
Front-Right Sensor Load Value	- 35.90	35.23	45.33	- 37.75
Rear-Left Sensor Load Value	45.33	- 37.75	- 35.90	35.23
Rear - Right Sensor Load Value	35.23	- 35.90	35.23	- 35.90

IMPORTANT: In a case when the values do not match the desired specification, it possible the sensor mounting position is incorrect.

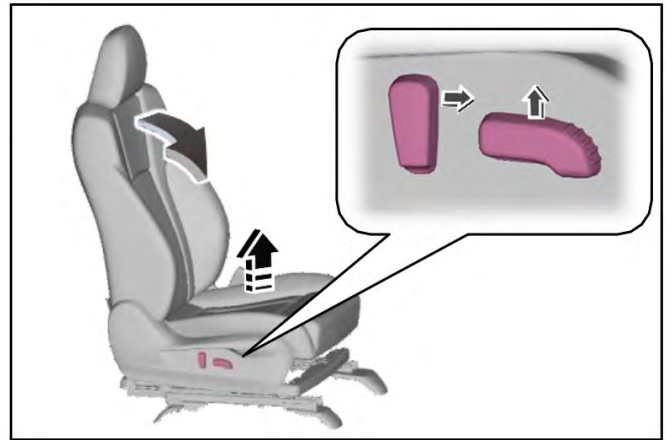
STEP 9: Tilt the seat backrest fully forward and raise the seat bottom to the maximum height.
