Service Alert

Subject: MYMAZDA APP CONNECTED VEHICLE ERROR CODE DESCRIPTION AND RECOVERY INFORMATION	Service Alert No.: SA-009/25
	Last Issued : 02/18/2025

Some customers may experience a Connected Vehicle failure. The MyMazda App may display an Error Code. This document provides Error Code description and recovery information to assist with repairs.

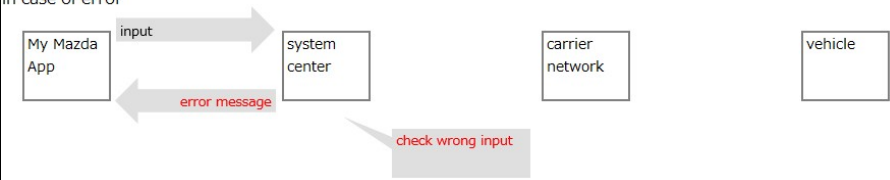
Dealer	Go to Vehicle Confirmation Instructions .
400C05	Description	Occurs when there is no data matching the conditions during processing (ex. inbox update process)	
	MyMazda App Message	Please check the input and try again. [400C05]	
	Process Flow	<p>normal flow</p>

<p>in case of error</p>

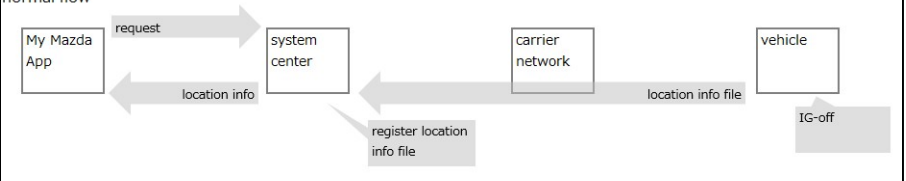
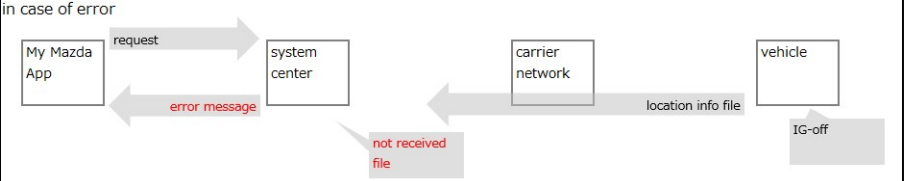
<ul style="list-style-type: none"> • If the information file cannot be sent to the system center when IG-off, the vehicle status may not be updated.
		Dealer	Follow the Vehicle Confirmation Instructions .
400S06	Description	This occurs when location information cannot be obtained when logging in, performing a service that obtains location information, such as displaying a map or Vehicle Finder. Main factorsThe signal condition at the parking place is poor.	
	MyMazda App Message	The location data is not available. [400S06]	
	Cause	The signal condition at the parking place is poor. Occurs in the case of specific conditions of in-vehicle data.

Process Flow	<p>normal flow</p>

<p>in case of error</p>

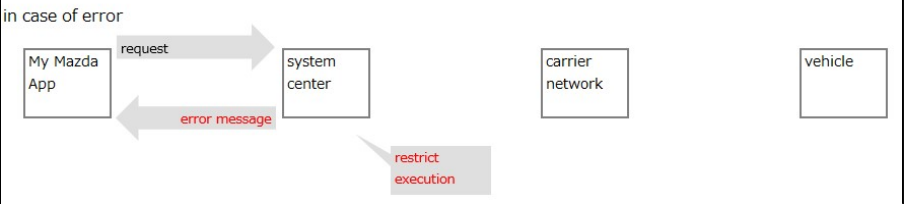
Dealer	Follow the Vehicle Confirmation Instructions .	
400S07	Description	It occurs if code generation for authentication is locked temporarily.	
	MyMazda App Message	N/A	
	Cause	Passcode generation is temporarily locked.	
	Process Flow	<p>normal flow</p>

<p>in case of error</p>

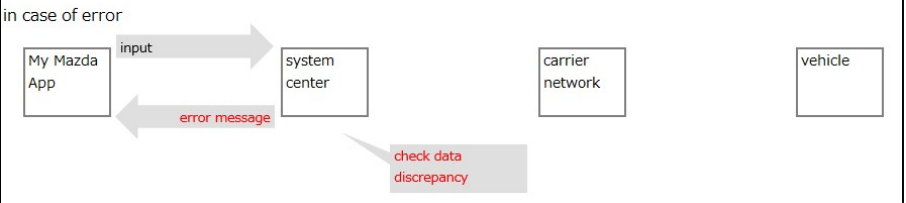
Confirmation/Recovery	Customer	Wait at least 60 minutes and try again.	
	Dealer	If the error continues to occur, there may be a problem with the system center -> Go to " Troubleshooting Instructions ".	
400S08	Description	This occurs when the OTP expiration time (10 minutes) has expired. *OTP = one time passcode	
	MyMazda App Message	N/A	
	Process Flow	<p>normal flow</p>

<p>in case of error</p>

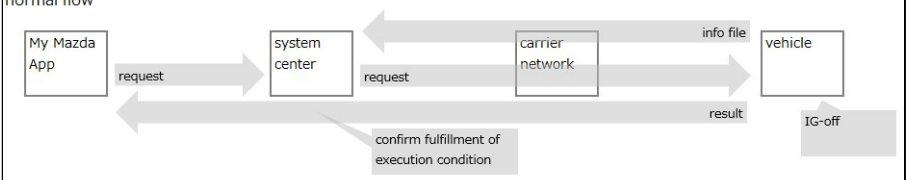
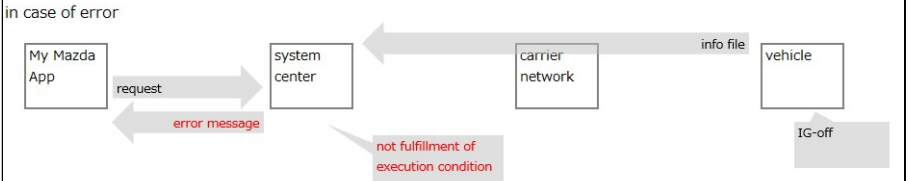
<p>If Remote Engine Start is used, the engine will stop running automatically after 15 minutes for safety, security and emissions. Remote Engine Start can only be used 2 consecutive times while the vehicle is not driven. After the vehicle has been driven, the use count is reset.</p>
	Cause	Exceeded the number of times the remote engine start.
	Process Flow	<p>normal flow</p>

<p>in case of error</p>

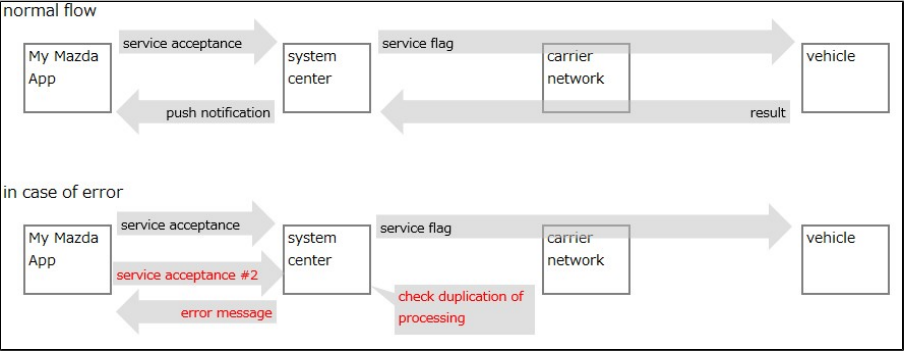
<p>If the information file cannot be sent to the center when IG-off, the vehicle status may not be updated.</p>
<p>400S12</p>	<p>Description</p>	<p>This occurs when a request is accepted again during the contract/ cancellation process for a connected service.</p>	
	<p>MyMazda App Message</p>	<p>"The enrollment process may take a few minutes. Once it is completed, you will be notified in the MyMazda app. Thank you for your patience. [400S12]"</p>	
	<p>Cause</p>	<p>Enrollment request is being processed.</p>	
	<p>Process Flow</p>

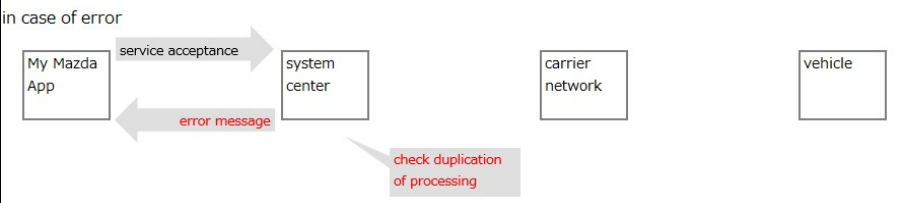
Cause	Enrollment processing has already been completed.	
	Process Flow	<p>normal flow</p>

<p>in case of error</p>

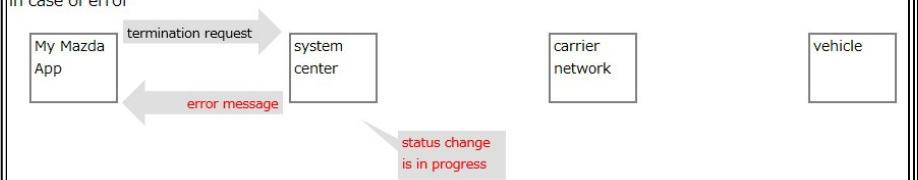
<p>Error</p> <p>Please wait for a while and try again. If the error error continues, please contact the call center. (400S21)</p> <p style="text-align: center;">OK</p>	<p>CV cancelation has failed. Update TCU to the latest software.</p>
Cause	<p>TCU replaced during TCU cancellation process Active In-Car WiFi contract</p>		
Process Flow	<p>normal flow</p>

<p>in case of error</p>

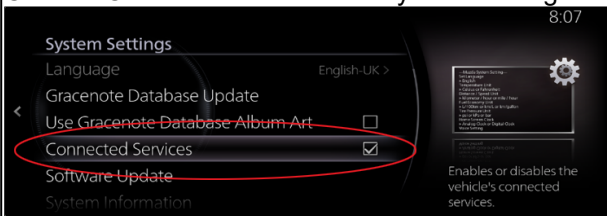
2	Check whether the vehicle requirements for remote operation are met (example : key left in vehicle during remote start function). Does the customer's smartphone MyMazda App have a failure message at the time of occurrence?	Yes	proceed to the next step
		No	Check the remote operation condition again and confirm if it works properly (example : key left in vehicle during remote start function).
3	Check MAZDA CONNECT settings. Confirm Connected Services in System Settings is Enabled.

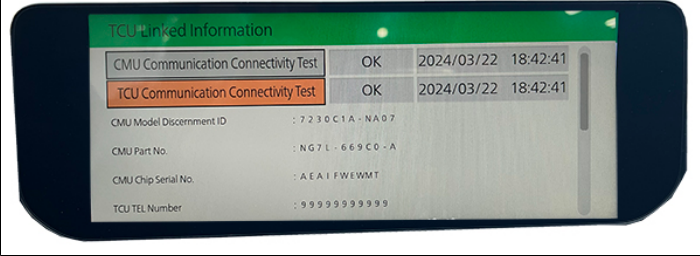
No Contract	CV enrollment needed. Go to Online Enrollment
2.	Perform CMU/TCU Communication Connectivity Test. Go to MGSS -> Diagnostic Assist Function -> Service Information -> TCU Linked Information. Perform: <ul style="list-style-type: none"> CMU Communication Connectivity Test (CMU, TCU Connection) TCU Communication Connectivity Test (TCU, Carrier Connection) 	OK	Go to next step
		NG	Go to Step 5.

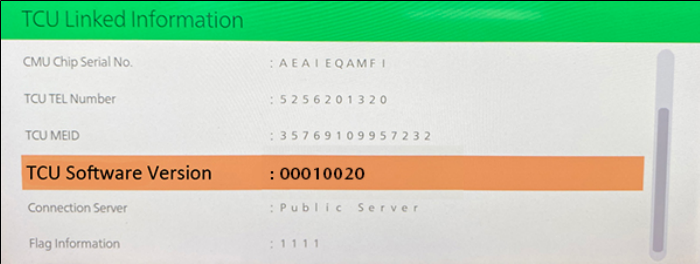
<p>3.</p>	<p>Is the TCU software at the latest software version? (2019 Mazda3, Confirm CMU software is at the latest version) Go to MGSS Diagnostic Assist Function -> Service Information -> TCU Linked Information -> TCU Software Version</p>

<p>Go to MGSS -> Infotainment/TCU -> Telematics Communication Unit (TCU) Updates and confirm at latest software version.</p>	<p>Yes</p> <p>Go to next step.</p> <p>No</p> <p>Update TCU software</p>																			
<p>4.</p>	<p>Check TCU CV Contract Status a. Go to MCVV -> Select "Vehicle Communication Line Status Reference" b. Enter VIN and then select "Search" c. Is the Status Detail "Open Completed" or "Closed Completed"? Example of Open Completed</p> <table border="1" data-bbox="161 1133 963 1238"> <thead> <tr> <th colspan="3">Vehicle Communication Line Atatus</th> </tr> <tr> <th>Status</th> <th>Request Date</th> <th>Status Detail</th> </tr> </thead> <tbody> <tr> <td>Opened</td> <td>10/12/2022 23:01</td> <td>Open Completed 10/12/2022 23:51</td> </tr> </tbody> </table> <p>Example of Closed Completed</p> <table border="1" data-bbox="161 1274 963 1379"> <thead> <tr> <th colspan="3">Vehicle Communication Line Atatus</th> </tr> <tr> <th>Status</th> <th>Request Date</th> <th>Status Detail</th> </tr> </thead> <tbody> <tr> <td>Closed</td> <td>10/12/2022 23:01</td> <td>Closed Completed 10/12/2022 23:51</td> </tr> </tbody> </table>	Vehicle Communication Line Atatus			Status	Request Date	Status Detail	Opened	10/12/2022 23:01	Open Completed 10/12/2022 23:51	Vehicle Communication Line Atatus			Status	Request Date	Status Detail	Closed	10/12/2022 23:01	Closed Completed 10/12/2022 23:51	<p>Open Completed</p> <p>Go to next step</p> <p>Closed Completed</p> <p>CV enrollment needed Go to Online Enrollment</p>
