**Warning Message "Power Steering Failed - Increased Force Requirement" / Fault Memory Entry "B200046 - Functional Restriction" in the Power Steering Control Unit (242/24)**

Model Line: **Taycan (Y1A / Y1B / Y1C)**

Concerns: **Power steering gear**

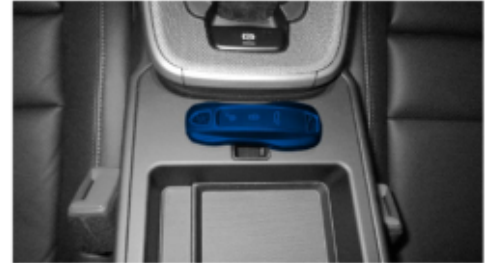
- 2 Place the original remote control in the emergency start tray.
- 3 Connect the **P90999 - PIWIS Tester 4**, establish readiness for operation and start the diagnostic application.
- 4 Reset power steering adaptation values.
  - 4.1 Select the **power steering** control unit in the overview.
  - 4.2 Select the **'Actuators / test'** tab.
  - 4.3 Select the **'All'** group and press **(F12)** to confirm further.
  - 4.4 Select the **'Reset all Learn values'** menu item and confirm with **(F12)**.
  - 4.5 Press **(F8)** to start.
- 5 Re-code power steering control unit through commissioning.

Representation of emergency start tray as an example
