WRE7 - Re-Programming Porsche Rear Seat Entertainment (Workshop Campaign)

Model Line: **Panamera (971)**

Concerns: **Porsche Rear Seat Entertainment (M-no. 9WY)**

Action: Re-program Porsche Rear Seat Entertainment display unit with an updated data record.

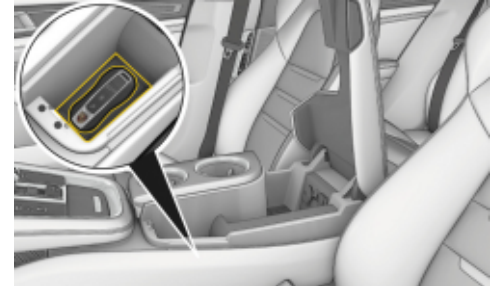
Place the driver's key in the storage compartment.

- 11.1 Switch on the ignition.
 - 11.2 **P90999 - PIWIS tester 4** must be connected and switched on.
 - 11.3 Select "**PCM control unit**" and confirm.
 - 11.4 Cancel VAL and start backup documentation.
 - 11.5 After a short time, the "Cancel backup documentation" function is activated in the PCM. Then select "**Cancel backup documentation**". The PCM then restarts again and PCM returns to the normal user interface.
PCM is restarted.
 - 11.6 **P90999 - PIWIS Tester 4** must now be disconnected from the vehicle.
 - 11.7 Switch off the ignition.
- 12 Establish bus idle.

For programming to begin, the backup documentation must be initiated via the PIWIS Tester, but not performed.
