GROUP	MODEL
Subsequent Repair Action	2022-2024MY EV6, EV6 GT (CV)
NUMBER	DATE
SC327Y	December 2024

SUBSEQUENT REPAIR ACTION

ICCU AND FUSE REPLACEMENT (SC327Y)

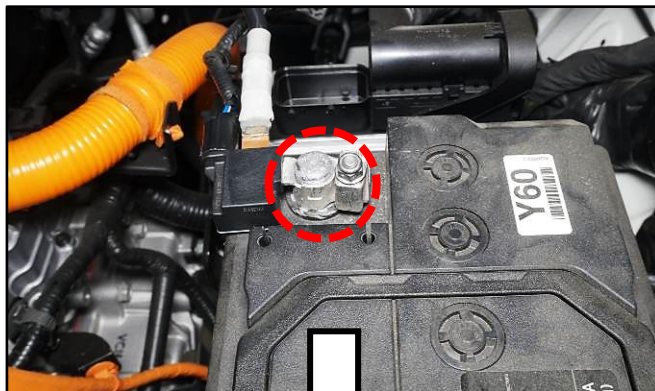
2. Open the hood and disconnect the battery negative (-) post cable.

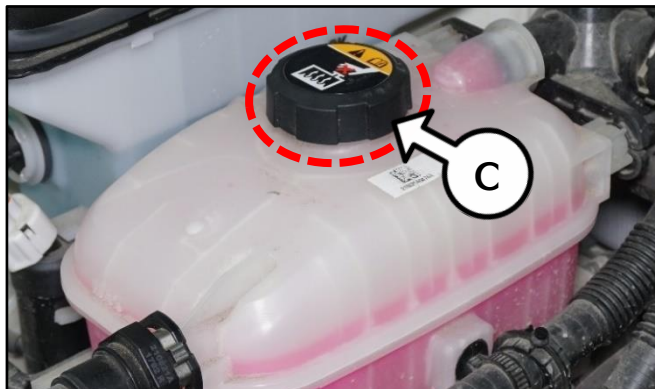
4. Open the coolant reservoir tank pressure cap (C) to release pressure.

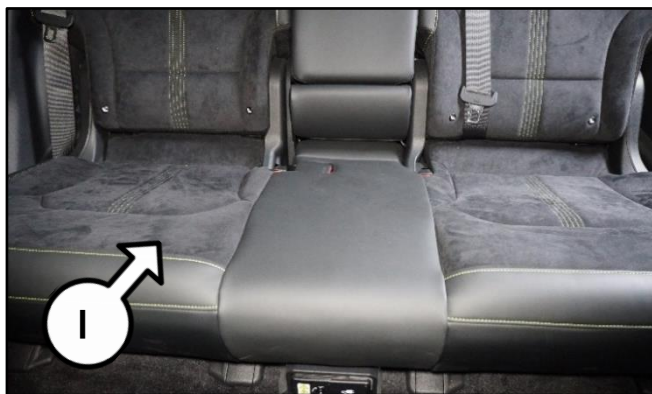
11. Remove the rear seat assembly (I) by referring to "Body Interior and Exterior → Rear Seat Assembly → Removal and Installation" in the applicable Shop Manual on KGIS.

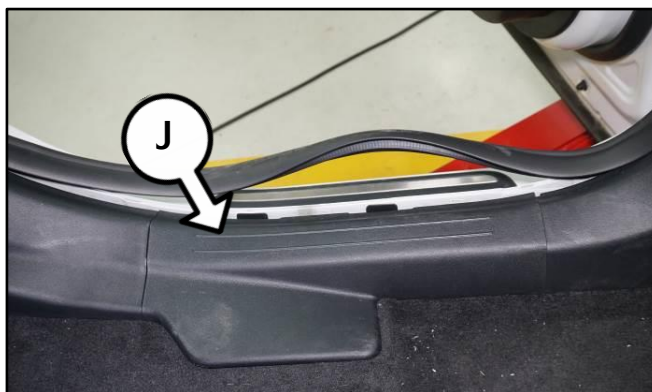
12. Remove the left (LH) and right (RH) side rear door scuff trim (J).

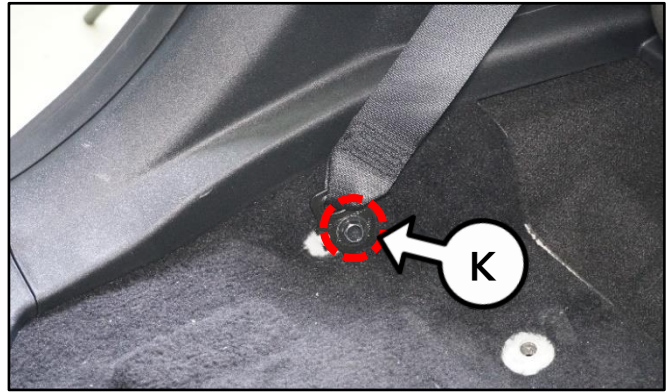
13. Remove both (LH and RH) the rear seat belt lower anchor retaining bolts (K).

Tightening torque for bolt (N):
29.7 - 44.1 lb.ft (40.2 - 59.8 N.m)

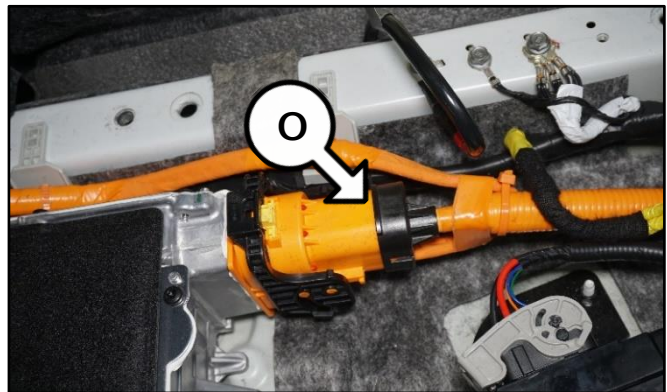
17. Disconnect the combo charge inlet wire harness connector (O).

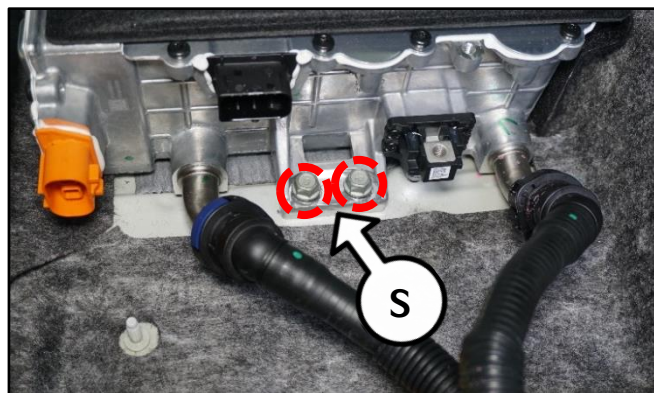
19. Remove the two (2) ICCU assembly retaining bolts (S).

Tightening torque for bolts (V):
5.8 - 8.7 lb.ft (7.8 - 11.8 N.m)
