GROUP	MODEL
ELE	2025MY EV9 (MV1, MV1a)
NUMBER	DATE
375	March 2025

TECHNICAL SERVICE BULLETIN

SERVICE ACTION: CCU OPERATION LOGIC IMPROVEMENT (SA608)

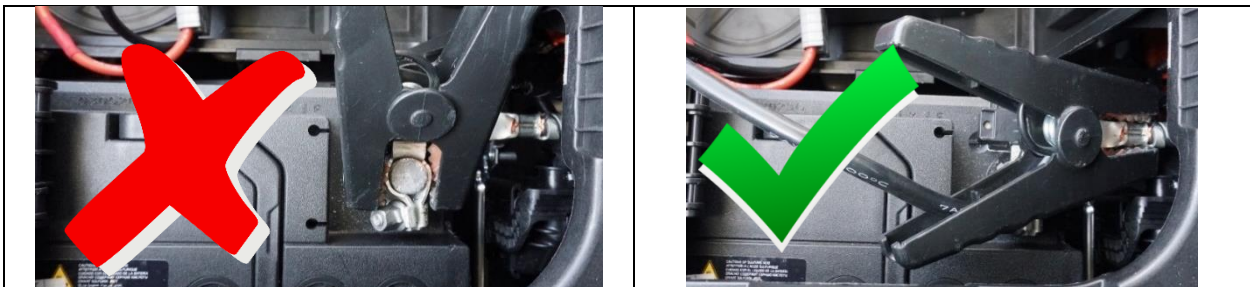
[Connect the negative \(-\) terminal to the battery as shown below.](#)

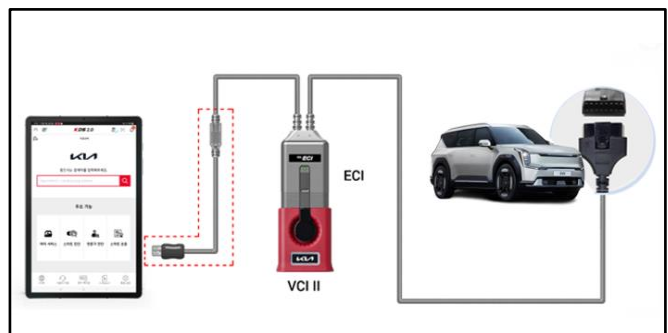
Connect the ECI DLC connector to the OBD-II connector, located under the driver's side of the instrument panel.

Connect the ECI USB -C connector to the KDS tablet.

Connect the VCI II to the ECI OBD-II connector.

Ensure the ECI cable is configured by referring to the ['KDS Configuration for ECI Cable Usage'](#).

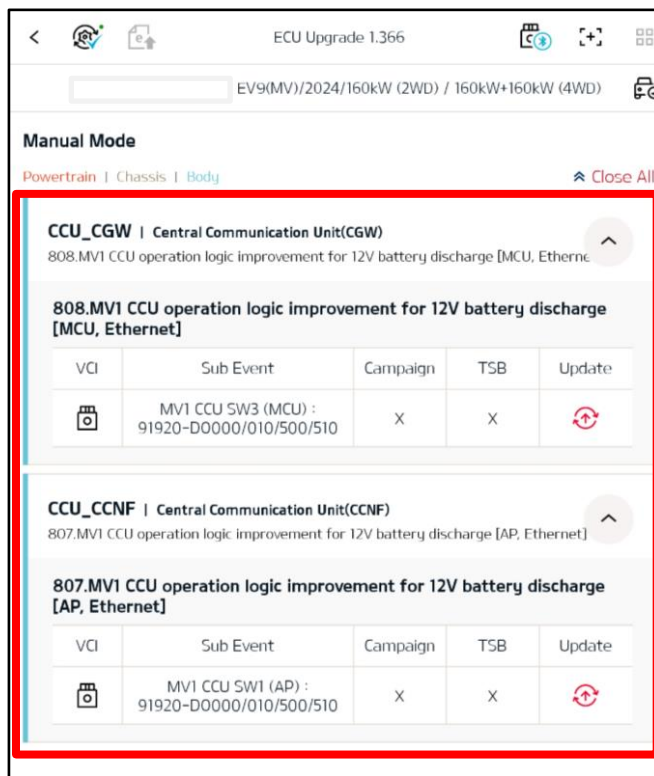
BOTH Upgrade Event #807 AND Upgrade Event #808 are REQUIRED to be installed on ALL MV1 (Korean built) vehicles.

Select the applicable 'CCU_CCNF' and 'CCU_CGW' system module and the Event Group.

- 807.MV1 CCU Operation Logic Improvement for 12V Battery Discharge [AP, Ethernet]

- 808.MV1 CCU Operation Logic Improvement for 12V Battery Discharge [MCU, Ethernet]

Verify the affected vehicle Calibration Identification of the applicable ECU ROM ID and reference the Information Table on page 3 as necessary.

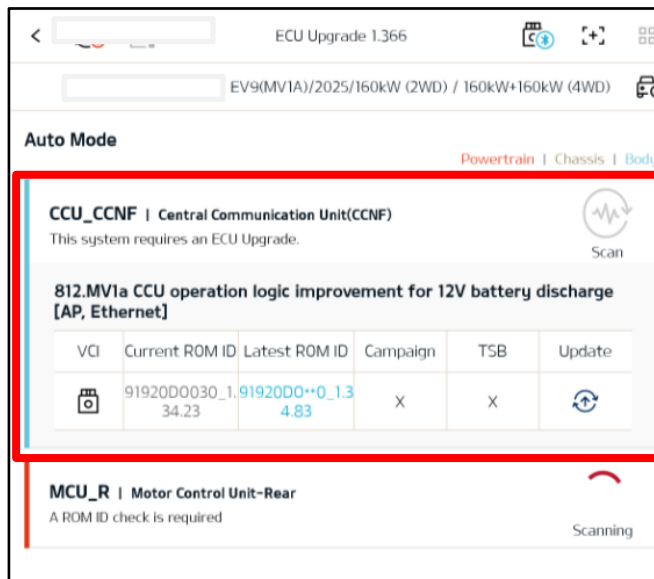
MV1a (KaGA built) vehicles only require Upgrade Event #812 to be installed.

Select the applicable 'CCU_CCNF' system module and the Event Group.

- 812.MV1a CCU Operation Logic Improvement for 12V Battery Discharge [AP, Ethernet]

Verify the affected vehicle Calibration Identification of the applicable ECU ROM ID and reference the Information Table on page 3 as necessary.
