GENERAL MOTORS
DCS7172
URGENT - DISTRIBUTE IMMEDIATELY

Subject: N252494750 - Service Update
Sound Mode Not Available in Radio Settings

Models: 2025 Cadillac OPTIQ

N252494750 Sound Mode Not Available in Radio Settings

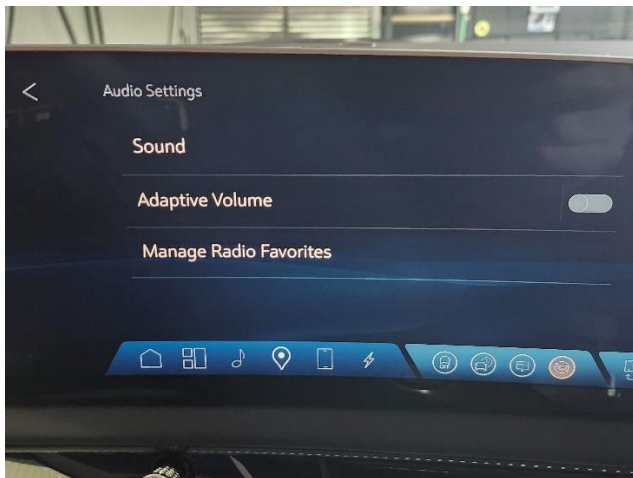
6862654

2. Select "Sound".

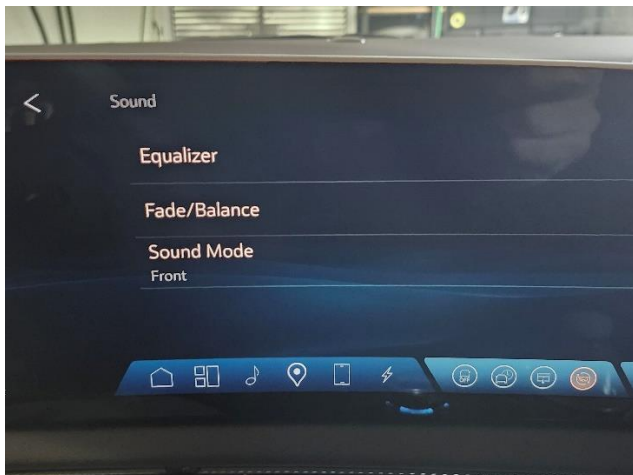
6862655

3. Select "Sound Mode".

- If the "Sound Mode" menu opens as designed, no further action is required.
- If the "Sound Mode" menu does not open, opens and instantly closes, or blanks out proceed to the next step.

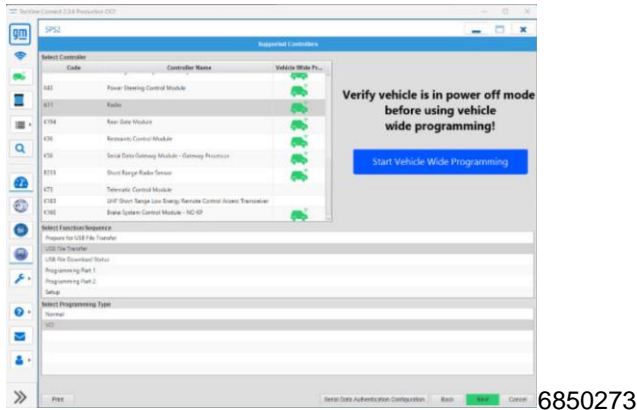
7. Select A11 Radio, USB File Transfer, VCI as pictured above.

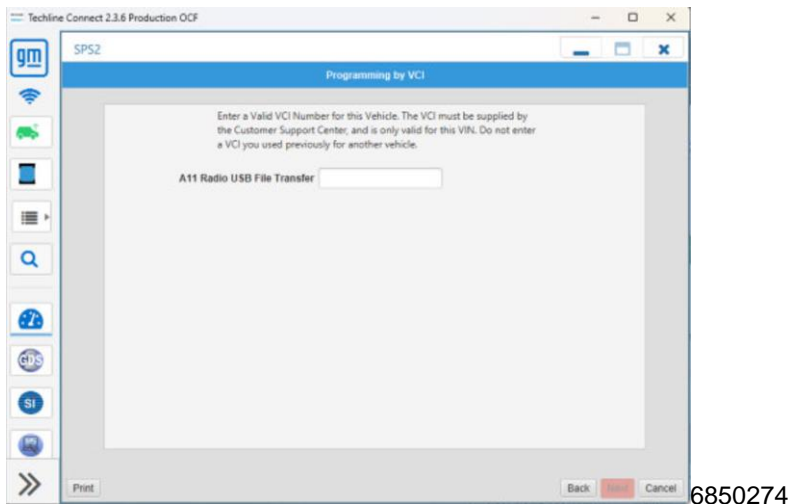
8. Enter the USB File Transfer number supplied by TCSC, then select "Next".

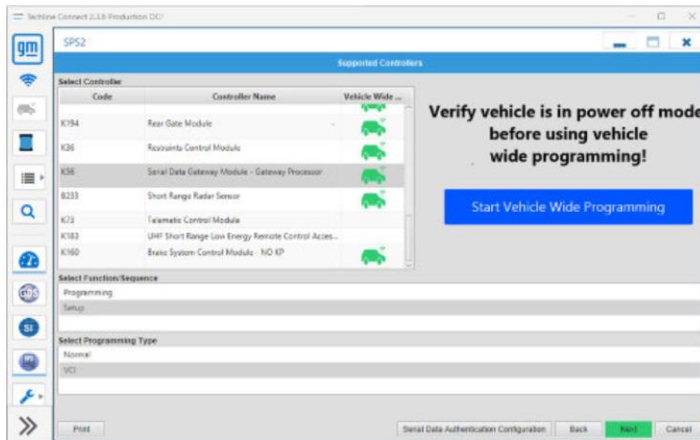
6850285

12. Select Serial Data Gateway Module, Setup, and VCI as indicated above.

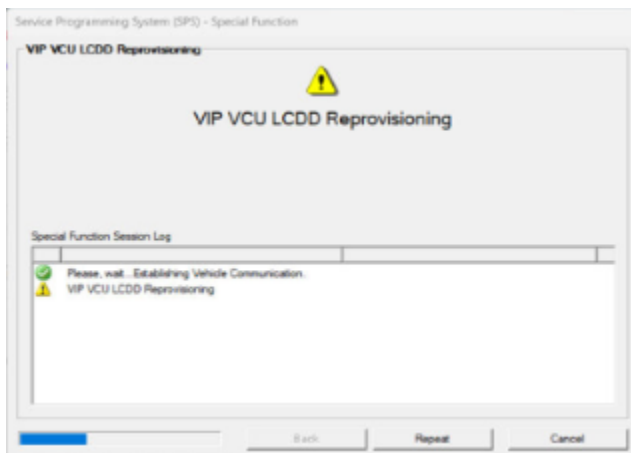
6850287

14. Follow the on-screen instructions to complete the Serial Data Gateway Module Setup. "Repeat" Screen may appear during Run/Service Mode procedure, select "repeat" as necessary.

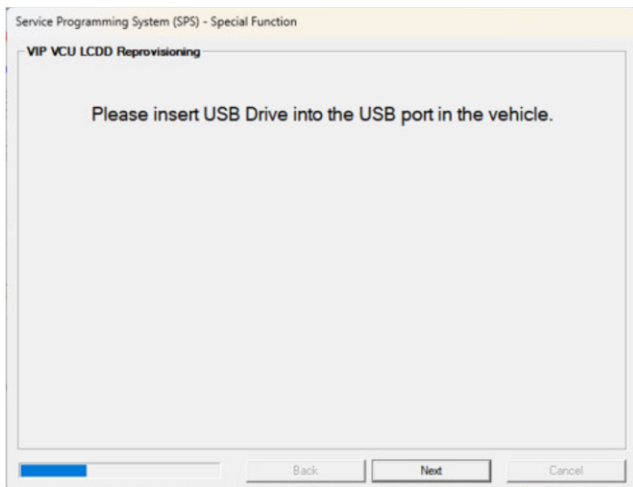
6850288

15. When the above message is displayed, insert the USB-C Drive into the USB-C port of the vehicle. Select "Next" after inserting.

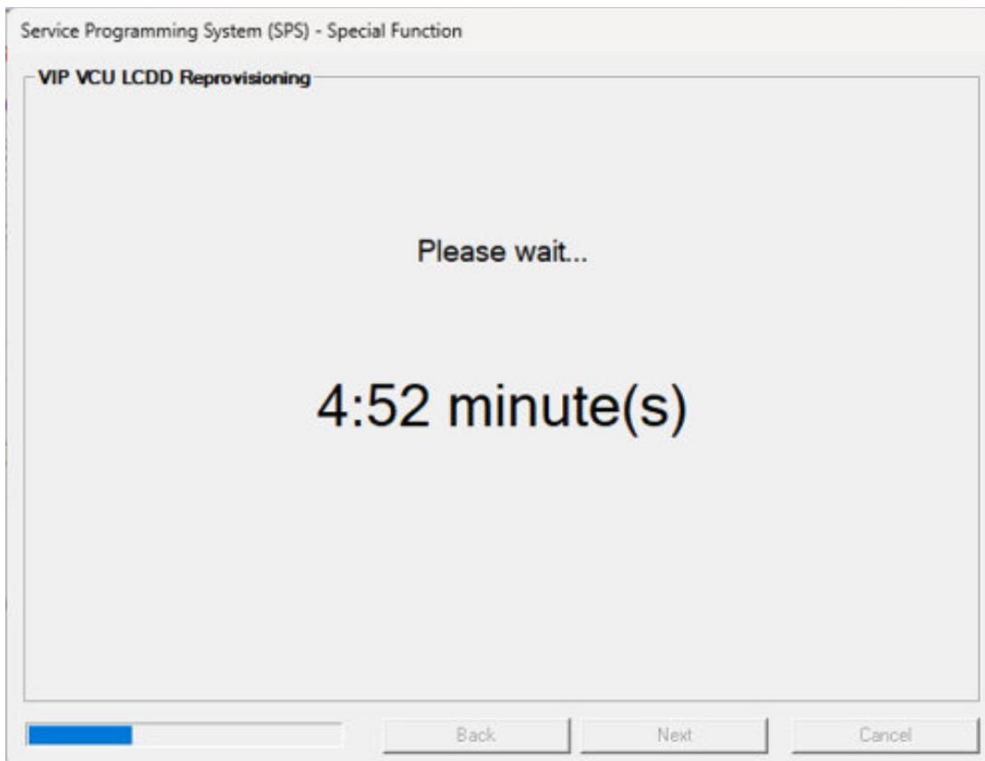
6850293

16. A 5 minute timer will begin counting down on SPS as shown above.
17. The radio display should go black, an "insert USB recovery disk" message will momentarily appear, and then a progress bar will be present (If the message does not present, allow the 5 minute timer to countdown).

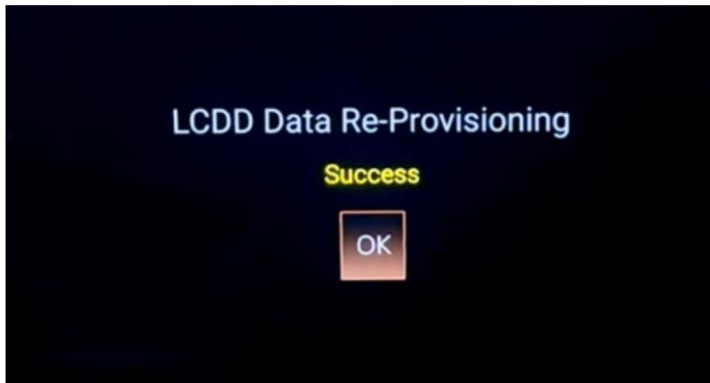
6850299

18. If programming is successful, the above screen will be displayed on the radio display.

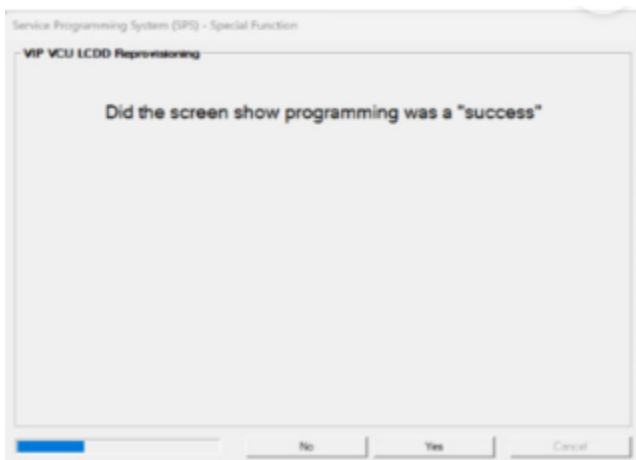
6851253

19. The above screen will be displayed on SPS. Please select the applicable "yes" or "no" option.

- If the LCDD Data Re-Provisioning Success screen did not present after the 5 minute timer, remove the USB-C drive and reinsert, select "No" within the SPS popup, and the procedure will reattempt.
- Select "Yes" if the screen appeared as indicated in the above step.
