Technical Service Bulletin

GROUP CAMPAIGN	NUMBER 25-01-022H
DATE MARCH 2025	MODEL(S) IONIQ 5 N (NE EV N)

SUBJECT: CENTRAL COMMUNICATION UNIT (CCU) MULTIPLE SUBSYSTEM SOFTWARE UPDATE (SERVICE CAMPAIGN TCTB)

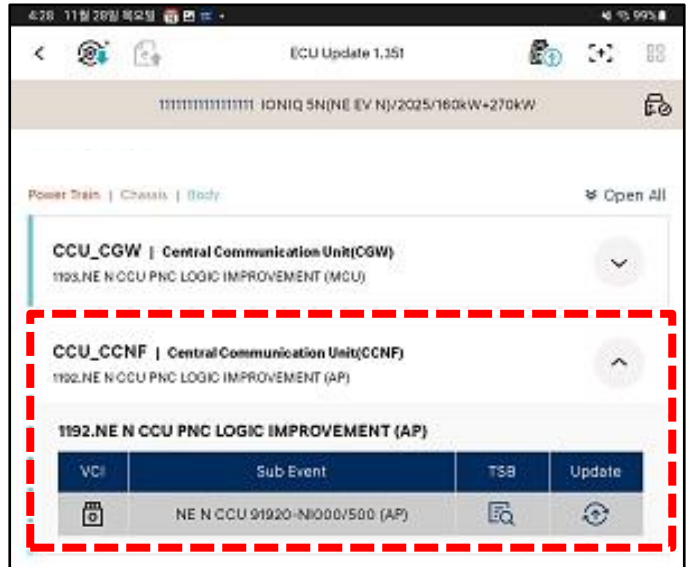
If the update fails, please remove the power connector or the battery (–) connector from the indoor fuse box for at least **5 seconds** and reassemble it to retry the update.

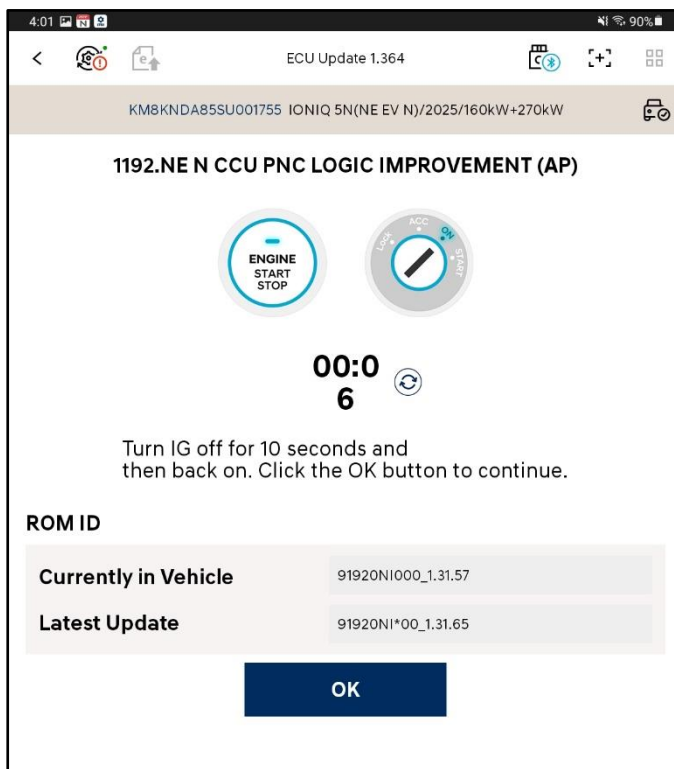
- After the ECU update process shows **100%** complete, follow the prompts on the screen to cycle the ignition **OFF** for at least **10 seconds** to reset the control unit (certain models may take up to **30 seconds**).

Use the **Refresh** button to reset the timer.

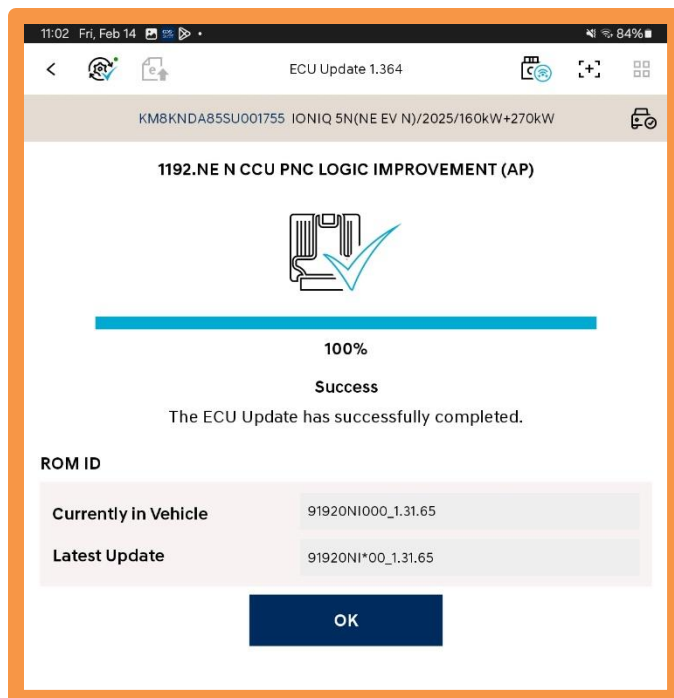
Take a screenshot of the ECU update complete screen using your tablet and upload to STUI (AP, 1 of 2 required).

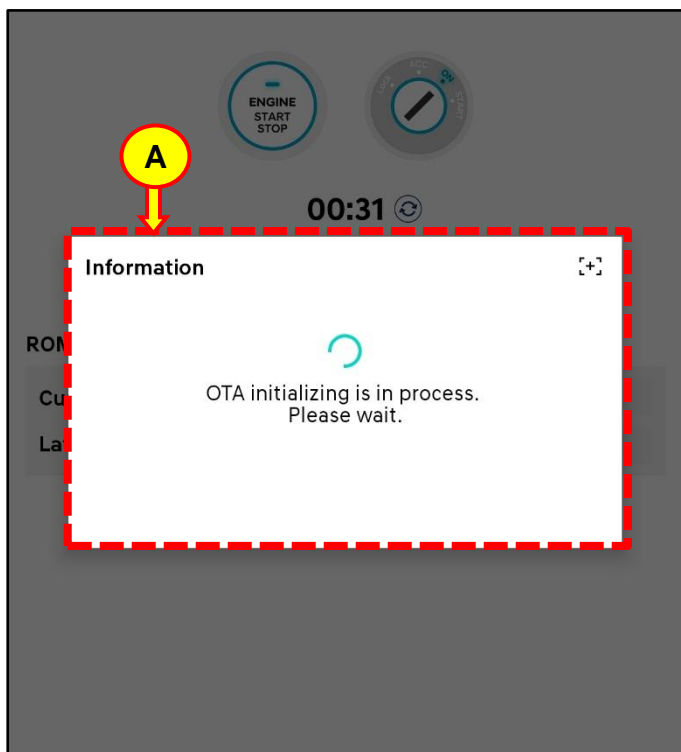
5. OTA initialization should perform automatically (A):
- If OTA initialization performs automatically, then proceed with the service procedure.
 - If the OTA initialization process fails, complete it manually under:
S/W Management > CCU_CCNF - Central Communication Unit (CCNF) > OTA Initialization (B).

- 10. Perform **steps 5 – 7** above to complete the update.
- 11. Place in **Ready** mode to confirm proper operation of the vehicle.

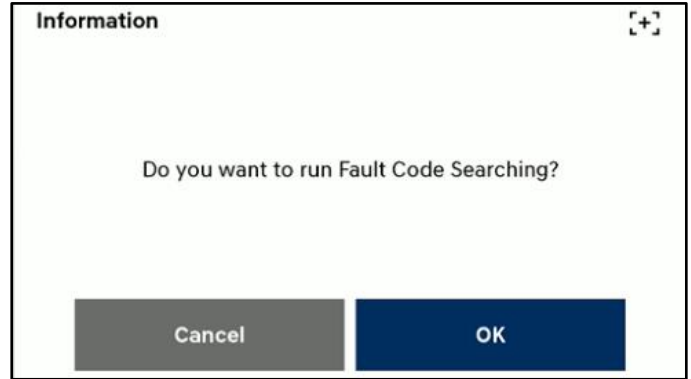
- 6. Perform an **All Systems Fault Code** search and erase DTC history that had incidentally occurred from the ECU update.

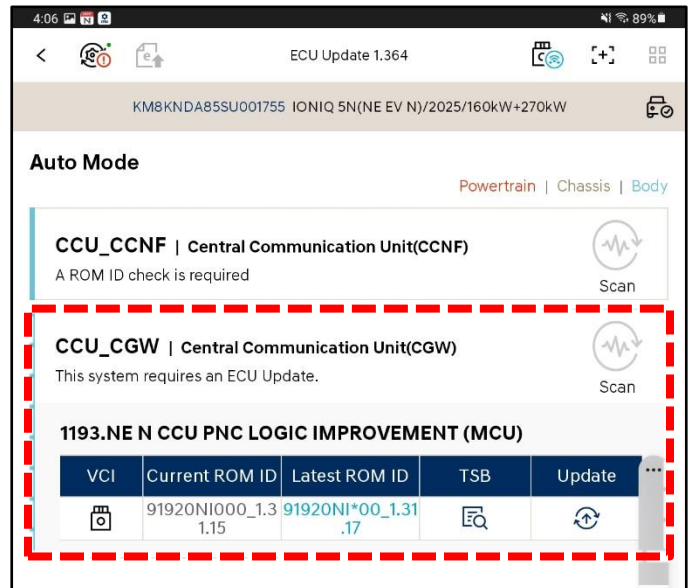
- 8. Perform the **second of 2** required ECU updates in **Auto Mode (MCU)**.

Both **AP** and **MCU** subsystems **must** be updated.

Use the ID Check to verify the ROM ID before updating the software.

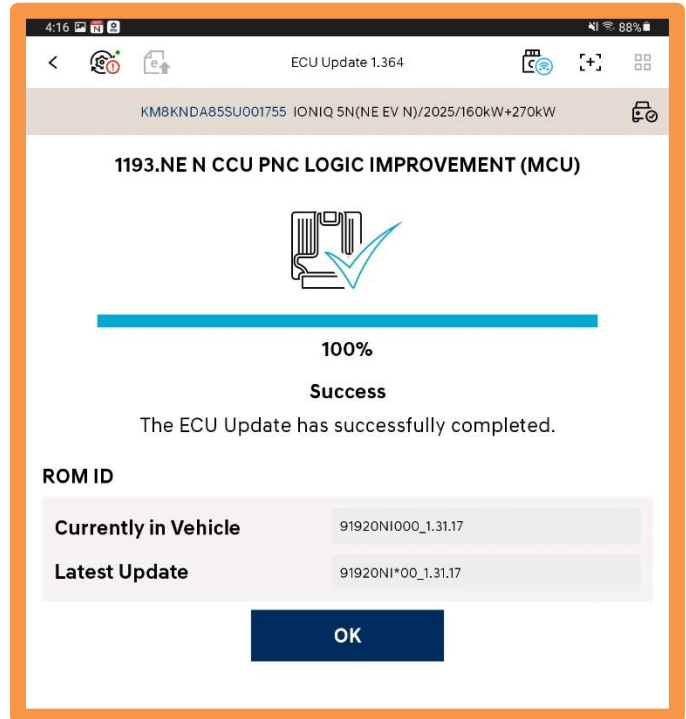
Take a screenshot of the ECU update complete screen using your tablet and upload to STUI (MCU, 2 of 2 required).
